Technical Service Bulletin

17-01-032

Elantra (AD)

**2017 ELANTRA (AD) MDPS MOTOR REPLACEMENT
(RECALL CAMPAIGN 161)**

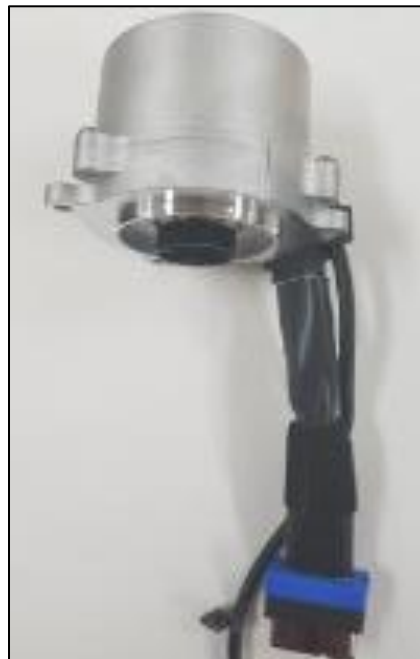
Description: Certain 2017 MY Elantra (AD) vehicles may illuminate the "EPS" indicator lamp in the instrument cluster due to a connection issue at the MDPS Motor-to-ECU connector. When the "EPS" lamp is illuminated, the vehicle may revert to manual steering mode. Steering control can be maintained; however, manual steering mode requires greater driver effort, particularly at low speeds. This could result in an increased risk of a crash. This bulletin describes the procedure to replace the MDPS Motor.
