<b>GROUP</b> <b>Safety Recall Campaign</b>	<b>MODEL</b> <b>2011-2014MY Optima (QF/TF)</b> <b>2012-2014MY Sorento (XMa)</b> <b>2011-2013MY Sportage (SL)</b>
	<b>NUMBER</b> <b>SC147 (Rev 2, 6/29/2017)</b>	<b>DATE</b> <b>June 2017</b>
<b>SAFETY RECALL CAMPAIGN</b>		
<b>SUBJECT: THETA II ENGINE INSPECTION AND/OR REPLACEMENT</b>

This bulletin provides the procedure to inspect, and if necessary, replace the engine long block assembly on the following vehicles:

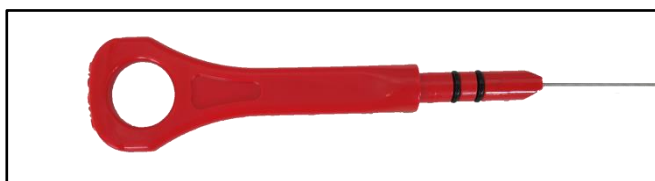
**Red Dipstick (P/N: 26611 2G040)  
(NO REPLACEMENT REQUIRED)**

**If the vehicle is equipped with a RED dipstick, replacement is not necessary.**
