| | <b>GROUP</b><br><b>Safety Recall Campaign</b> | <b>MODEL</b><br><b>2011-2014MY Optima (QF/TF)</b><br><b>2012-2014MY Sorento (XMa)</b><br><b>2011-2013MY Sportage (SL)</b> |
| | <b>NUMBER</b><br><b>SC147 (Rev 7, 03/29/2018)</b> | <b>DATE</b><br><b>June 2017</b> |
| <b>SUBJECT: THETA II ENGINE INSPECTION AND/OR REPLACEMENT</b> | | |

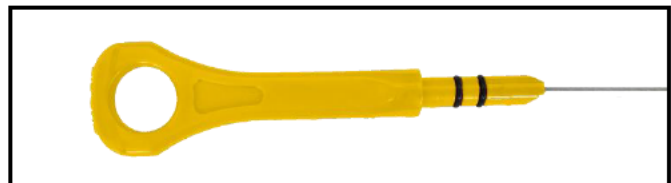
**Yellow Dipstick (P/N: 26611 2G020)**

21. Disconnect the engine noise tester from the KDS and carefully remove the adapter (B) from the dipstick tube by grasping the engine noise tester adapter.
22. For 2011-2013MY vehicles only: If the vehicle is equipped with a YELLOW dipstick, discard the dipstick and replace it with a new ORANGE one.

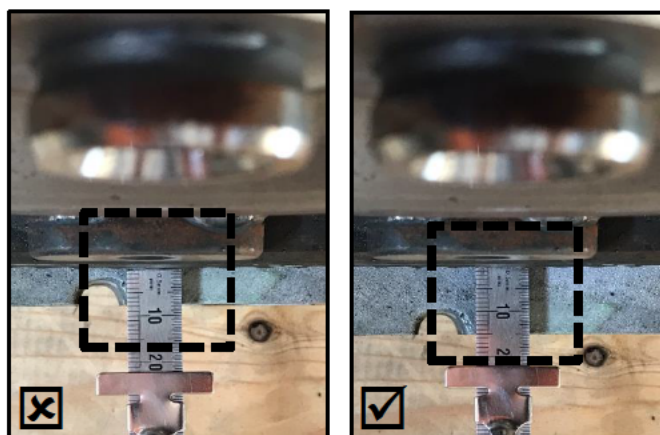
Not Fully Inserted

Fully Inserted

- If the torque converter has moved from the fully inserted position, carefully push inward while rotating the torque converter until it is recessed approximately 9/16 – 5/8" (14 – 16mm) (☑) into the transaxle case when reinstalling the automatic transaxle.
