| | <b>GROUP</b><br><b>Safety Recall Campaign</b> | <b>MODEL</b><br><b>2011-2014MY Optima (QF/TF)</b><br><b>2012-2014MY Sorento (XMa)</b><br><b>2011-2013MY Sportage (SL)</b> |
| | <b>NUMBER</b><br><b>SC147 (Rev 11, 04/13/2020)</b> | <b>DATE</b><br><b>June 2017</b> |

**SUBJECT: THETA II ENGINE INSPECTION AND/OR REPLACEMENT**

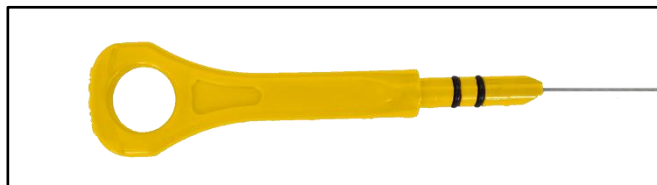
**Yellow Dipstick (P/N: 26611 2G020)**

21. Disconnect the engine noise tester from the KDS and carefully remove the adapter (B) from the dipstick tube by grasping the engine noise tester adapter.
22. For 2011-2013MY vehicles only: If the vehicle is equipped with a YELLOW dipstick, discard the dipstick and replace it with a new ORANGE one.

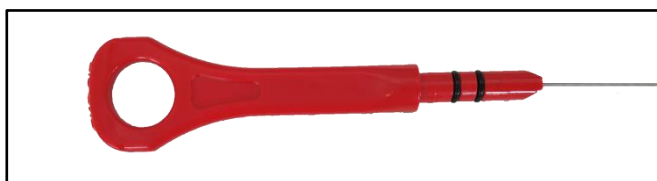
**Red Dipstick (P/N: 26611 2G040)  
(NO REPLACEMENT REQUIRED)**

**If the vehicle is equipped with a RED dipstick, replacement is not necessary.**

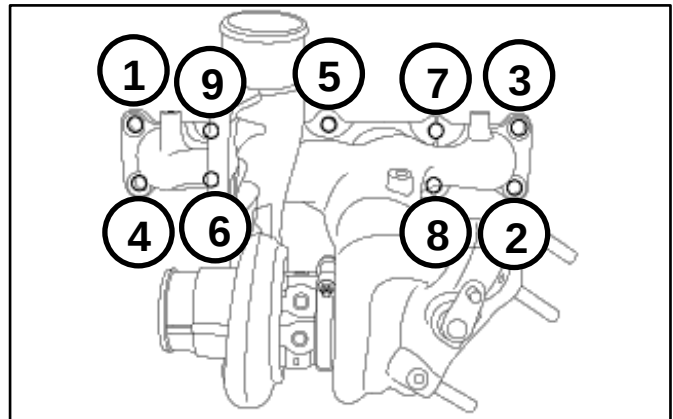
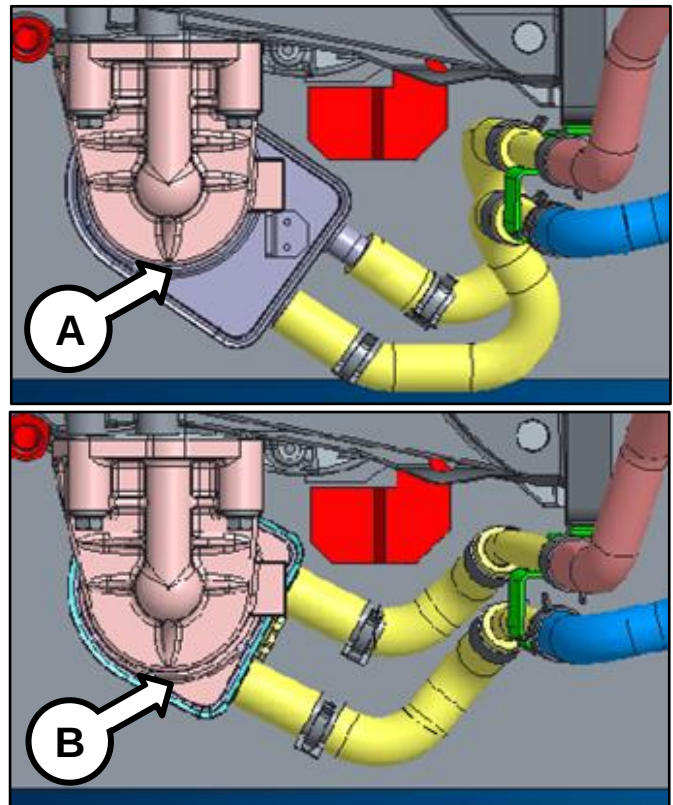
New engines may be supplied with a different oil cooler. Use steps below to determine the need for a replacement oil cooler tube assembly.

- If the new engine's (bigger) oil cooler (A) does not match the old engine's (smaller) oil cooler (B), replace the oil cooler tube assembly with the improved part. See parts table on page 15.
- If the new engine's (bigger) oil cooler (A) matches the old engine's (bigger) oil cooler (A), reuse the old engine's oil cooler tube assembly.
- If the new engine's (smaller) oil cooler (B) matches the old engine's (smaller) oil cooler (B), reuse the old engine's oil cooler tube assembly.
