| | <b>GROUP</b><br><b>Safety Recall Campaign</b> | <b>MODEL</b><br><b>2011-2014MY Optima (QF/TF)</b><br><b>2012-2014MY Sorento (XMa)</b><br><b>2011-2013MY Sportage (SL)</b> |
| | <b>NUMBER</b><br><b>SC147 (Rev 8, 05/11/2018)</b> | <b>DATE</b><br><b>June 2017</b> |
| <b>SUBJECT: THETA II ENGINE INSPECTION AND/OR REPLACEMENT</b> | | |

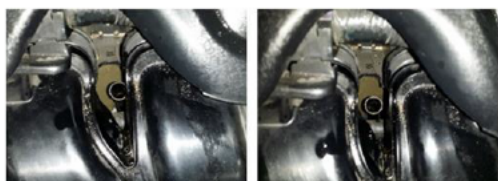
To avoid false readings, ensure the adapter (B) is properly inserted into the dipstick tube and that the tube is not in contact with the intake manifold.

If the dipstick tube is not centered and is close to or touching the manifold, carefully adjust (bend) and center the dipstick tube with a pry bar.

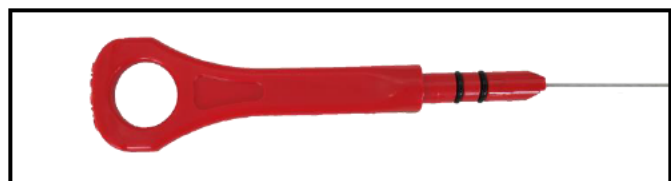
**Red Dipstick (P/N: 26611 2G040)  
(NO REPLACEMENT REQUIRED)**

**If the vehicle is equipped with a RED dipstick, replacement is not necessary.**

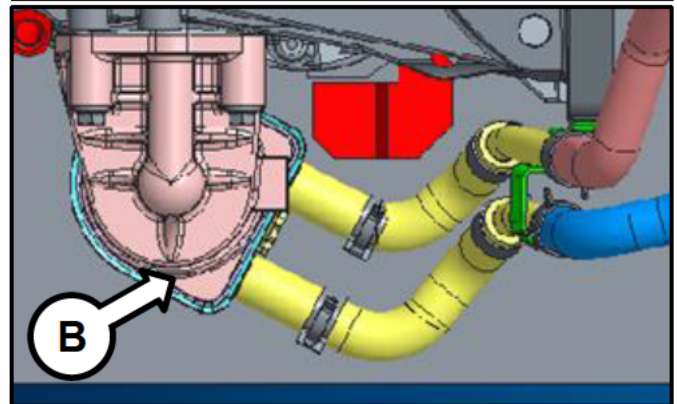
New engines may be supplied with a different oil cooler. Use steps below to determine the need for a replacement oil cooler tube assembly.

- If the new engine's (bigger) oil cooler (A) does not match the old engine's (smaller) oil cooler (B), replace the oil cooler tube assembly with the improved part. See parts table on page 15.
- If the new engine's (bigger) oil cooler (A) matches the old engine's (bigger) oil cooler (A), reuse the old engine's oil cooler tube assembly.
- If the new engine's (smaller) oil cooler (B) matches the old engine's (smaller) oil cooler (B), reuse the old engine's oil cooler tube assembly.
