| | <b>GROUP</b><br><b>Safety Recall Campaign</b> | <b>MODEL</b><br><b>2011-2014MY Optima (QF/TF)</b><br><b>2012-2014MY Sorento (XMa)</b><br><b>2011-2013MY Sportage (SL)</b> |
| | <b>NUMBER</b><br><b>SC147 (Rev 14, 01/29/2021)</b> | <b>DATE</b><br><b>June 2017</b> |

**SUBJECT: THETA II ENGINE INSPECTION AND/OR REPLACEMENT**

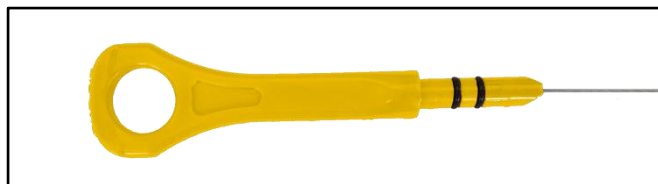
For 2011-2013MY vehicles only: If the vehicle is equipped with a YELLOW dipstick, discard the dipstick and replace it with a new ORANGE one.

**If the vehicle is equipped with a RED dipstick, replacement is not necessary.**

On all vehicles with an inspection result of "PASS": Change the oil and filter and refill with 5W-30 oil. Use the new (ORANGE) or verified (RED) dipstick to verify proper oil level after oil change and if applicable, reset the maintenance reminder on the instrument cluster.

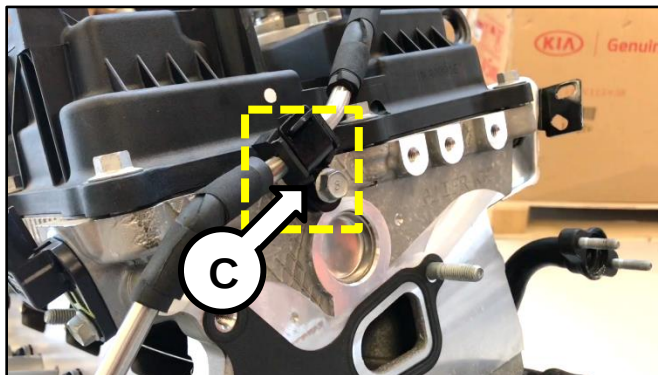
If the bracket and bolt are missing, order and install a new bracket and bolt.

2. Install the pipe retaining bracket and bolt (C) and torque to specifications.

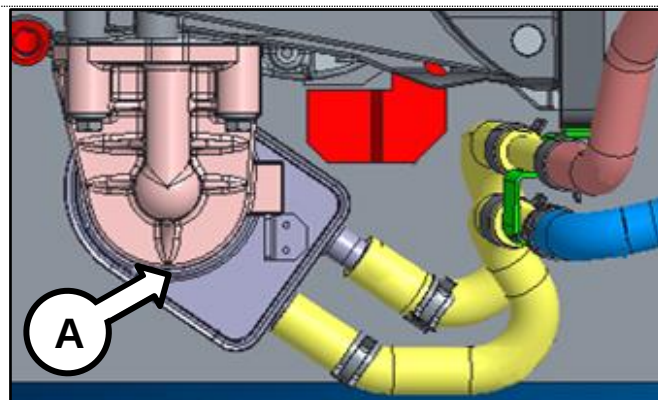
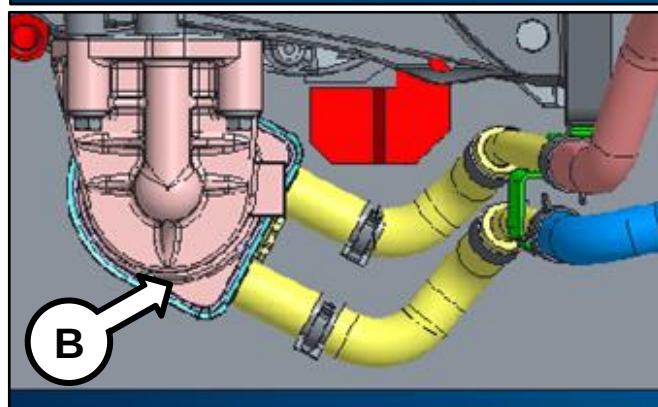
New engines may be supplied with a different oil cooler. Use steps below to determine the need for a replacement oil cooler tube assembly.

- If the new engine's (bigger) oil cooler (A) does not match the old engine's (smaller) oil cooler (B), replace the oil cooler tube assembly with the improved part. See parts table on page 20-21.
- If the new engine's (bigger) oil cooler (A) matches the old engine's (bigger) oil cooler (A), reuse the old engine's oil cooler tube assembly.
- If the new engine's (smaller) oil cooler (B) matches the old engine's (smaller) oil cooler (B), reuse the old engine's oil cooler tube assembly.
