GROUP
Safety Recall Campaign

MODEL
**2011-2014MY
Optima (QF/TF)
2012-2014MY
Sorento (XMa)
2011-2013MY
Sportage (SL)**

NUMBER
SC147 (Rev 10, 05/16/2019)

SUBJECT: THETA II ENGINE INSPECTION AND/OR REPLACEMENT

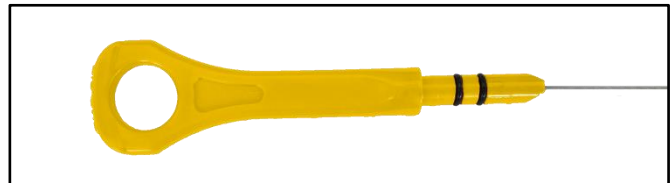
Yellow Dipstick (P/N: 26611 2G020)

21. Disconnect the engine noise tester from the KDS and carefully remove the adapter (B) from the dipstick tube by grasping the engine noise tester adapter.
22. For 2011-2013MY vehicles only: If the vehicle is equipped with a YELLOW dipstick, discard the dipstick and replace it with a new ORANGE one.

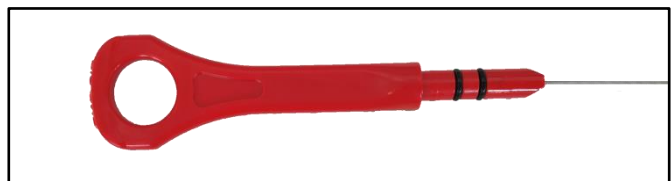
**Red Dipstick (P/N: 26611 2G040)
(NO REPLACEMENT REQUIRED)**

If the vehicle is equipped with a RED dipstick, replacement is not necessary.

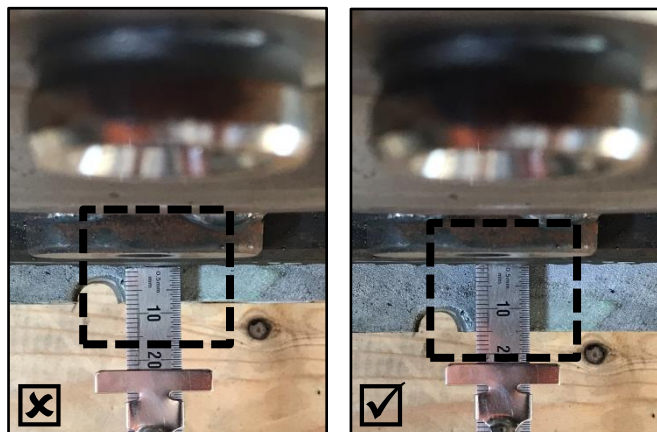
Not Fully Inserted

Fully Inserted

- If the torque converter has moved from the fully inserted position, carefully push inward while rotating the torque converter until it is recessed approximately 9/16 – 5/8" (14 – 16mm) (☑) into the transaxle case when reinstalling the automatic transaxle.
