<b>GROUP</b> <b>Safety Recall Campaign</b>	<b>MODEL</b> <b>2011-2014MY Optima (QF/TF)</b> <b>2012-2014MY Sorento (XMa)</b> <b>2011-2013MY Sportage (SL)</b>
	<b>NUMBER</b> <b>SC147 (Rev 3, 7/14/2017)</b>	<b>DATE</b> <b>June 2017</b>
<b>SAFETY RECALL CAMPAIGN</b>		
<b>SUBJECT: THETA II ENGINE INSPECTION AND/OR REPLACEMENT</b>

This bulletin provides the procedure to inspect, and if necessary, replace the engine long block assembly on the following vehicles:

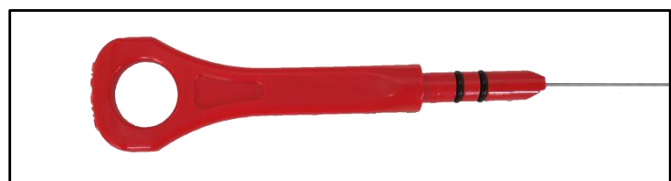
**Red Dipstick (P/N: 26611 2G040)  
(NO REPLACEMENT REQUIRED)**

**If the vehicle is equipped with a RED dipstick, replacement is not necessary.**
