| | <b>GROUP</b><br><b>Safety Recall Campaign</b> | <b>MODEL</b><br><b>2011-2014MY Optima (QF/TF)</b><br><b>2012-2014MY Sorento (XMa)</b><br><b>2011-2013MY Sportage (SL)</b> |
| | <b>NUMBER</b><br><b>SC147 (Rev 9, 11/09/2018)</b> | <b>DATE</b><br><b>June 2017</b> |
| <b>SUBJECT: THETA II ENGINE INSPECTION AND/OR REPLACEMENT</b> | | |

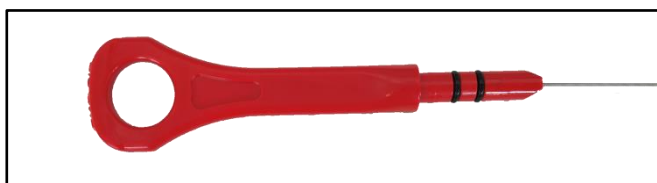
**Red Dipstick (P/N: 26611 2G040)  
(NO REPLACEMENT REQUIRED)**

**If the vehicle is equipped with a RED dipstick, replacement is not necessary.**

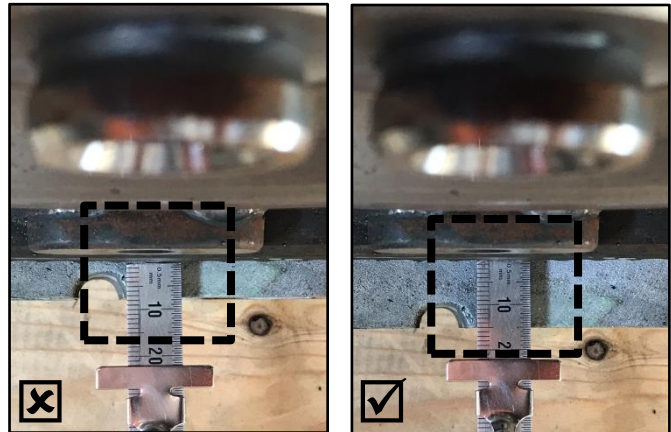
Not Fully Inserted

Fully Inserted

- If the torque converter has moved from the fully inserted position, carefully push inward while rotating the torque converter until it is recessed approximately  $\frac{9}{16}$  –  $\frac{5}{8}$ " (14 – 16mm) (✓) into the transaxle case when reinstalling the automatic transaxle.
