Vehicle Safety Recall - Technical Service Bulletin

Subject: Autocar® ACX with Cummins ISX12G engine and Peterbilt® 320 with Cummins ISX12G engine

Bulletin Date: April 2017

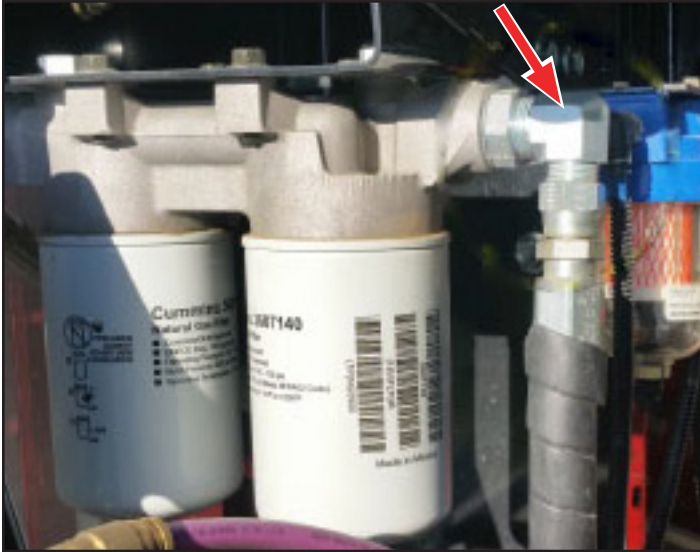
Figure 3

Autocar ISX12G units may have been shipped with a SAE - 12 x #10 JIC 90 fitting at the filter (Figure 3). The SAE - 12 x #10 JIC 90 fitting does not fit into the housing correctly, allowing for a potential slow leak of CNG.

7. Remove the low pressure hose from the fitting using a 1" open end wrench. Use a 1-1/4" wrench to carefully remove the fitting from the filter housing. Discard the fitting.

8. Use a 1-1/16" wrench and a 1-1/4" wrench to install the correct fitting (P/N 1546290) and reducer (if Ngen McNeilus system use reducer P/N 1260596 or if Agility system use reducer P/N 1355170) to the filter. Attach the hose using a 1" wrench.

9. Use a torque wrench to torque to the follow values as appropriate:
 - #12 JIC flare = 84 ft-lbs
 - #10 JIC flare = 60 ft-lbs
 - M27 O-ring boss = 100 N•m~70 ft-lbs.

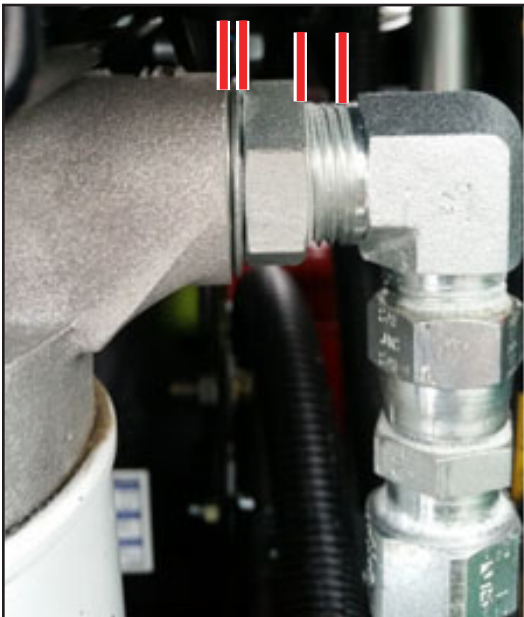
Figure 4

- The fitting will only thread into the housing approximately four threads and then bind (Figure 4).
- It is not possible to position the fitting to allow for hose routing angles (Figure 4).
- The swivel nut and washer are forced against the last thread distorting the washer (Figure 4).

Incorrect Fitting

SAE - 12 x #10 JIC 90

Washer has cone shaped distortion
3 to 4 threads showing

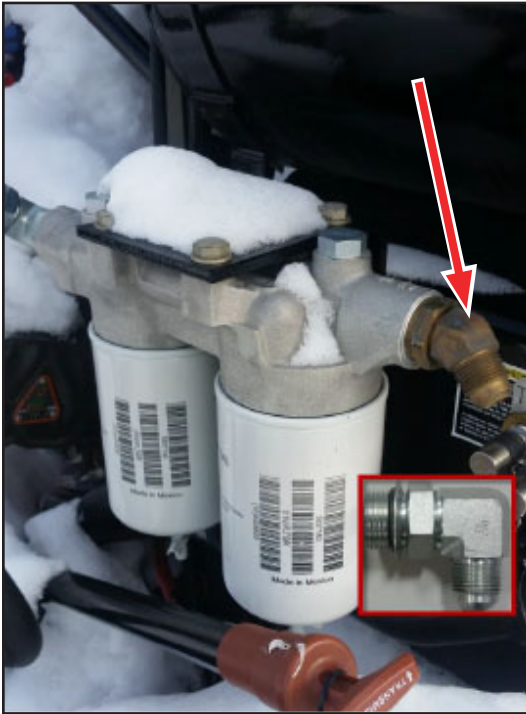
Figure 5

Peterbilt ISX12G units may have been shipped with a brass M27 x 2.0 x #10 JIC 45 or a SAE - 12 x #10 JIC 90 fitting at the filter (Figure 5). Both the brass M27 x 2.0 x #10 JIC 45 and SAE - 12 x #10 JIC 90 fitting do not fit into the housing correctly, allowing for a potential slow leak of CNG. See Figure 7 for an image of the correct fitting.

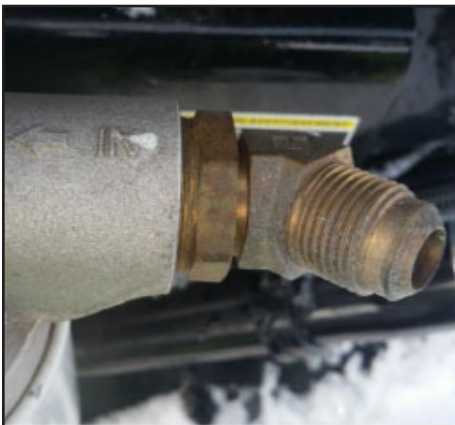
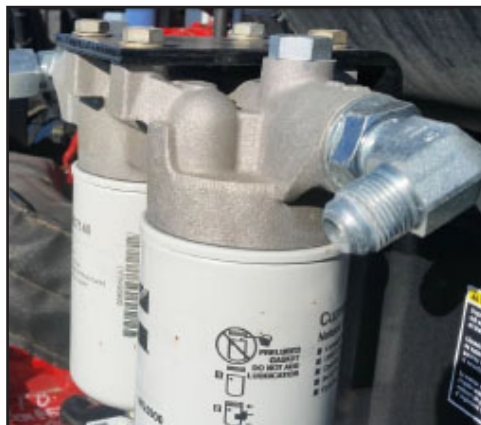
Figure 6

- The fitting is brass (Figure 6).
- The fitting will only thread into the housing approximately four threads and then bind (Figure 6).
- It is not possible to position the fitting to allow for hose routing angles (Figure 6).
- The swivel nut and washer are forced against the last thread distorting the washer (Figure 6).

Incorrect Fitting

Brass M27 X 2.0 X #10 JIC 45

SAE - 12 X #10 JIC 90

Washer has cone shaped distortion
3 to 4 threads showing
