# SAFETY RECALL

Mack Trucks Inc.  
Greensboro, NC USA

Date	Number	Page
6/17	<b>SC0407</b>	1 (19)

## High Amperage Alternator Cable, Replacement

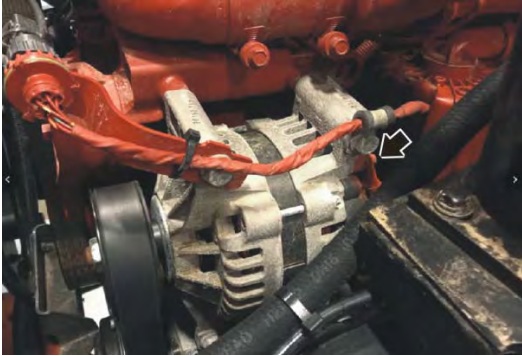
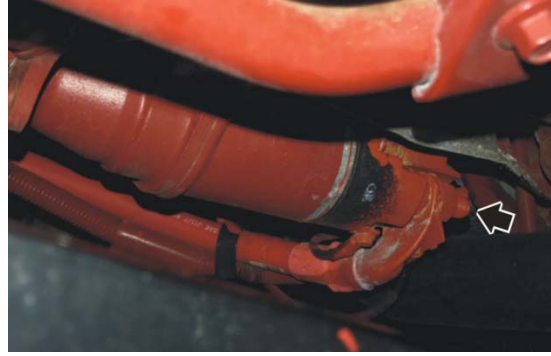
On LE, LR and MR trucks with the optional high amperage alternators (greater than 200 amps), the alternator charging cable may be of insufficient size to adequately support the amount of electrical current that is supplied by the alternator. To correct this issue, replace the alternator charging cable with a larger gauge cable as instructed in this document.

1. Tilt the cab forward.
2. Remove the nuts fastening the cable terminals to the alternator terminal stud and starter terminal stud.

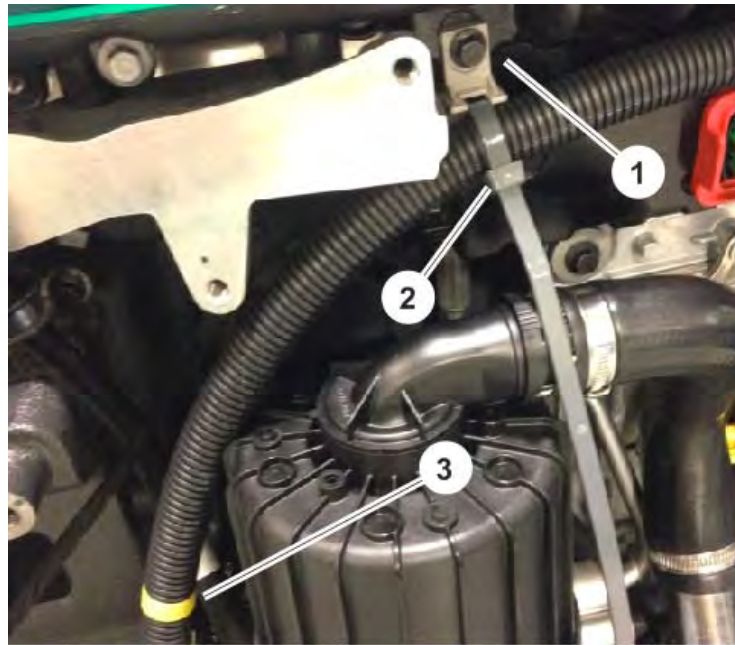
Improper routing and securing can lead to cable rubbing and potential short circuiting.

1. Starting near the alternator, install a plastic p-clamp **(1)** as shown in the picture. Then secure the new cable with a cable tie **(2)** approximately 240mm from the yellow tape **(3)**.
