Revised August 2017

Dealer Service Instructions for:

# Safety Recall T26 / NHTSA 17V-301 Left Front Half Shaft Engagement

### 2017 (MP) Jeep® Compass

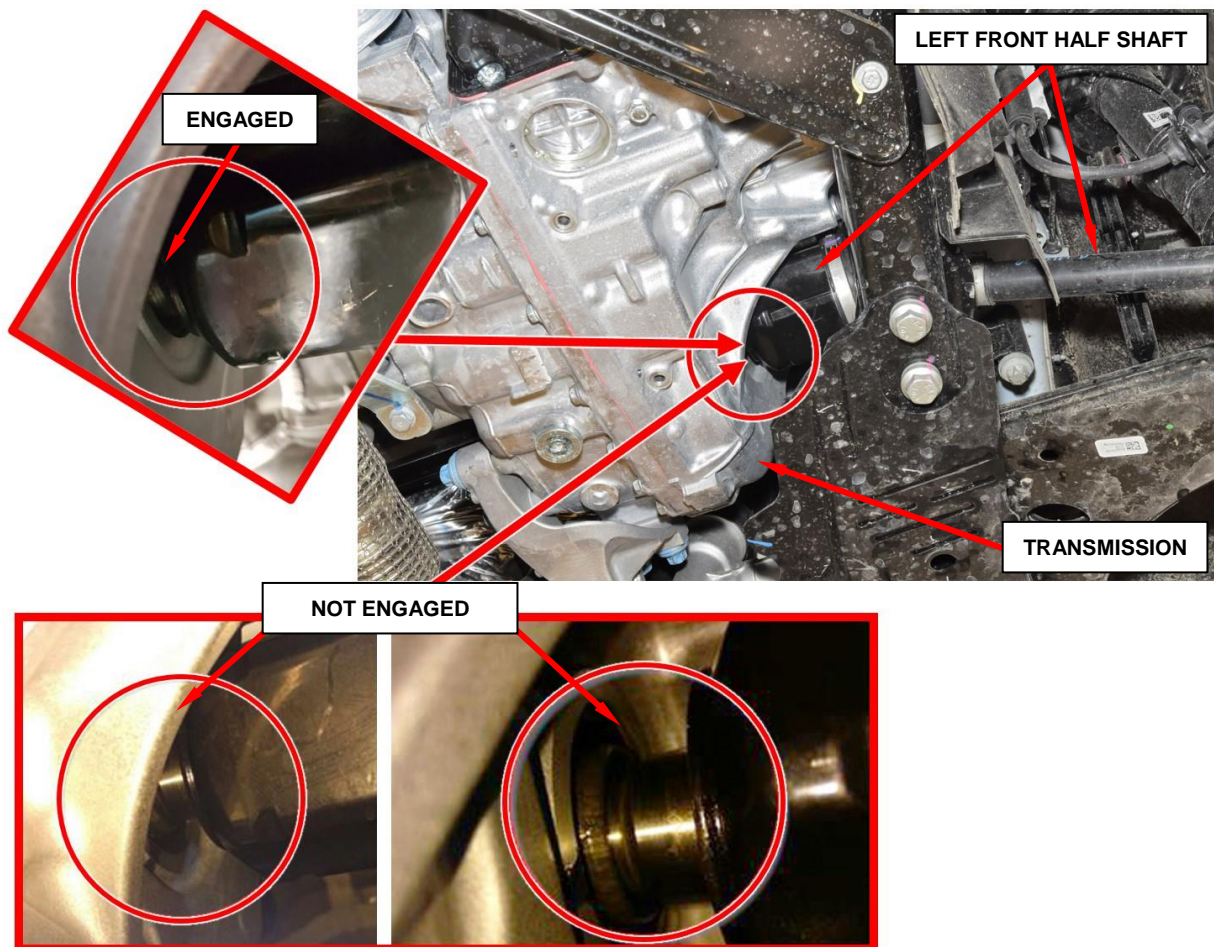
**Figure 1 – Inspect Left Front Half Shaft Engagement Into Transmission**

1. Raise and support the vehicle.
2. If equipped, remove the belly pan.
3. Visually inspect that the left front half shaft is fully engaged into the transmission side gear (Figure 1).

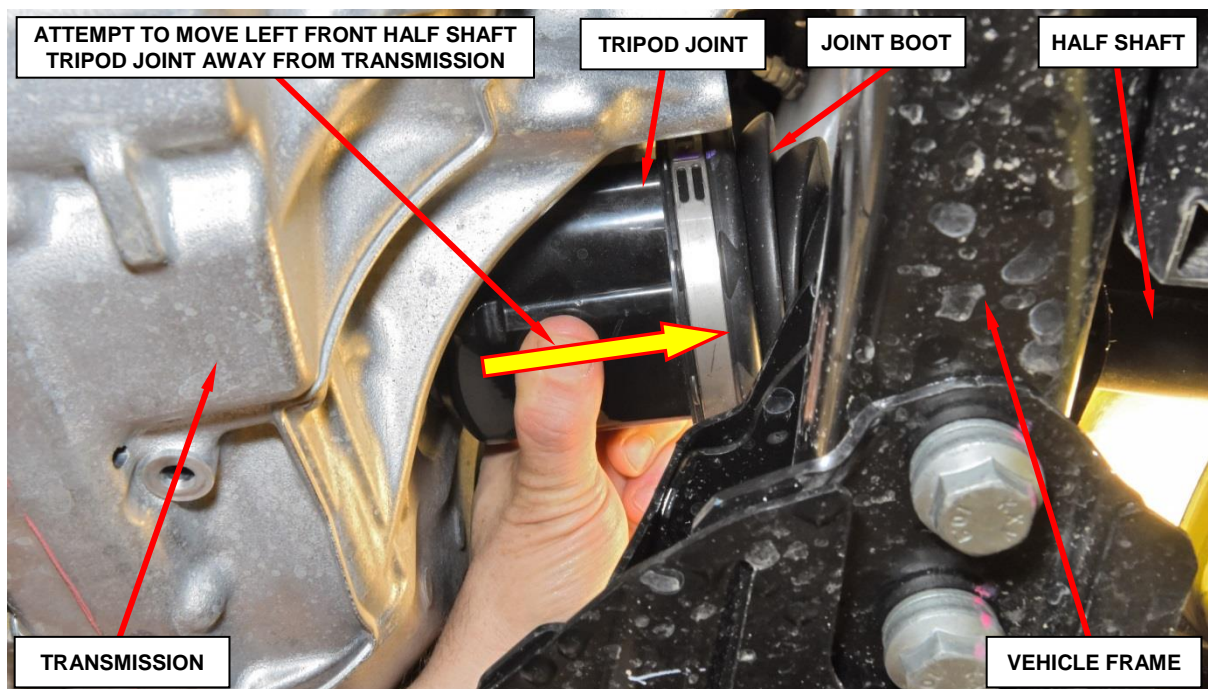
**Figure 2 – Check Left Front Half Shaft Engagement Into Transmission**

4. Hold the left front half shaft inboard tripod joint (transmission side) with both hands and axially pull the tripod joint toward the wheel direction (away from the transmission) to determine if the tripod joint is properly retained by the circlip in the transmission side gear. A half shaft tripod joint that is properly retained by the circlip will not move. A half shaft tripod joint that is NOT properly retained by the circlip will be easily moved while applying minimal axial force away from transmission (Figure 2).
- If half shaft is found to be properly retained, continue with **Step 5**.
  - If half shaft is found to be NOT properly retained, proceed to section **B. Left Front Half Shaft Replacement**.

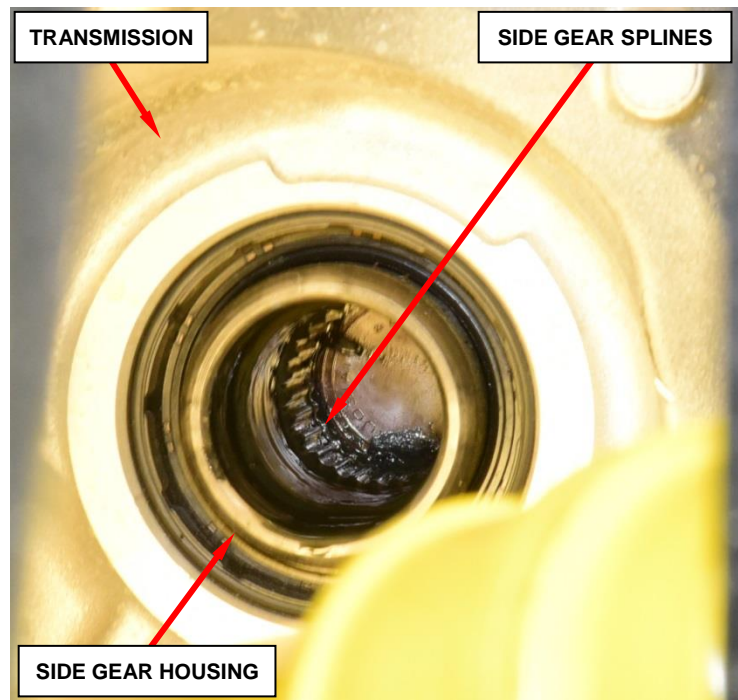
**Figure 9 – Clean/Inspect Transmission Side Gear Housing Splines**

**NOTE; Damage to the transmission side gear housing splines is NOT anticipated for this campaign. If any damage to the splines did occur caused by a half shaft that disengaged from the transmission side gear, the dealer must first check if a related LOP has been created for repairs prior to performing the repair. If no related LOP is found, the LOP review process must be followed to request a related Recall LOP be added as follows:**

10. Remove and clean any debris from the transmission side gear housing splines. Inspect the splines for any damage (Figure 9).
