# Safety Recall **Code: 23W5**

**Heat Shield/Boost Hose**

July 7, 2017

U.S.A. & CANADA: Certain 2012-2014 MY Volkswagen Passat TDI vehicles equipped with a DSG transmission

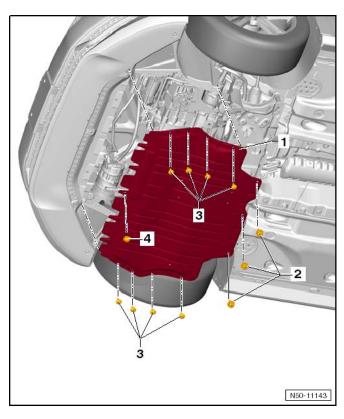
An underbody heat shield may not be long enough to sufficiently protect the right drive halfshaft grease boot from heat. The radiant heat may damage the boot and this could lead to a grease leak from the boot. If leaking grease comes into contact with heated surfaces of the exhaust system and/or diesel particulate filter (DPF), it could lead to a vehicle fire.

- · Raise vehicle on hoist.
- Remove bolts <2, 3 and 4>.
- Remove noise insulation <1>.

- Remove bolts <1> and remove the heat shield.
- Install new heat shield and torque bolts <1> to 25 Nm.

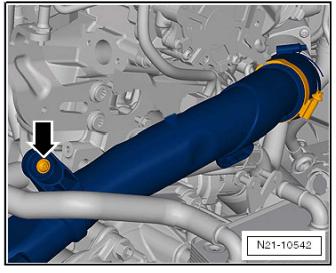
A leaking boost hose may lead to a flashing glow plug light and engage the engine limp mode. Eventually, the Malfunction Indicator Light (MIL) will illuminate. If either of these warnings is ignored, the DPF may get overloaded. If a customer experiences any of these vehicle symptoms, they are advised to make an appointment with an authorized Volkswagen dealer to have the vehicle inspected without delay.

• Remove bolt <arrow> from charge air pipe.

- Loosen hose clamp <1>.
- Pull charge air pipe out of boost hose <3>.
- Loosen hose clamp <2> and remove upper boost hose <3>.
- Install new boost hose <3>.

Tighten clamps <1 and 2> to 3 Nm.
