Campaign Service BULLETIN

BULLETIN NUMBER:
CB17-J-001

IMPORTANT SAFETY RECALL

STOPPER BRACKET INSTALLATION – 17V-324
(Transport Canada – 2017-265)

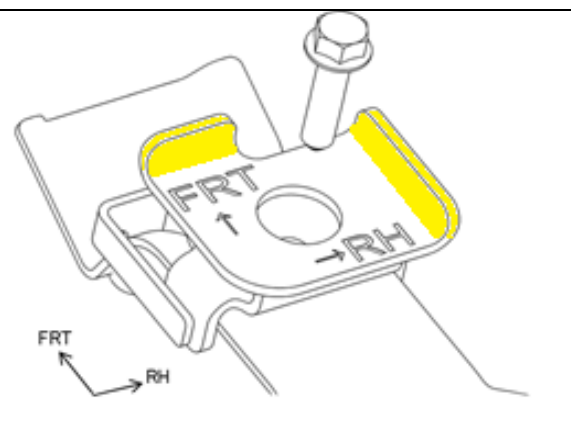
Figure 4 – Stopper Bracket Alignment. Yellow indicates stopper bracket flange.

4. Temporarily install and hand tighten the new stopper bracket using the new bolt provided (see Figure 3). When tightened (even by hand), the head of the new mounting bolt should be below the flat surface of the new stopper bracket. Be sure the stopper bracket is aligned properly (see Figure 4).

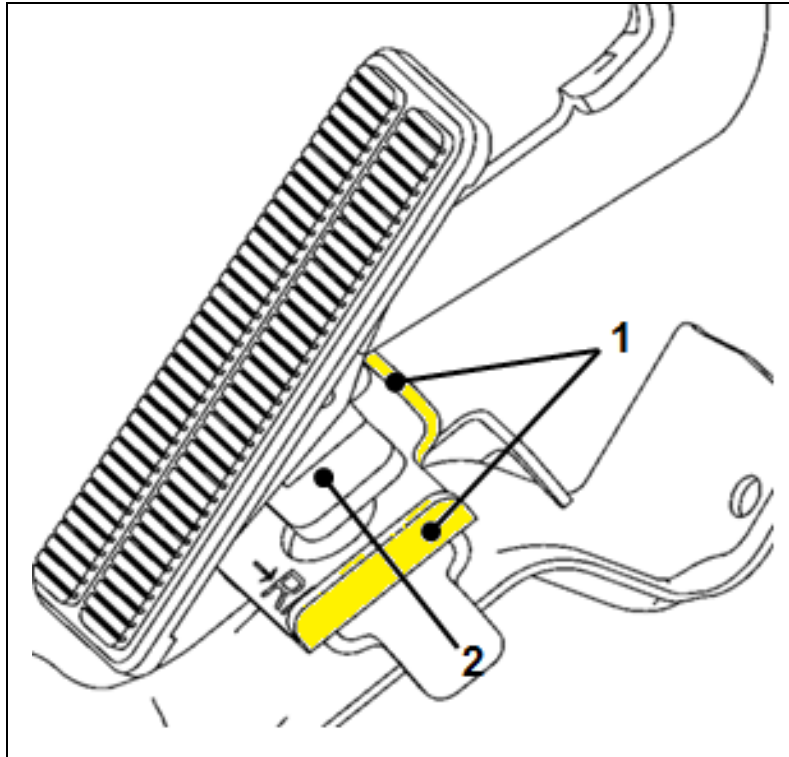
Figure 5 – View From Right Side

1. Flange (in yellow)
2. Stopper Plate

5. Depress the accelerator and ensure the stopper plate does not hit the flanged area of the stopper bracket (see Figures 5 and 6).

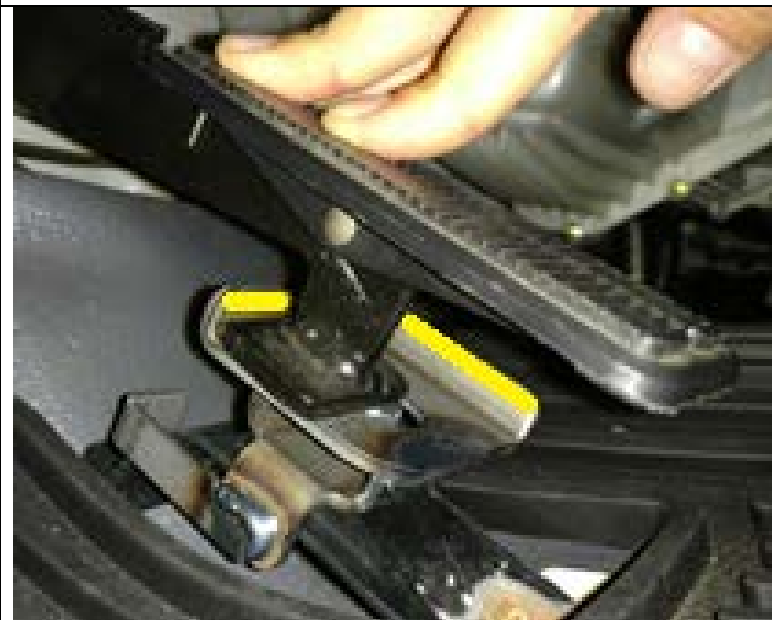
Figure 6 – View From Left Side. Yellow indicates stopper bracket flange.

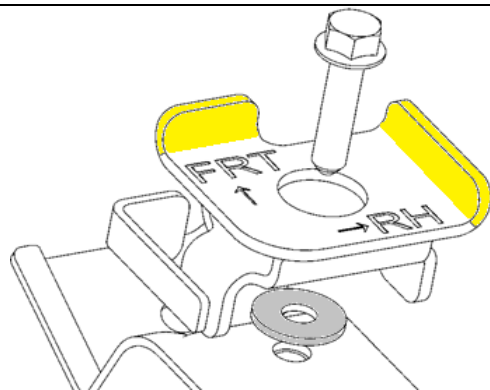
Figure 8 – View From Left Side. Yellow indicates stopper bracket flange.

- ii. If the washer does fit between these two parts, remove the stopper bracket and add the washer between the stopper bracket and the floor (see Figure 8), and reinstall. This will adjust the clearance. Check the clearance again by repeating Step 6 with the second washer and follow the results.
