RECALL 17V-328: E65/E66 (7 SERIES) DOOR LATCHES

This Service Information bulletin supersedes SI B51 24 17 **dated June 2018**

E65 (7 Series)

E66 (7 Series)

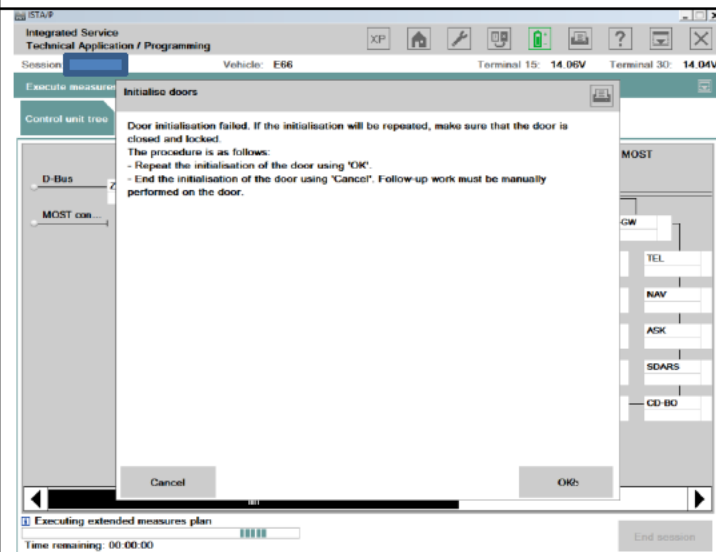
17. If the door does not open then this door will fail and need to be manually reworked.

Note: you will only see this screen if the door initialization has failed.

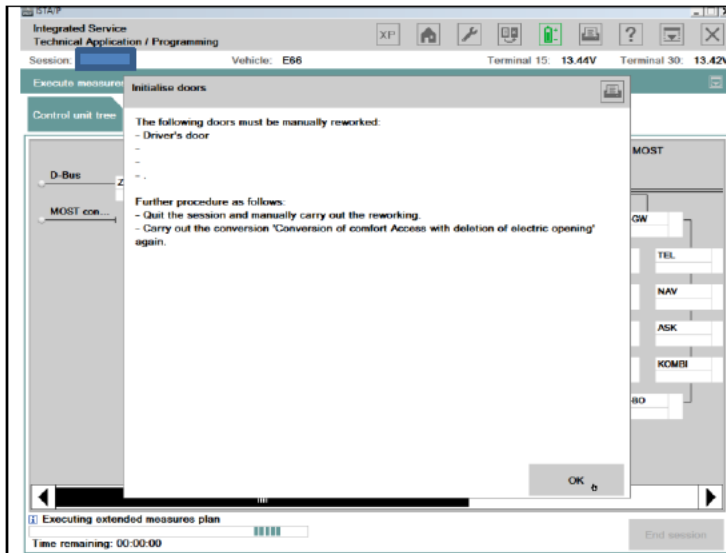
22. At the end of the session you will get the results of the test.
23. In this example only the driver's door needs to be reworked (door lock removed and electric opener cam removed). Always manually rework the doors that are listed.
24. **All other doors do not need to have the cam removed.**
25. **End the programming session, turn off the ignition.**
26. **At this point the windows cannot be moved so rework is not possible until after the 2nd programming session**
