RECALL 17V-328: E65/E66 (7 SERIES) DOOR LATCHES

E65 (7 Series)

BMW AG is conducting a Voluntary Safety Recall (effective May 18, 2017) on Model Year 2005 - 2007 BMW 7 Series, with option 322 Comfort Access (CA), and involves the door latch.

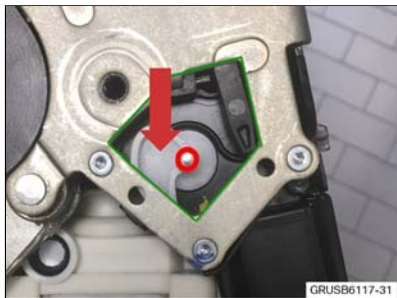
4. Once the door lock is removed, modify each lock by removing the white or yellow opening assist cam (red arrow).
5. If the door lock is replaced modify the new door lock as outlined below

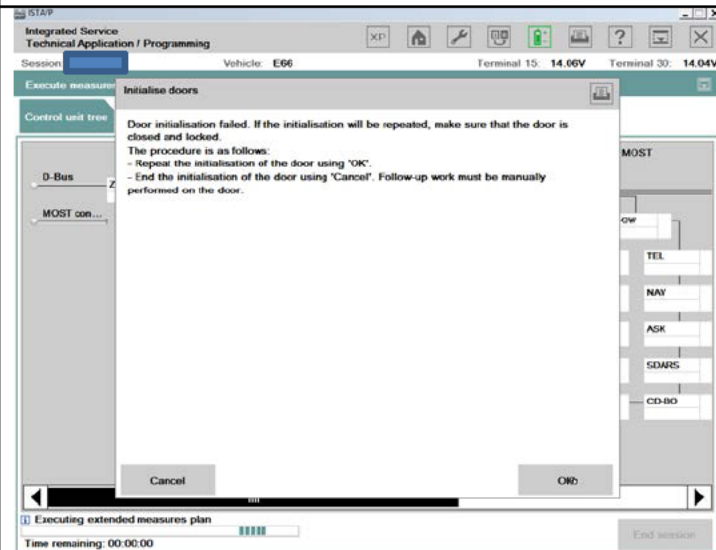
17. If the door does not open then this door will fail and need to be manually reworked.

Note: you will only see this screen if the door initialization has failed.

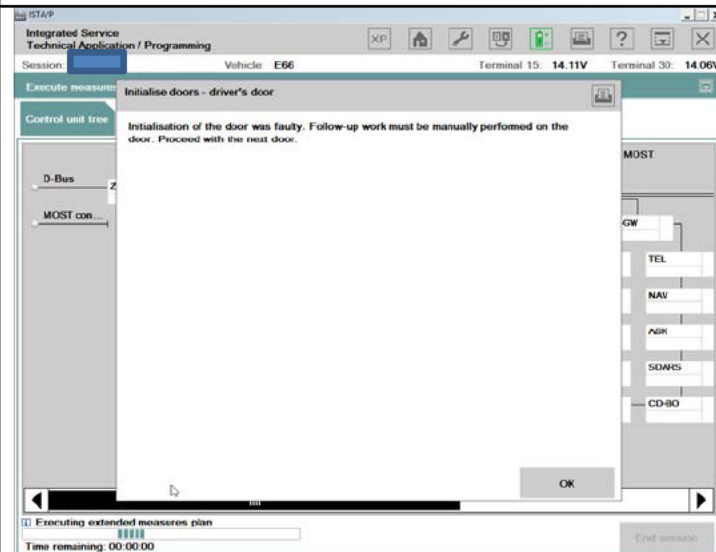
18. Once the door initialization fails on that one door, proceed to the next door as prompted by ISTA/P.

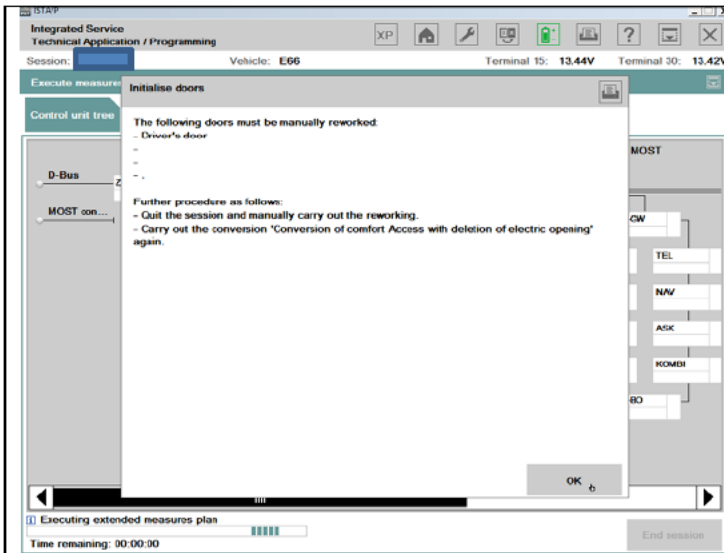
22. At the end of the session you will get the results of the test.
23. In this example only the driver's door needs to be reworked (door lock removed and electric opener cam removed). Always manually rework the doors that are listed.
24. **All other doors do not need to have the cam removed.**
25. End the programming session, turn off the ignition and rework the doors as needed.
