SI B51 24 17
Body Equipment

RECALL 17V-328: E65/E66 (7 SERIES) DOOR LATCHES

E65 (7 Series)

E66 (7 Series)

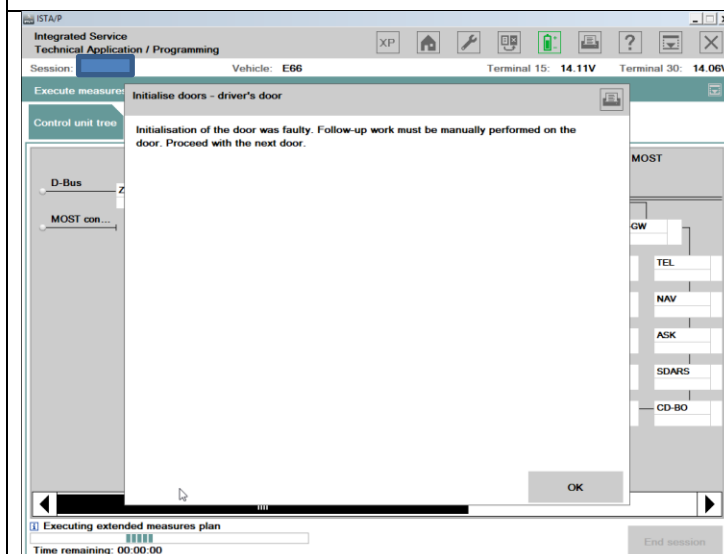
17. If the door does not open then this door will fail and need to be manually reworked.

Note: you will only see this screen if the door initialization has failed.
