Service Bulletin No. 397B

<i>MODEL</i> D Series	<i>TYPE</i> Field Change Program	<i>SECTION/GROUP</i> 8-Engine	<i>DATE</i> June 13, 2017
<i>SUBJECT</i> EXHAUST SYSTEM BELLOWS PIPE			
<i>CONDITIONS</i>

Ref. NHTSA Recall No.:17V-337 (REISSUANCE OF 13V-142)

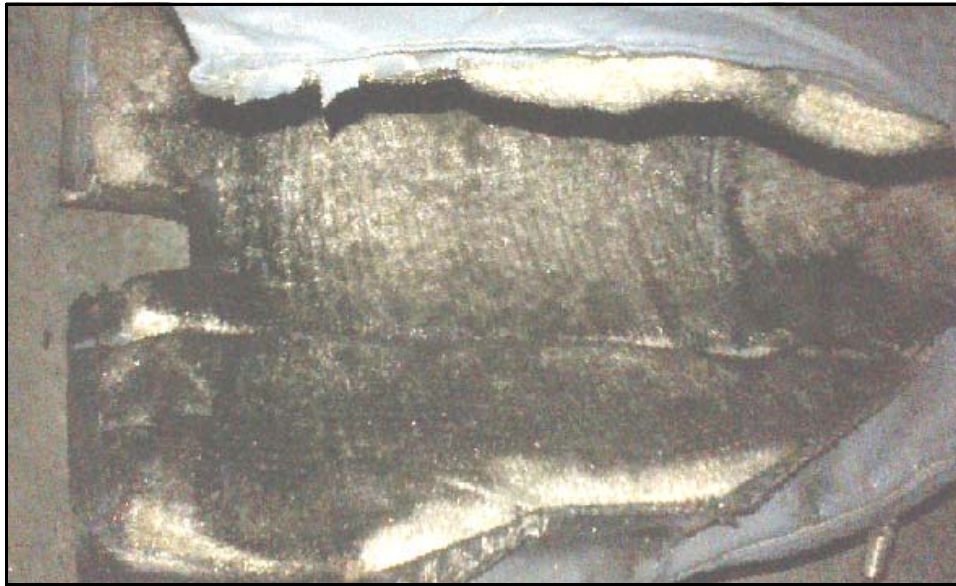
Figure 2.

- 1. the interior jacket of the blanket has evidence of smoke leaks and soot (refer to Figure 2); or**

If any one (1) of the above three (3) conditions exists, a new bellows pipe, p/n 08-20-1786, is required to be installed in Step 8. of this procedure.

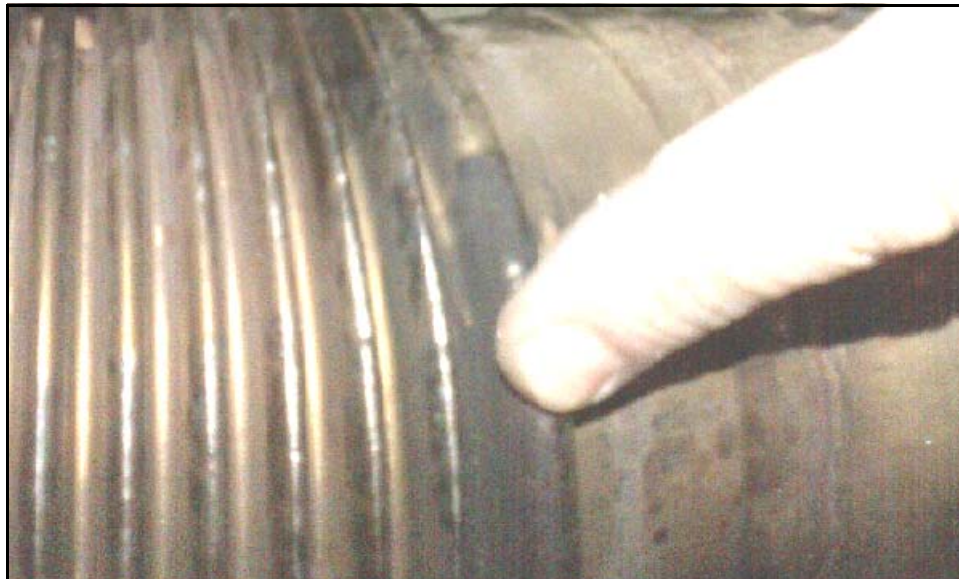
Figure 3.

- 2. the bellows pipe has a crack or evidence of breakage (refer to Figure 3); or**

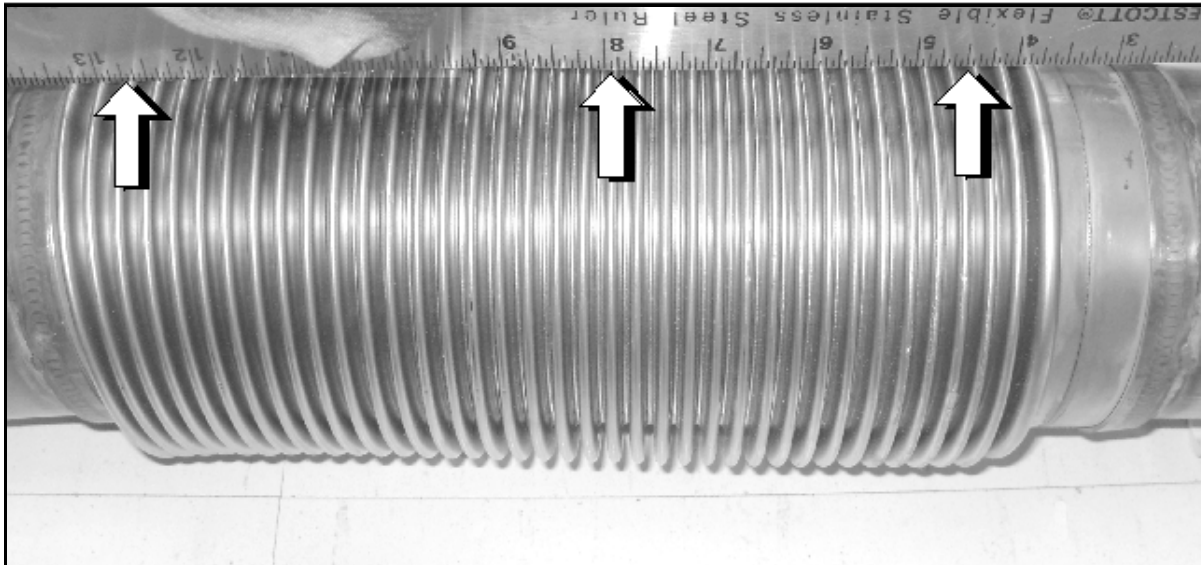
Figure 4.

3. the bellows pipe has a gap of more than 0.250 inch between a straight edge and the bellows due to permanent deformation, when a straight edge is positioned over the bellows at multiple positions around the circumference (refer to Figure 4).
