**HYUNDAI**
Technical Service Bulletin

GROUP RECALL	NUMBER 17-01-050
DATE JULY, 2017	MODEL(S) Santa Fe (NC) Santa Fe Sport (AN)

SUBJECT: 2013-2017 SANTA FE (NC) AND SANTA FE SPORT (AN)
 SECONDARY HOOD LATCH CABLE REPLACEMENT
 (RECALL CAMPAIGN 163)

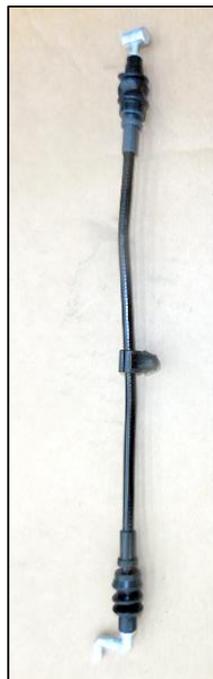
Description: This bulletin describes the procedure to replace the secondary hood latch cable on certain 2013-2017 MY Santa Fe (NC) and Santa Fe Sport (AN) vehicles. The secondary hood latch cable may become corroded over time and cause the latch to remain in the open position when the hood is closed. If the hood is not securely closed or the primary hood latch is released while driving, the hood may open and obscure the driver's vision, increasing the risk of a crash. The hood will not open if the primary latch is securely latched.
