Safety Recall T34 / NHTSA 17V-371 PHEV Power Inverter Module

2017-2018 (RU) Chrysler Pacifica PHEV

The Power Inverter Module (PIM) on about 1,600 of the above-referenced vehicles may experience diode failure due to an over-voltage condition. PIM diode failure will cause the vehicle to lose motive power without warning. The vehicle will not power back on and the diode failure may be accompanied by illumination of a Malfunction Indicator Lamp (MIL). A loss of motive power could cause a crash without warning. In addition, an update to the On-Board Diagnostic system is necessary.

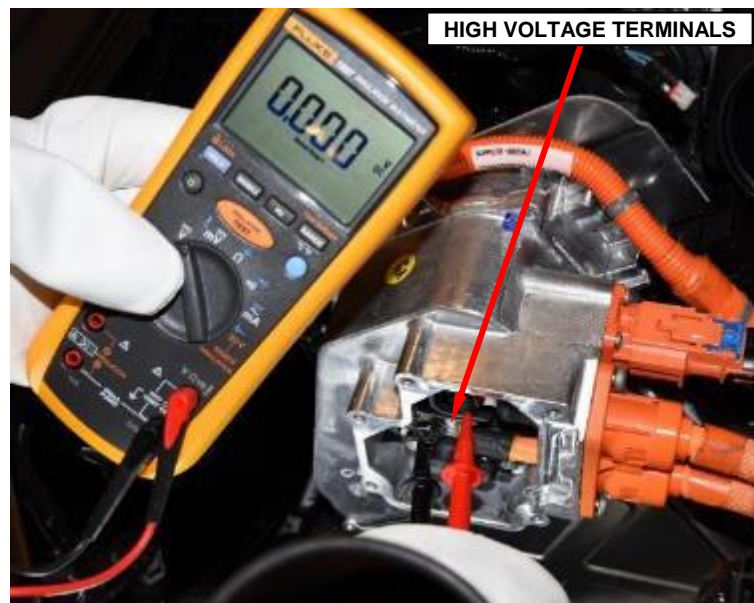
Figure 15 – Check PIM Voltage

- If the voltage measured is near 0-volts, the high-voltage components are safe to work on with the exception of the high-voltage battery internal components.

- If the voltage is not near 0-volts, an internal condition exists within the high-voltage battery that is preventing it from being powered down. **Do not attempt to carry out repairs on any of the vehicle's high-voltage components or wiring. Contact the STAR Center for service support.**

23. Measure the voltage between the positive and negative high voltage terminals. Also, measure the voltage between each high voltage terminal and chassis ground (Figure 15). The measured voltage should be near 0-volts.

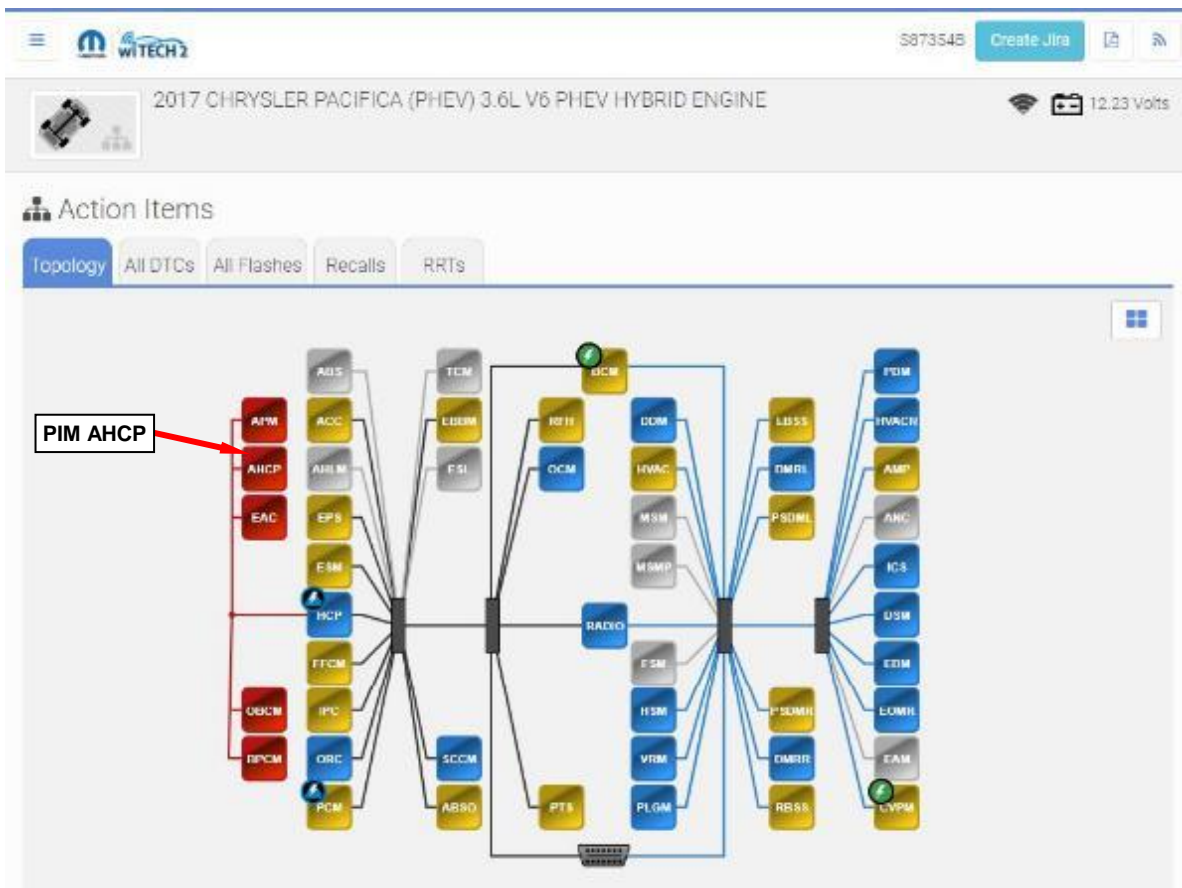
Figure 43 – wiTECH Screen Image Is An Example Of A Newly Installed PIM With Bootloader Software Causing The AHCP To Display Solid Red. There Is Nothing Wrong With This PIM, Therefore Continue With The Software Flash Procedure.
