August 2017

Dealer Service Instructions for:

Safety Recall T33 / NHTSA 17V-376 Steering Wheel Wiring

2011-2012 (RT) Dodge Grand Caravan

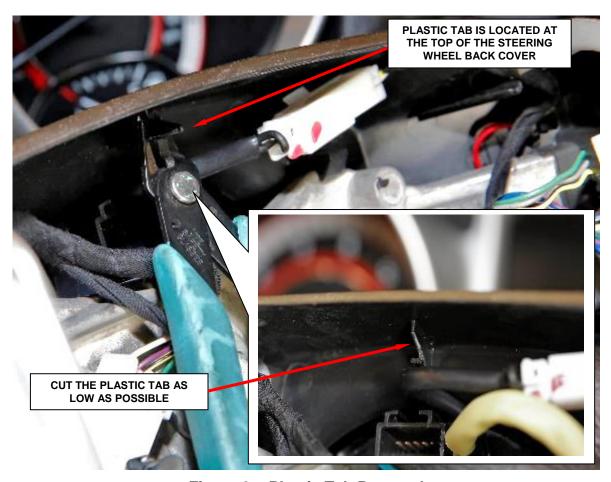
Figure 3 - Plastic Tab Removal

- 9. Disconnect the SCCM 6-way electrical connector (Figure 4).
- 10. Using a diagonal plier or equivalent, remove the free-standing portion of the plastic tab on the steering wheel plastic back cover as shown (Figure 3).

NOTE: The free-standing portion of the plastic tab is approximately 0.5 inch (13mm) tall. Remove as much of the plastic tab as possible without cutting into the steering wheel back cover.

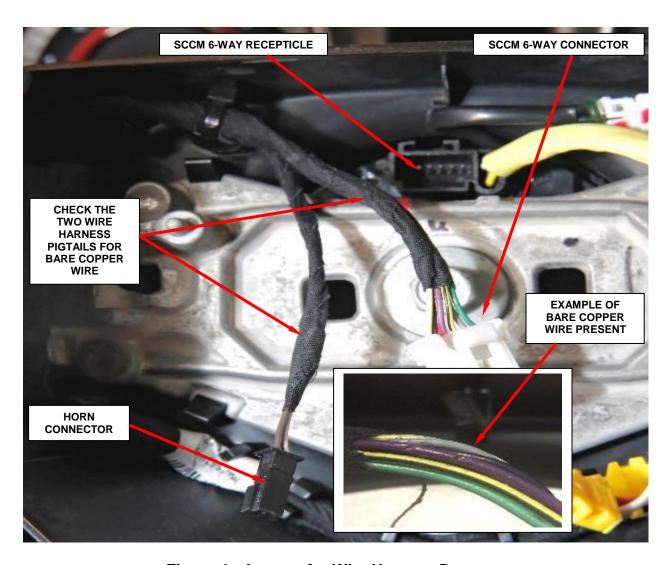
Figure 4 – Inspect for Wire Harness Damage

11. Inspect the steering wheel wire harness at the SCCM 6-way electrical connector and the horn connector pigtails for damage (Figures 4 and 5).

- ➤ If bare copper wire is present on either pigtail submit a STAR Case including a digital image (photo) and contact STAR Center to obtain parts, then continue with Section **B. Replace Steering Wheel Wire Harness.**
- ➤ If no damage is present continue with **Step 12.**

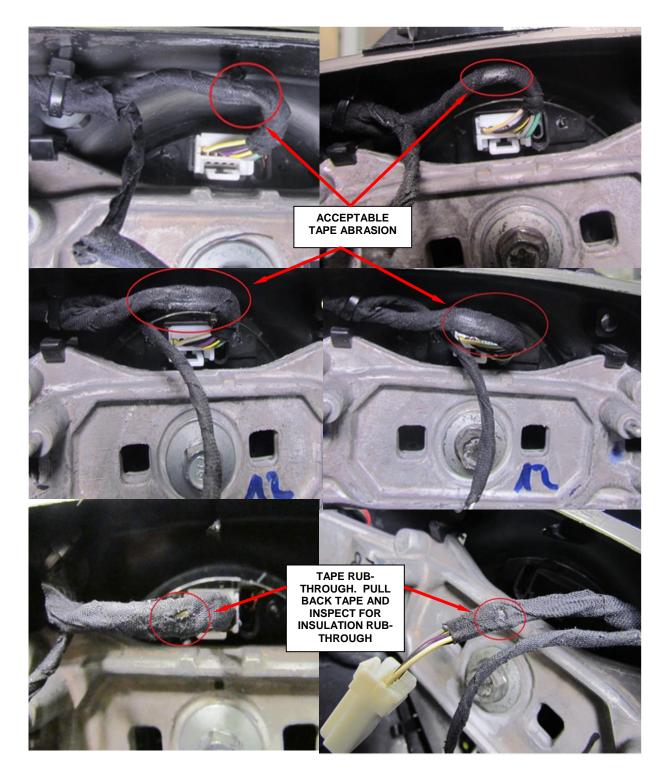
Figure 5 - Tape Inspection

Note: Damage or chaffing to the tape wrap on the pigtails <u>does not</u> require a harness replacement. If tape rub through is present, pull back the tape and inspect for insulation rub-through (Figure 5).
