Dealer Operator / General Manager	Sales New Vehicles	Sales Used Vehicles	Business Manager (F&I)	Service	Parts & Accessories	Administration
Date: Bulletin #	Jul 17, 2017 SV-ZMC-017-369	Source: Phone #:	Zero Motorcycles Aftersales Department US: (888) 786-9376 Ext. 2			Program Period: Commencing July 17, 2017

SERVICE BULLETIN: 2017 Flasher Relay Recall

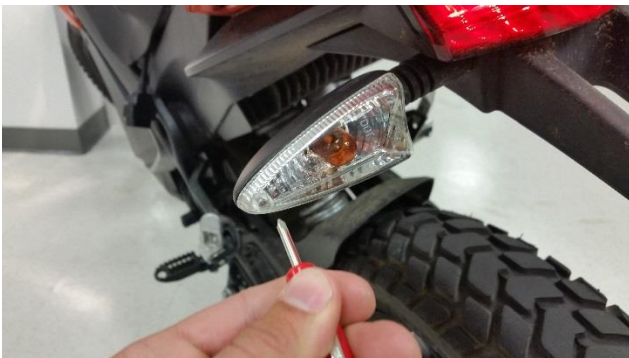
Figure 1: Removing indicator lens

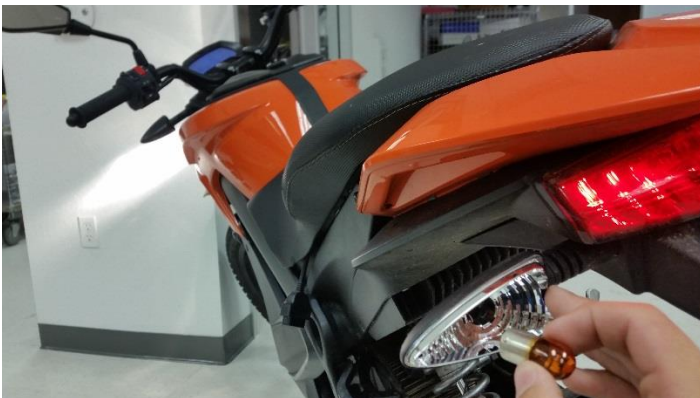
Figure 2: Pull out bulb and ensure front indicator begins to flash faster

- When the rear bulb is removed from the circuit, the front left bulb and dash icon should start flashing twice as fast. **If the flash rate does not increase when only one bulb is left flashing then the flasher relay unit must be replaced.**
- Reinstall the bulb and ensure the flash rate returns to the normal operating rate.
- Reinstall the lens to the turn signal housing and tighten the screw to secure it.
- To confirm hazard light functionality, activate the red hazard switch (fig 3) on the left hand switch gear and confirm that all four turn signal bulbs flash at a consistent rate.

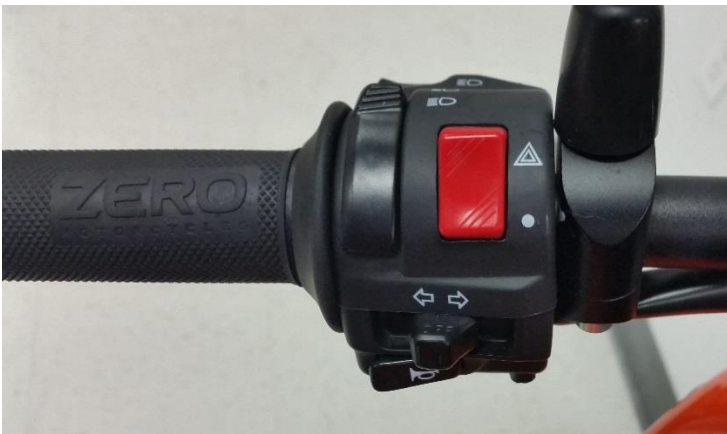
Figure 3: Red hazard switch to flash all four signal bulbs

- Let the hazards flash for 30 seconds and ensure all bulbs continue to flash.
- If the bulbs flash erratically or stop flashing, while the hazard switch is on, the flasher relay unit should be replaced. Please order part number 65-08015 - TURN SIGNAL FLASHER ECIE LOW NOISE.
- When test is complete, turn off hazard switch, and key off motorcycle.
- If flasher relay is replaced, repeat test to confirm functionality.
