CONVENTIONAL DOOR HINGE BOLT

CAMPAIGN NO: M0300

REFERENCE: QA-170804-N1

SUBJECT VEHICLES: 18MY Conventional Trucks equipped with a J08 engine

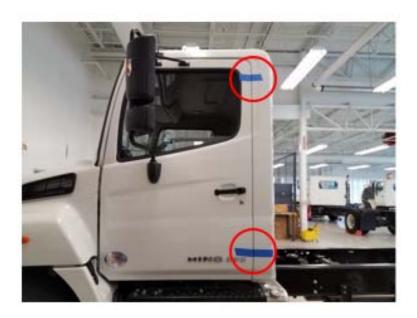
1. Place masking tape over the door and cab surfaces in the locations shown in the photograph below. This will prevent damage to the painted surfaces during step **2.**

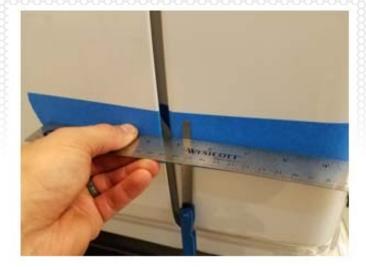
2. Using a straight edge and a feeler gauge, measure and record the door to cab overlap at the locations marked with tape in step

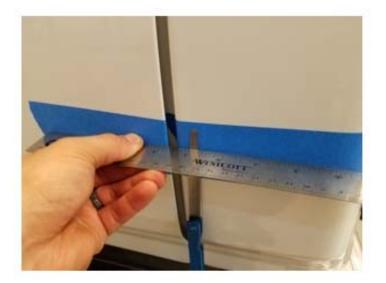
3. If the door to cab overlap measures less than 1.5mm, proceed to step **17.** If the overlap measures 1.5mm-3.0mm, proceed to step **10.** If the overlap measures greater than 3.0mm, continue to step **4.**

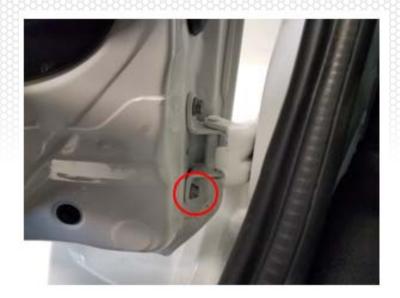
4. Open the door and loosen the lower most door hinge bolt $\frac{1}{2}$ turn. Close the door.

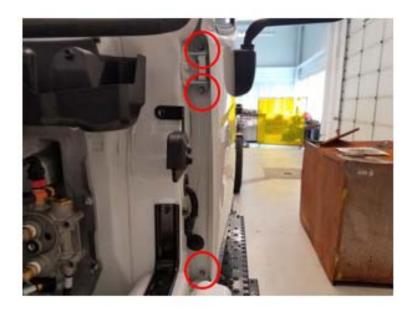
5. Open the hood and loosen the upper three door hinge bolts, locations shown in the photograph below, ½ turn.

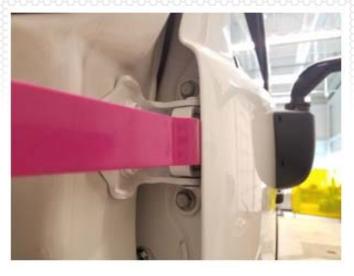
6. Using a plastic pry tool to prevent damage to the paint, gently pry outwards on the door at the upper hinge. While holding pressure against the door, hand tighten the three door hinge bolts loosened in step **5**.

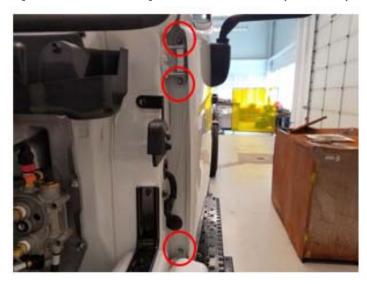
7. Remove the plastic pry tool and tighten the upper three door hinge bolts to the specified torque.

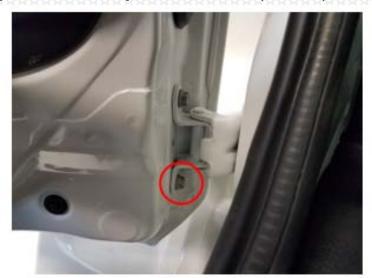
. Open the door and tighten the lower most door hinge bolt to the specified torque.

Specified Torque: 16.2 lb-ft (22Nm)

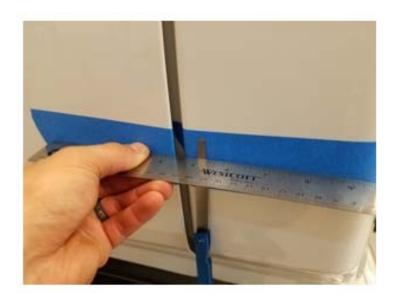
. Close the door and re-measure the door to cab overlap as shown in step **2**. If the overlap now measures less than 1.5mm, proceed to step **17**. If the overlap measures greater than 1.5mm, continue to step **10**.

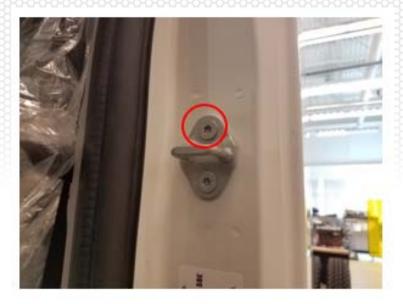
10. Open the door and loosen the upper door striker bolt ½ turn.

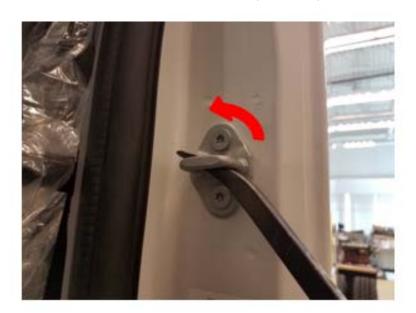
11. Carefully use a pry bar to move the upper door striker bolt towards the inside of the cab. Tighten the upper door striker bolt to the specified torque.

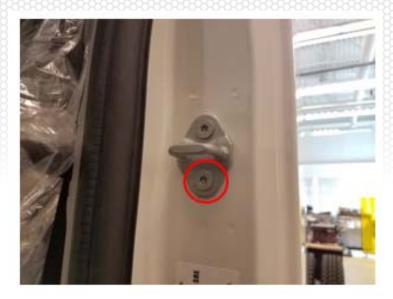
12. Loosen the lower door striker bolt ½ turn.

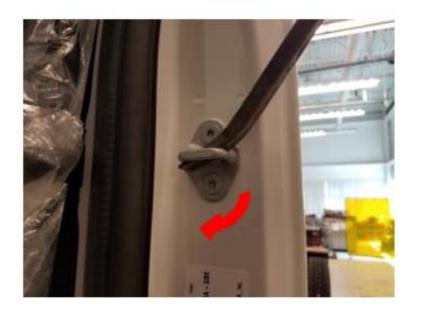
13. Carefully use a pry bar to move the lower door striker bolt towards the inside of the cab. Tighten the lower door striker bolt to the specified torque.

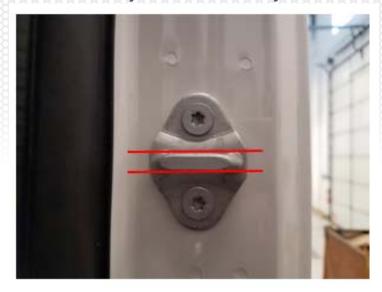
14. Check to make sure the door striker is square with the door frame and re-adjust if necessary.

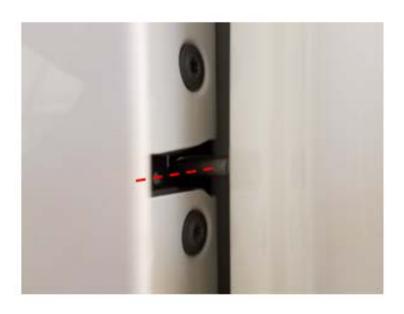
15. Slowly close the door and make sure the door striker properly aligns with the center of the door latch. If necessary, adjust striker alignment with a rubber mallet. Ensure striker bolts are tightened to the specified torque.

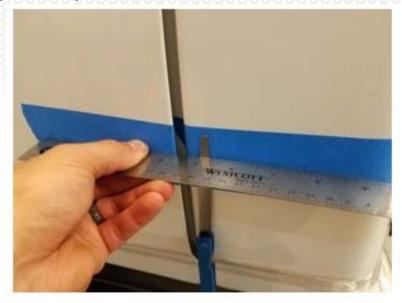
16. Close the door and re-measure the door to cab overlap as shown in step **2**. If the overlap now measures less than 1.5mm, proceed to step **17**. If the overlap measures greater than 1.5mm, repeat steps **4 - 15**.

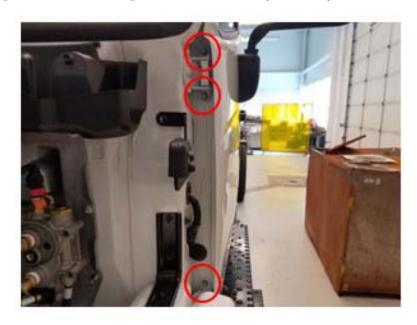
17. Open the hood and re-torque the upper door hinge bolts to the specified torque. It is important to re-torque these fasteners even if these were tightened in step **7**.

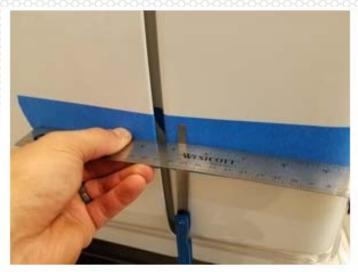
18. Use the straight edge and feeler gauge to confirm door to cab overlap is less than 1.5mm. If the overlap is not correct, perform steps **3 – 16**.
