# Thor Motor Coach Recall Repair Instructions

Recall #	17V-522		
Description/Title:	<b>LP Rubber Hose</b>		
Affected Product Line(s):	<b>Certain 2018 Chateau, Four Winds, and Freedom Elite motorhomes</b>		
Service Campaign # :	<b>RC000144</b>	Released Date:	<b>10/4/2017</b>
Failure Code:	<b>Inspect: TMCRC80468Y Repair: TMCRC80468V</b>	Document Date:	<b>10/4/2017</b>
Time Allowed:	<b>Inspect: 0.2 Repair: 0.4</b>	Document Revision:	<b>A</b>

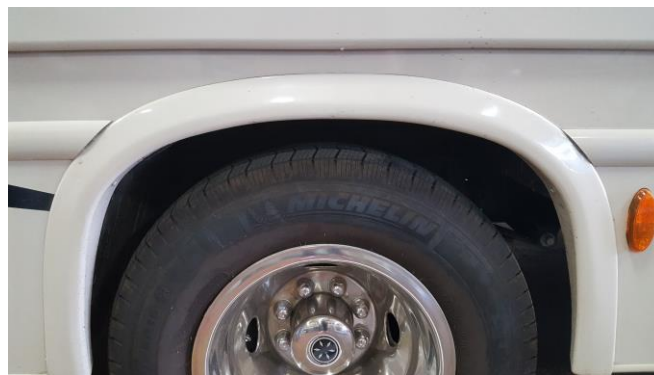
**Figure 1**

Inspect the routing of the rubber LP hose in the wheel well to determine the need for additional p-clamps or relocation of p-clams for proper securement to eliminate potential for sagging. (Figure 1)
