# Dana<sup>®</sup> Spicer<sup>®</sup> Steer Axle

## Information Bulletin

ABIB-1701

Topic: Steer Knuckle Recall Process – Recall Number 17E041

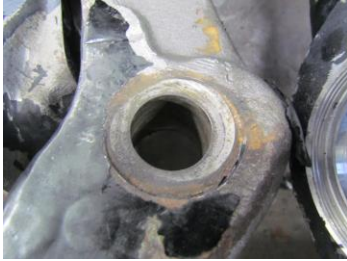
Tie Rod Arm Taper Bore

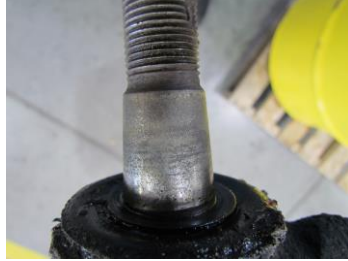
Tie Rod End Taper Stud

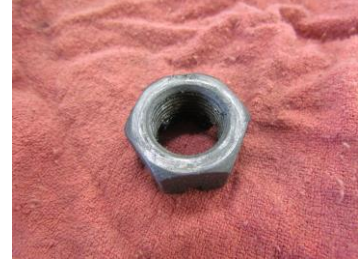
Back of Tie Rod Nut

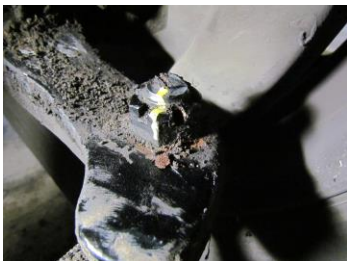
Nut Rotation

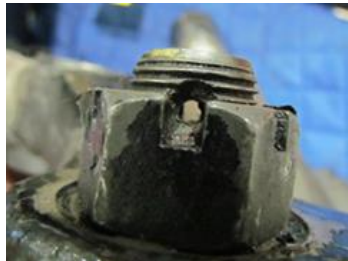
Cotter Pin Hole Position

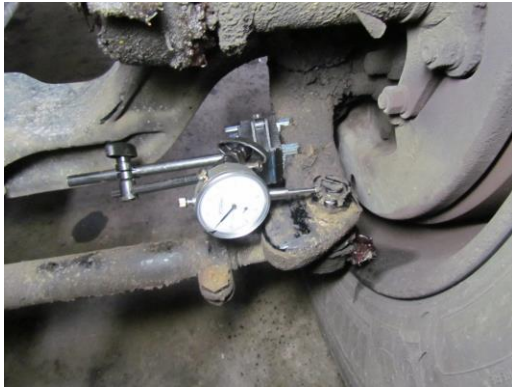
Dial Indicator Mounting Position

1. Block the forward and rear of at least one of the drive axle tires so the vehicle cannot move during this procedure.
2. With a flexible, magnetic base dial indicator, mount the base of the indicator on the tie rod arm so that the indicator tip can be centered on the threads of the stud just above the nut.

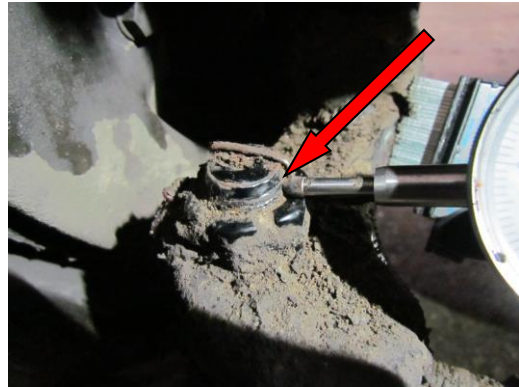
Dial Indicator Tip Must be Placed on The Stud

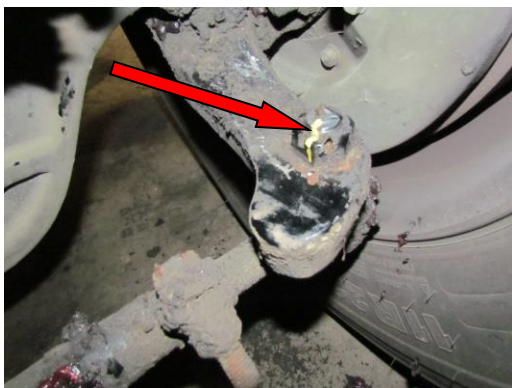
Paint Mark to Identify Nut Rotation

3. With someone in the cab of the truck turning the steering wheel (engine off) just enough to cause movement in the wheels, document how much movement is found on each side of the steer axle. Record results on the supplied form.
4. The next step is to remove the cotter pins and check for proper nut torque. Put a paint mark across one side of the nut and top of the stud. With a torque wrench and a 1 1/4" socket, torque the nut in a clockwise (tighten) direction until the nut just starts to rotate or you reach 130 ft. lbs. **Important: Do not exceed 170 ft. lbs.** Record your findings on the recall form.

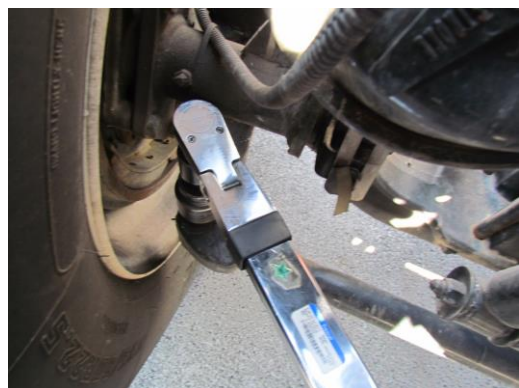
Check Nut Torque – Do Not Exceed 170 ft. lbs.

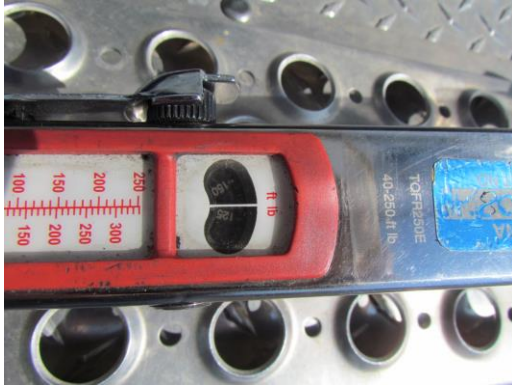
**Retorque to 130 ft. lbs**

- If you found rotation of the nut before you reached 130 ft. lbs., we can now torque the nut to 130 ft. lbs. Using the paint mark, record the amount of movement to the nut. Example: Use the paint mark as the 12:00 position, if the nut rotates  $\frac{1}{4}$  turn to reach 130 ft. lbs., document the nut rotated as the 3:00 position.

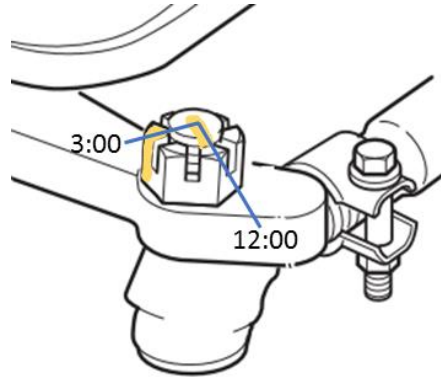
**Record Rotation on Nut**

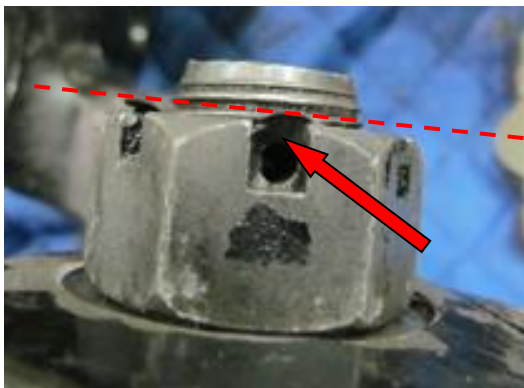
**Good Cotter Pin Hole Position**

- With the nut torque to 130 ft. lbs. advance the nut so that the cotter pin hole is aligned with a slot in the nut, reinstall the dial indicator and check for tie rod stud movement once again. Record results on the form supplied.  
**Note:** Never back the nut off to align the cotter pin hole to the nut slot. Torque may reach 170 ft. lbs. to obtain proper alignment.
- Important:** Any tie rod stud with movement after proper nut torque and alignment will require the replacement of that knuckle and tie rod.
- Important:** One last check. After the nut has been aligned with a slot in the nut, the cotter pin hole **CAN NOT** be above the top of the nut as shown below. Any cotter pin hole that is above the top of the nut surface will require the replacement of the knuckle and tie rod end.

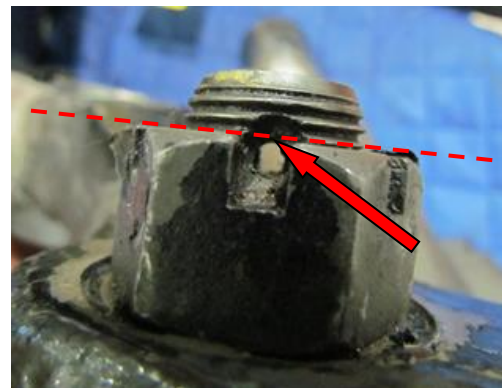
**Cotter Pin Hole at Maximum Height**
