Technical Service Bulletin

GROUP RECALL	NUMBER 17-01-066
DATE NOVEMBER, 2017	MODEL(S) IONIQ EV

SUBJECT: IONIQ EV EPCU (RECALL CAMPAIGN 166)

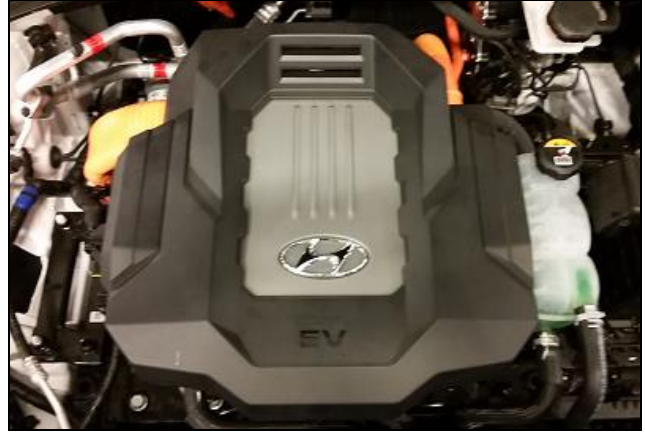
2. Open the hood and remove the EPCU top plastic cover (“engine” cover).

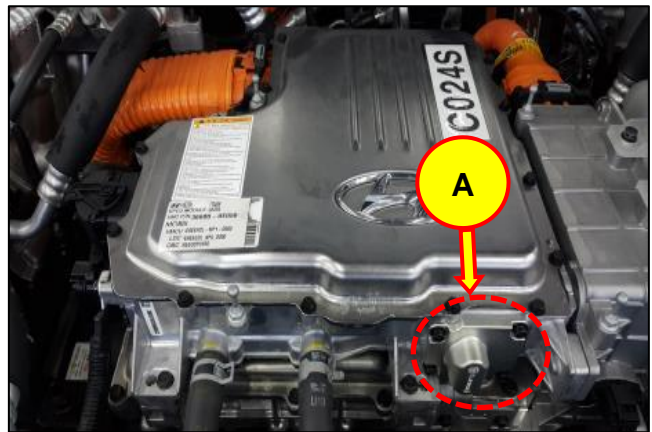
3. Remove the EPCU service cover (A).

Tightening torque:

3.9 - 5.9 N.m (0.4 - 0.6 kgf.m, 2.9 - 4.3 lb-ft)

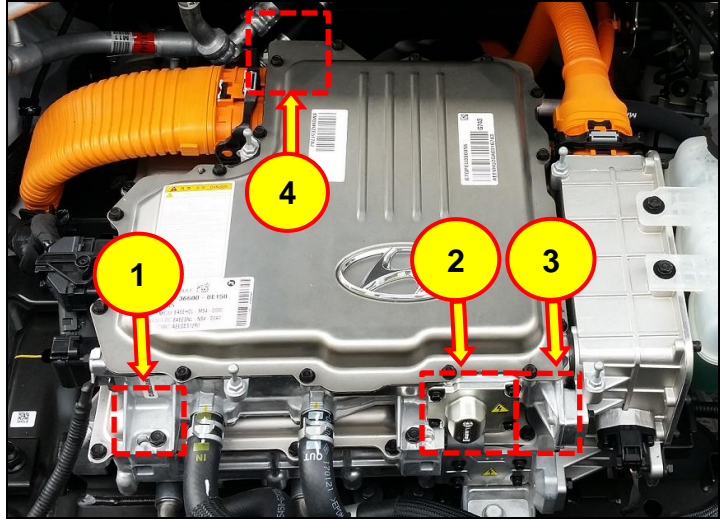
4. Inspect the EPCU using the UV Flash Light in areas #1 through #4.

Area #4 is located on the back of the EPCU assembly.

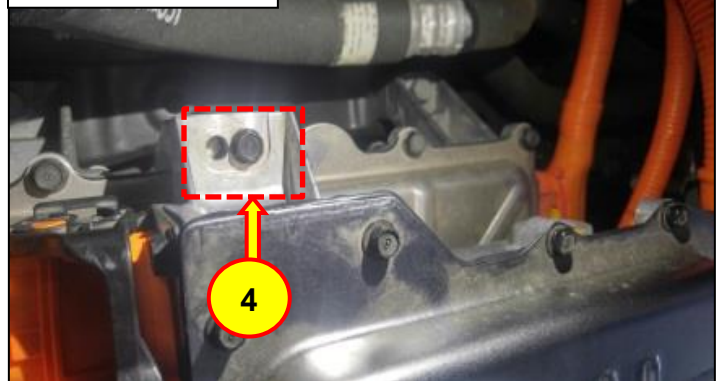
Detail - Area #4

- Inspect the EPCU for fluorescent light blue patches as shown on the right.

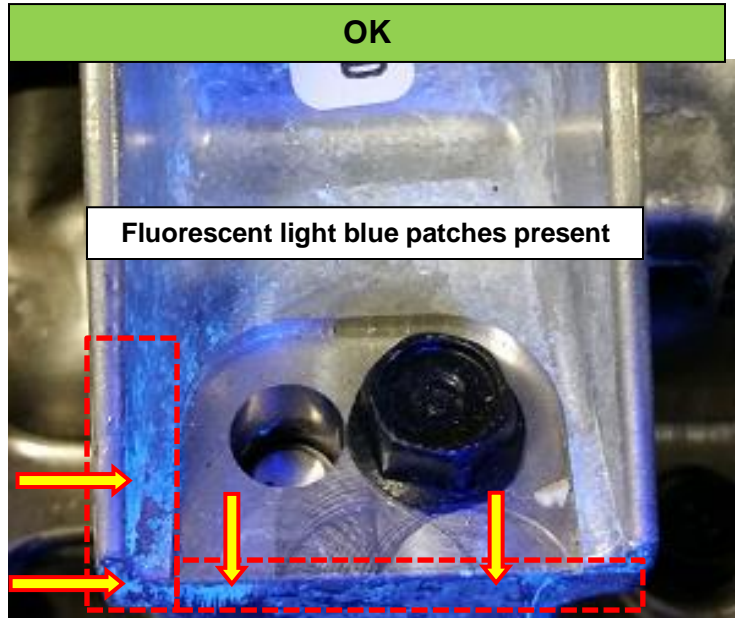
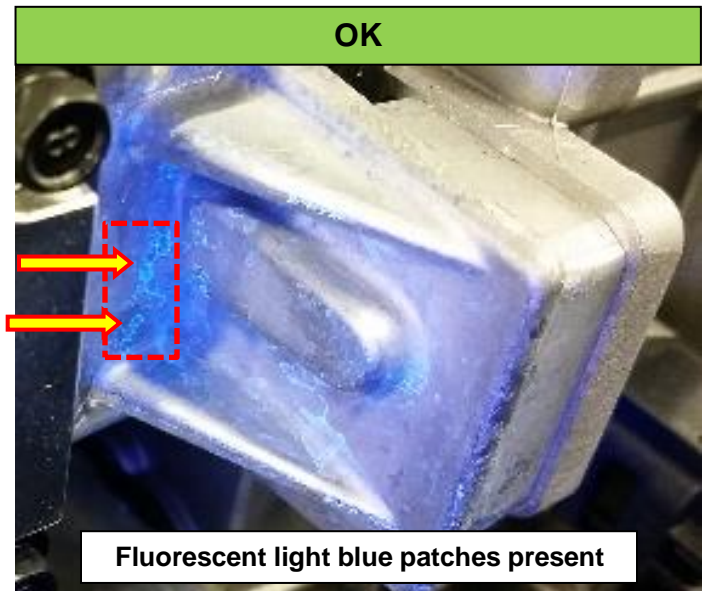
If light blue patches **are present in 2 or more of the 4 areas**, the EPCU is **OK**.

Follow the preceding steps in reverse order to complete the procedure. **DO NOT** replace the EPCU.

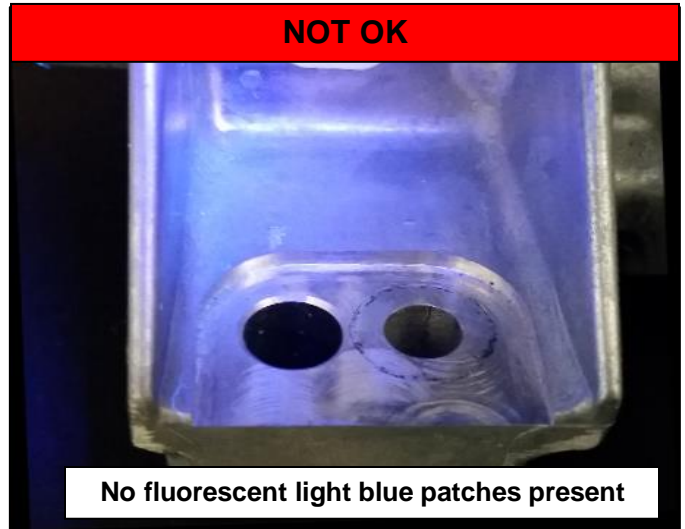
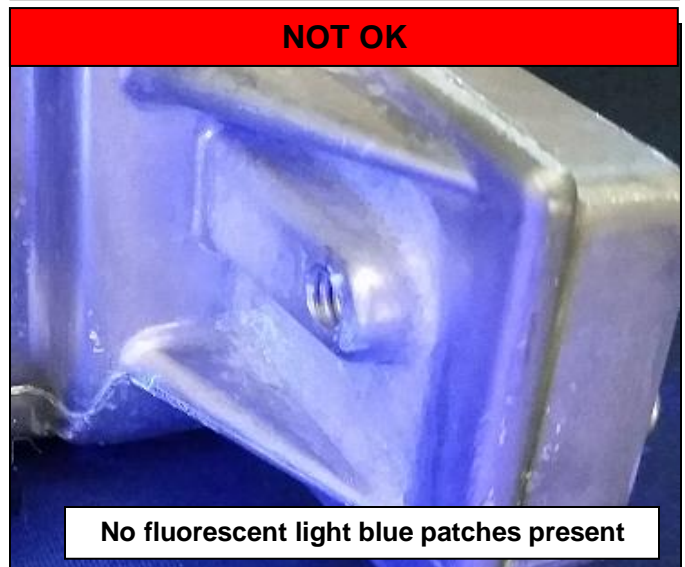
6. If light blue patches are **not present in any areas OR present in 1 of the 4 areas**, the EPCU is **NOT OK**. Continue to the next step to replace the EPCU.

7. Follow the Shop Manual to replace the EPCU assembly.

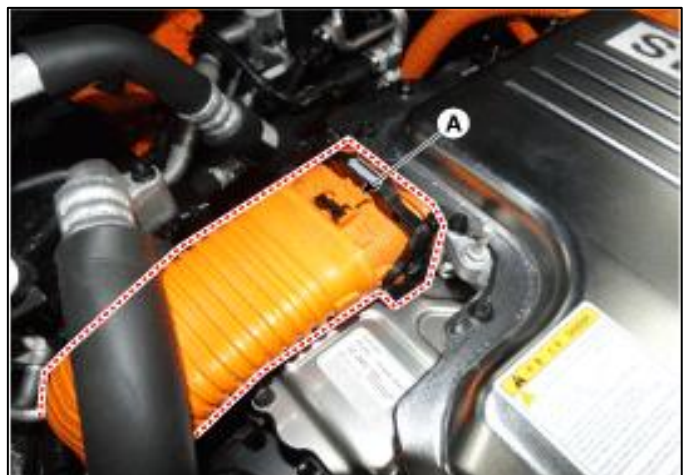
8. Carefully install the EPCU side power cable connector (A).

Take caution when installing the side power cable connector. Improper assembly may cause injury to the service technician and/or result in damage to the inverter, drive motor, and high voltage battery.
