SAFETY RECALL BULLETIN

NHTSA RECALL 17V-533

AUTOCAR, LLC SAFETY RECALL ACX-1703

Autocar and Dana have determined that a safety defect exists in the steer knuckle and tie rod connection of the steer axle in certain 2015-2016 model-year Xpeditors.

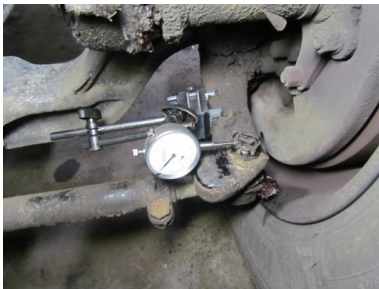
Dial Indicator Mounting Position

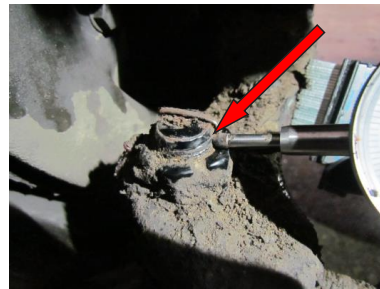
Dial Indicator Tip Must be Placed on The Stud

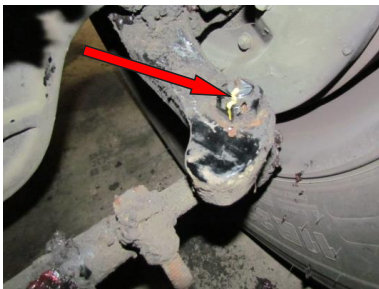
Paint Mark to Identify Nut Rotation

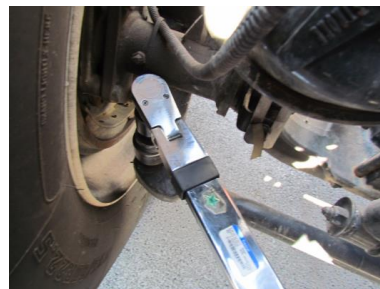
Check Nut Torque – Do Not Exceed 170 ft. lbs.

5. If there is no rotation of the nut at 130 ft. lbs. install a new cotter pin and return the truck to service.

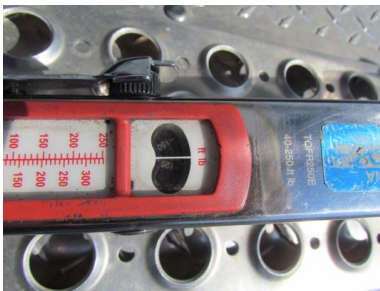
- If you found rotation of the nut before you reached 130 ft. lbs., we can now torque the nut to 130 ft. lbs. Using the paint mark, record the amount of movement to the nut. Example: Use the paint mark as the 12:00 position, if the nut rotates $\frac{1}{4}$ turn to reach 130 ft. lbs., document the nut rotated as the 3:00 position.

Retorque to 130 ft. lbs

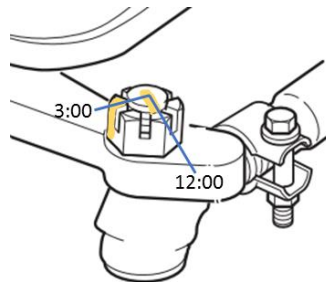
Record Rotation on Nut

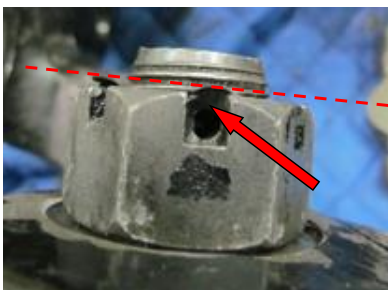
Good Cotter Pin Hole Position

- With the nut torque to 130 ft. lbs. advance the nut so that the cotter pin hole is aligned with a slot in the nut, reinstall the dial indicator and check for tie rod stud movement once again. Record results on the form supplied.
Note: Never back the nut off to align the cotter pin hole to the nut slot. Torque may reach 170 ft. lbs. to obtain proper alignment.
- Important:** Any tie rod stud with movement after proper nut torque and alignment will require the replacement of that knuckle and tie rod.
- Important:** One last check. After the nut has been aligned with a slot in the nut, the cotter pin hole **CAN NOT** be above the top of the nut as shown below. Any cotter pin hole that is above the top of the nut surface will require the replacement of the knuckle and tie rod end.

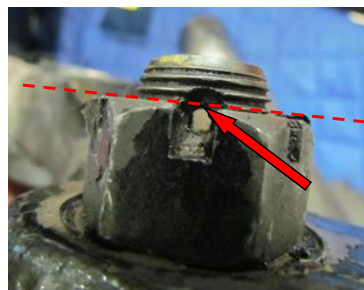
Cotter Pin Hole at Maximum Height
