SAFETY RECALL

Date	Number	Release	Page
10.2017	RVXX1702	01	1 (11)

DANA® Steer Axle, Inspection

VNL, VNM

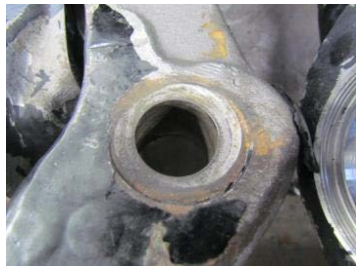
Tie Rod Arm Taper Bore

7. If your inspection identifies that components may need to be replaced you will need to take pictures of the damage parts and the position of the cotter pin hole. It's important to remember that RTW will be using the pictures you send to determine if components need to be replaced. If the pictures are out of focus, too light, too dark, too far away or too close-up the process will be delayed until new pictures are submitted. Use the example below as a guide of what your pictures should resemble.

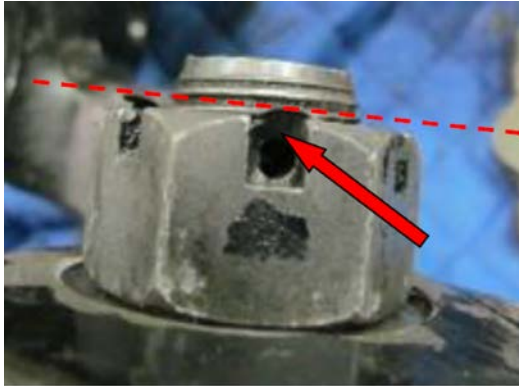
Good Cotter Pin Hole Position

9. One last check. After the nut has been aligned with a slot in the nut, the cotter pin hole **CANNOT** be above the top of the nut as shown in the figure below. Any cotter pin hole that is above the top of the nut surface will require the replacement of the knuckle and tie rod end.
