## THOR MOTOR COACH AM EQUIPMENT WINDSHIELD WIPER INSPECTION/REPAIR INSTRUCTIONS

(Rev 6/21/17)

APPLIES TO: TUSCANY MY 2014-2016, TUSCANY XTE MY 2014-2016

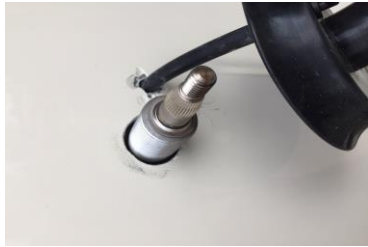
5.) Verify holes in the fiberglass front cap are not interfering with the pivot shaft. (Pivot shaft must not be bound or under pressure) If pivot shafts appear to be interfering with fiberglass cap remove system entirely and redrill with hole saw to eliminate interference and place hole in proper position for the wiper system (DO NOT OVERDRILL). Pivot shaft only needs 1/16" of clearance to edge of hole.

ACCEPTABLE

NOT ACCEPTABLE

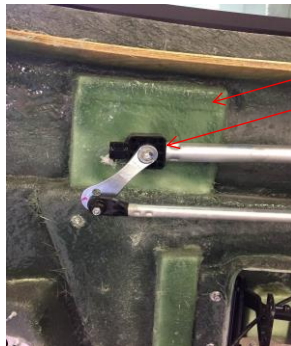
6.) If pivot shaft alignment does not show any signs of binding with the pivot shaft hole in the front cap, verify that the wiper stringer plate sits flush against the backer laminated into the inside of the front cap. If there is a gap between the face of the stringer plate and the laminated backer, remove system and sand backer with 80 grit sandpaper so that system will sit flush.

BACKER

WIPER STRINGER PLATE
