SERVICE PROCEDURE

17507

SUBJECT: SAFETY RECALL

Tie Rod Castellated Nut on certain 9900i, DuraStar®, LoneStar®, PayStar®, ProStar®, TerraStar®, TranStar®, and WorkStar® model trucks built 04 March 2015 thru 18 June 2015 and FBC bus, SFC bus, and FE bus chassis built 09 March 2015 thru 21 July 2015 with Spicer D or E series steer axles.

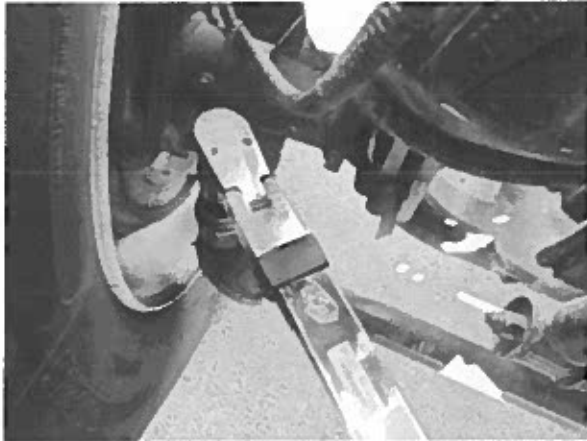
Figure 4. Verifying Nut Torque

NOTE: Never back the nut off to align the cotter pin hole to the nut slot. Torque may reach 170 lb-ft (230 nm) to obtain proper alignment.

11. Tighten nut to 130 lb-ft (176 nm) (Figure 5):
 - a. If nut does not turn when 130 lb-ft (176 nm) is reached, go to Step 22.
 - b. If nut does turn before 130 lb-ft (176 nm) is reached, go to Step 12.
12. With nut tightened to 130 lb-ft (176 nm), advance nut so cotter pin hole is aligned with slot in castellated nut.
13. Reinstall dial indicator and check for tie rod stud movement, record readings.

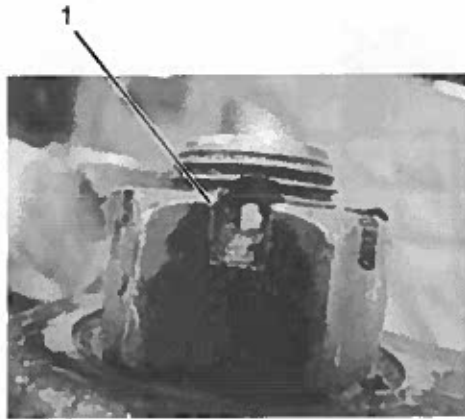
Figure 5. Unacceptable Cotter Pin Hole Position

1. Top of castellated nut

NOTE: Any tie rod stud with movement after proper nut torque and alignment and / or the cotter pin hole is above the top of the nut surface will require the authorization from Dana to replace the components and will be sent to you.

14. After nut has been aligned with cotter pin hole in stud, check to see if cotter pin hole is above top of castellated nut (Figure 6, Item 1):
 - a. If top of cotter pin hole is even with or less than top of nut, continue to Step 22.
 - b. If cotter pin hole is above top of nut surface, continue to Step 15.
15. If no tie rod and knuckle require replacement, proceed to Step 22. If one or both tie rods and knuckles require replacement, proceed to Step 16.
16. For each tie rod and knuckle require replacement, fill out document at end of letter before calling Dana's Real Time Warranty Center.
17. After completing form and taking required photos, email information to Spicer.rtw@dana.com with repair order number in subject line.
