GROUP	NUMBER			
RECALL	17-01-060			
DATE	MODEL(S)			
OCTOBER, 2017	2018MY SANTA FE SPORT (AN)

2018 SANTA FE SPORT (AN) FRONT COIL SPRING REPLACEMENT (RECALL CAMPAIGN 167)

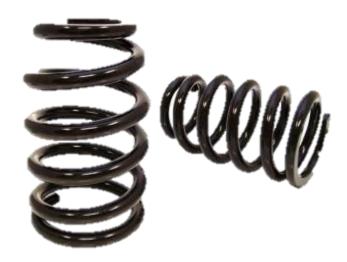
Description: On certain 2018MY Santa Fe Sport vehicles (AN), the front coil spring may have been manufactured with a process that could result in a spring fracture. A fractured spring can make contact with the tire, potentially resulting in a tire puncture, increasing the risk of a crash. This bulletin describes the procedure to replace the front coil springs.
