Technical Service Bulletin

GROUP RECALL	NUMBER 17-01-071
DATE DECEMBER, 2017	MODEL(S) SANTA FE (NC)

SUBJECT: SANTA FE 3.3L V6 ENGINE INSPECTION AND REPLACEMENT
(RECALL CAMPAIGN 168)

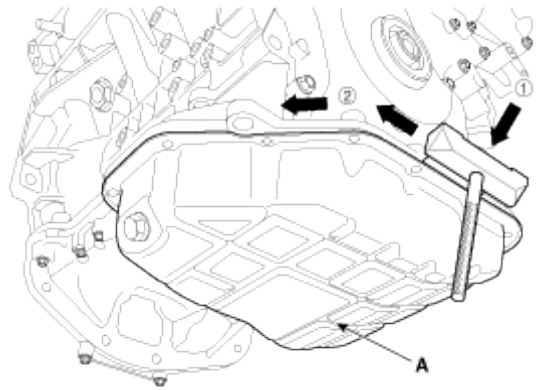
1. Carefully remove the lower oil pan using the oil pan remover SST and referring to applicable vehicle shop manual.

Carefully remove the oil pan. It will be reused if engine replacement is not required.

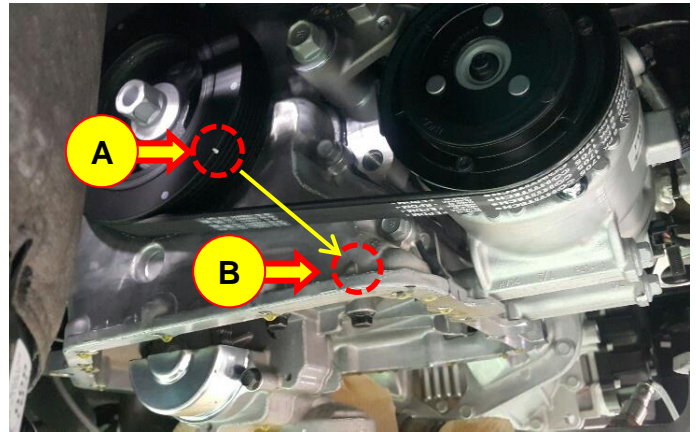
2. Align the timing mark (A) of the damper pulley to location (B) by rotating the crankshaft.

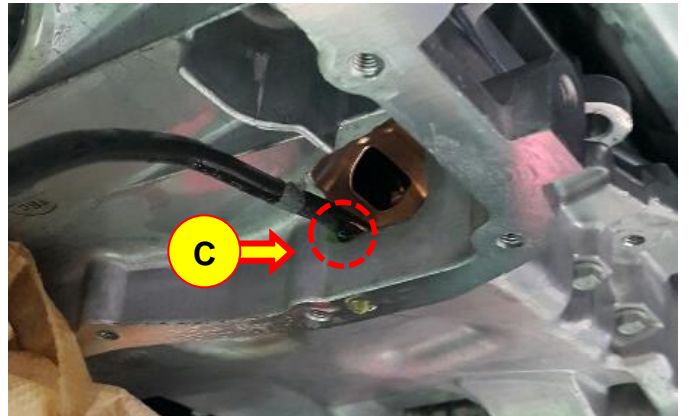
Insert the borescope into the hole of the oil pan at a depth no greater than the rubber stopper as shown. Align the borescope to the bottom left corner (C).

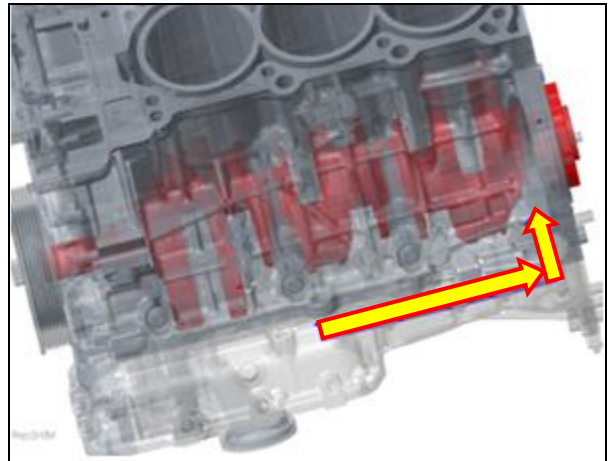
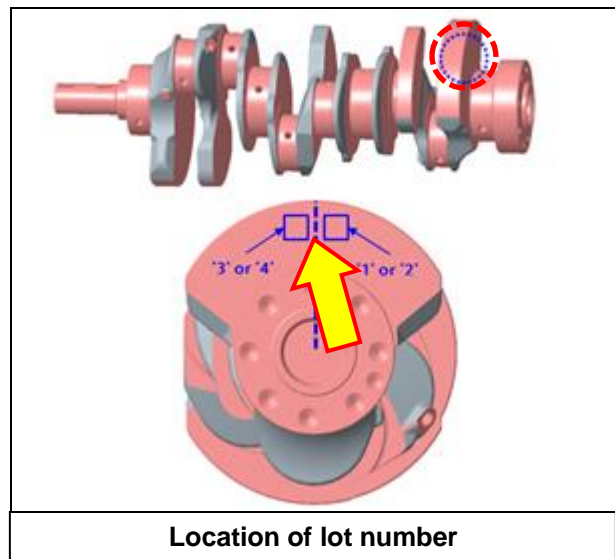
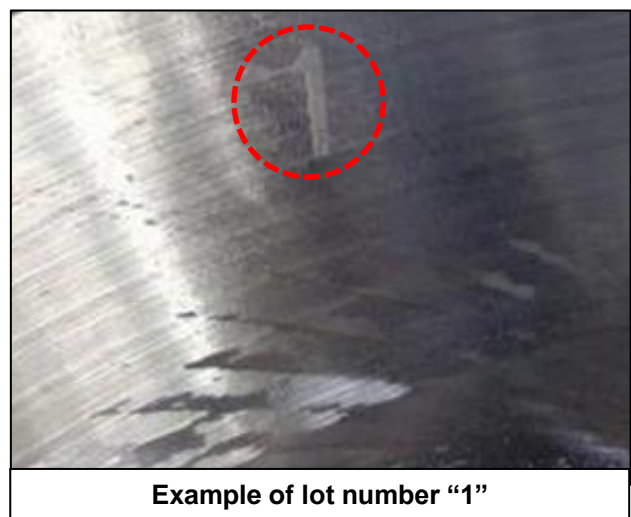
4. Inspect the crankshaft lot number using the borescope. Feed the borescope through the oil pan along the path shown.

The lot number may be partially inscribed on the crankshaft. Refer to the photos for examples where the lot number is "1".

Record the lot number on the repair order and replace the engine sub assembly according to the Shop Manual.

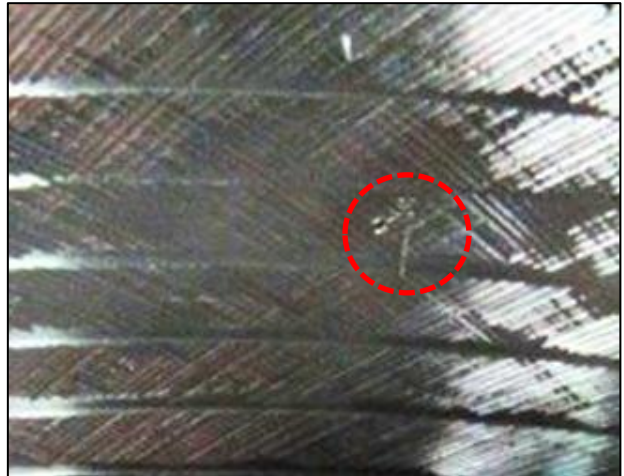
**Example of lot number "1"
(lot number partially inscribed)**

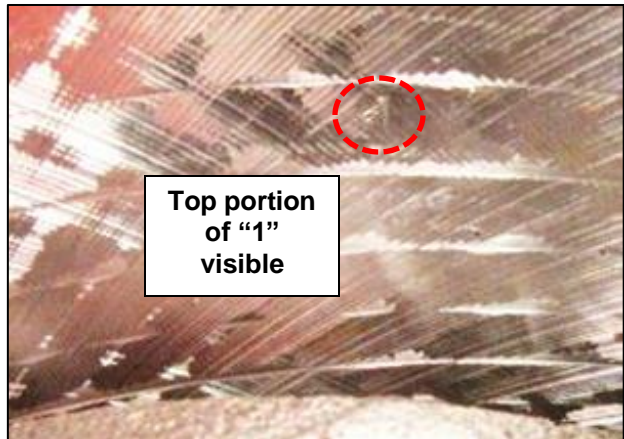
**Example of lot number "1"
(lot number partially inscribed)**
