SERVICE PROCEDURE

17508

SUBJECT: SAFETY RECALL

Tie Rod Castellated Nut on certain CE school bus models built 11 March 2015 thru 01 June 2015 with Spicer D or E series steer axles.

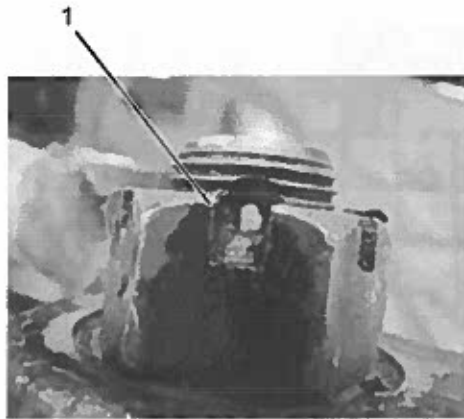
Figure 5. Unacceptable Cotter Pin Hole Position

NOTE: Any tie rod stud with movement after proper nut torque and alignment and / or the cotter pin hole is above the top of the nut surface will require the authorization from Dana to replace the components and will be sent to you.

14. After nut has been aligned with cotter pin hole in stud, check to see if cotter pin hole is above top of castellated nut (Figure 5, Item 1):
 - a. If top of cotter pin hole is even with or less than top of nut, continue to Step 22.
 - b. If cotter pin hole is above top of nut surface, continue to Step 15.
15. If no tie rod and knuckle require replacement, proceed to Step 22. If one or both tie rods and knuckles require replacement, proceed to Step 16.
16. For each tie rod and knuckle that require replacement, fill out document at end of letter before calling Dana's Real Time Warranty Center.
17. After completing form and taking required photos, email information to Spicer.rtw@dana.com with repair order number in subject line.
