# Recall Bulletin 170914REV

Fleetwood Bounder  
manufactured  
March 24, 2014  
through May 22,  
2015 (DC Level  
510 thru 609)

Fleetwood  
Southwind  
manufactured  
March 11, 2014  
through March 2,  
2016 (DC Level  
500 thru 625)

**SUBJECT:**  
Inspection /  
Correction of  
Battery Tray  
Installation

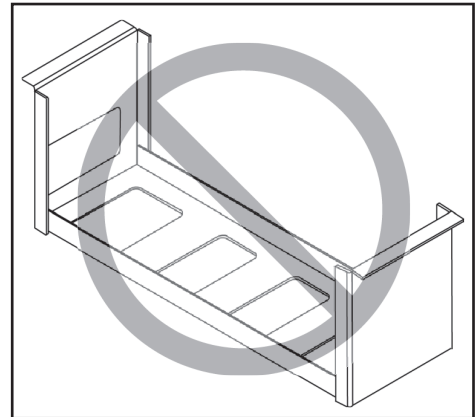
**Figure 1**

- a) If the battery tray is formed as one solid piece (has no angle steel members) as shown in **Figure 1**, no repairs are necessary. Take photos and then reinstall the entry step cover. Ensure the bulb seal is properly positioned around the perimeter before reinstalling the cover.

*If the battery tray is formed as one solid piece as shown above, no repairs are required.*

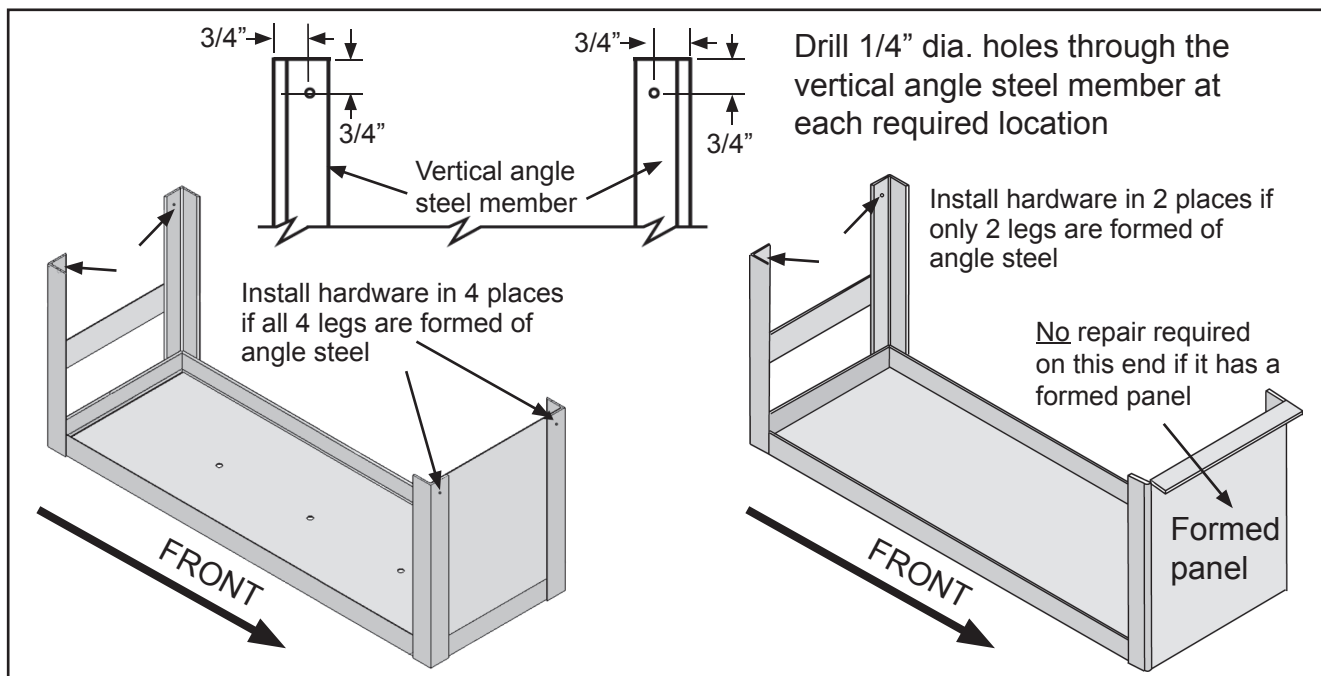
On motorhomes affected by this recall, the welds on the battery tray, attached to the underside of the chassis bridge, may be insufficient. If the welds are insufficient they may break and allow the battery tray to partially or fully detach from the chassis bridge.

- b) If the battery tray has 2 or 4 vertical members composed of angle steel as shown in **Figure 2**, continue to CORRECTION, Step 5, next page.

*If the step cage is constructed with either (2) or four (4) angle steel members, repairs are required.*

5. Locate the upper corners of the battery tray's vertical angle steel members. Using **Figure 2** on Page 2 as a guide, drill a 1/4" diameter hole through the vertical angle steel and the chassis structural steel, in each required location.
6. Install a grade 5 bolt, two flat washers, and a nylon lock nut at each newly drilled location, using the stacking order shown in **Figure 3**. Tighten nuts to 12 -15 ft./lbs. See Parts list for hardware requirements.
