GROUP
Safety Recall

MODEL
2017MY
Sorento (UMa)
3.3L

NUMBER
SC153 (Rev 1, 12/18/2017)

SUBJECT: 3.3L LAMBDA ENGINE INSPECTION /
REPLACEMENT (SC153)

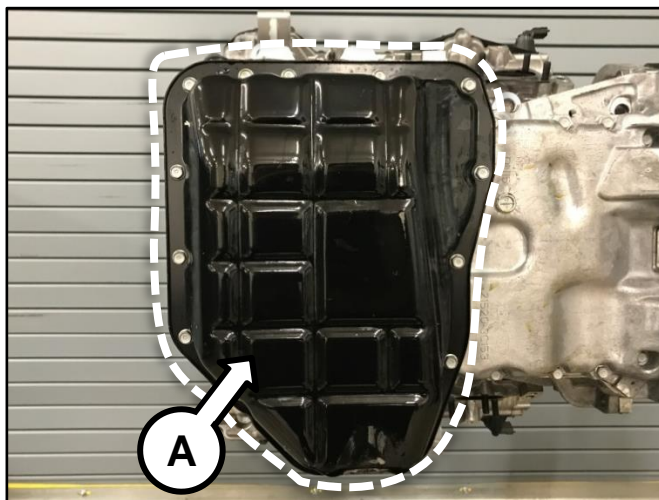
1. Remove the lower oil pan (A) by referring to the “Engine Mechanical System → Lubrication System → Oil Pan → Repair procedures” chapter in the applicable Shop Manual.

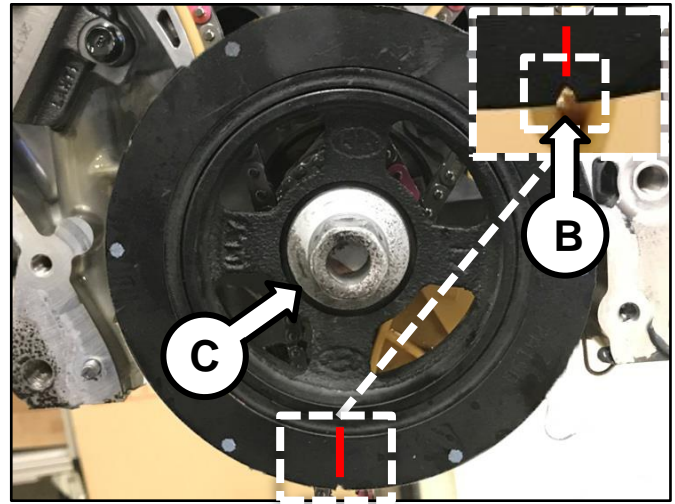
2. Rotate the crankshaft and bring the timing mark (B, red mark) on the crank pulley (C) to the 6 o'clock position.

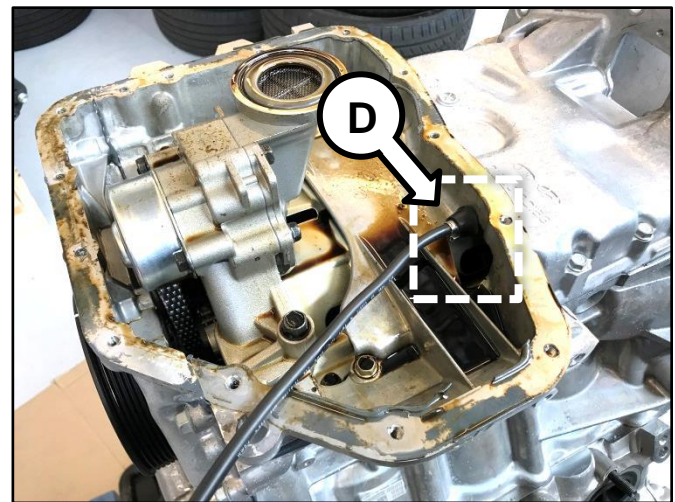
3. Insert the provided endoscope towards the rear of the engine through the oil return passage opening (D) of the upper oil pan.

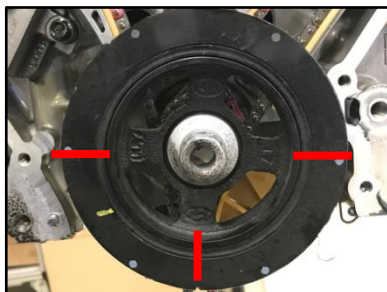
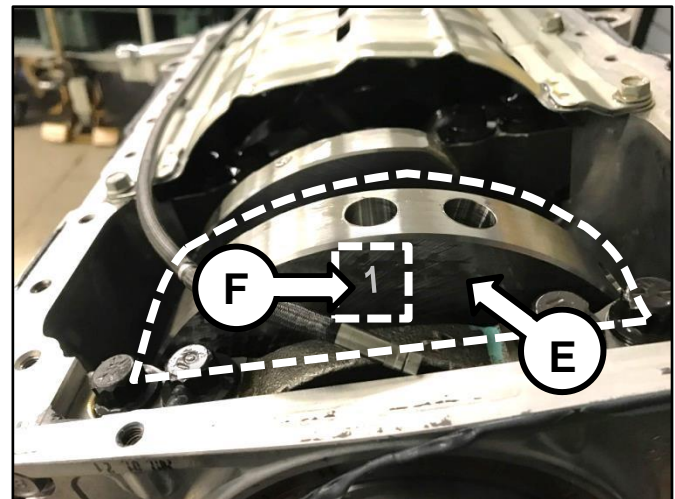
4. Locate the last crankshaft counter weight (E) (furthest away from the crank pulley). Using the endoscope, locate the lot number stamped on the back side (F) of the counter weight.

If the lot number cannot be located, rotate the crankshaft 90° to the left or right from the timing mark (red mark) on the crankshaft pulley.

Upper oil pan was removed in this image for demonstration purposes only. DO NOT remove the upper oil pan.

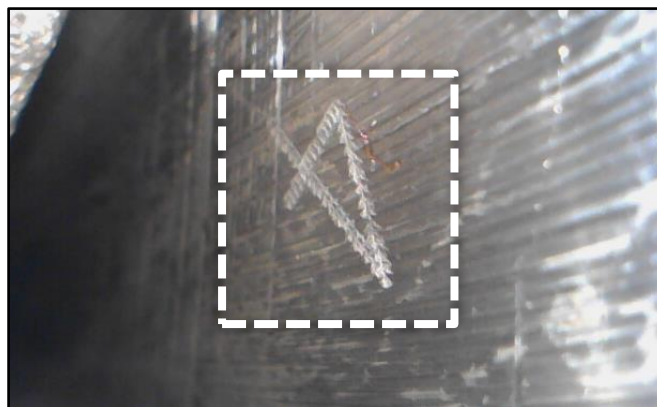
Example of lot number (4) shown on an endoscope.

If the lot number is 2, 3 or 4, replace the lower oil pan by referring to the “Engine Mechanical System → Lubrication System → Repair procedures” chapter in the applicable Shop Manual on KGIS and refill with new engine oil.

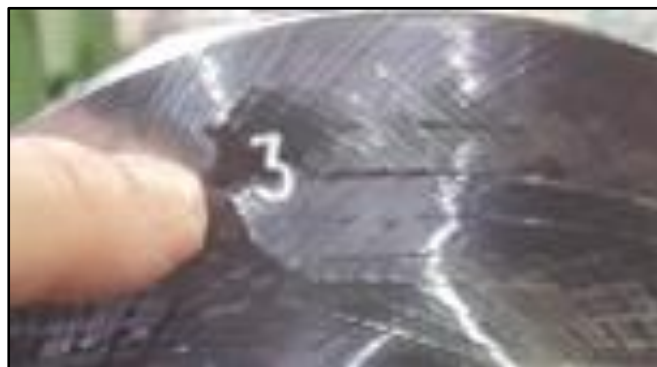
Example of lot number (3) shown on an endoscope.
