GROUP Safety Recall	MODEL 2017MY Sorento (UMa) 3.3L
	NUMBER SC153 (Rev 2, 2/5/2018)	DATE November 2017
SAFETY RECALL		
SUBJECT: 3.3L LAMBDA ENGINE INSPECTION / REPLACEMENT (SC153)

This bulletin provides the procedure to inspect, and if necessary, replace the engine sub-assembly on certain 2017MY Sorento (UMa) vehicles, equipped with a Lambda engine produced from March 27, 2017 through March 30, 2017. The engine's crankshaft may not have been properly heat-treated during the manufacturing process. An improperly heat-treated crankshaft may produce a cyclic knocking noise from the engine, as well as result in the illumination of the vehicle's malfunction indicator lamp (MIL). If the warnings are ignored and the vehicle continues to be driven, the crankshaft may fail, and the vehicle may stall while in motion, increasing the risk of a crash. In addition, under certain conditions, a fire may occur. If the engine replacement is not necessary, replace the lower oil pan.

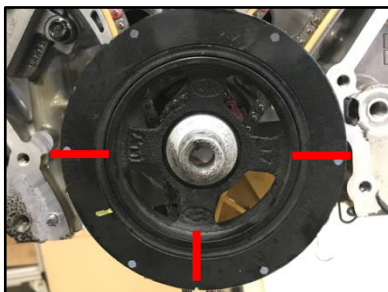
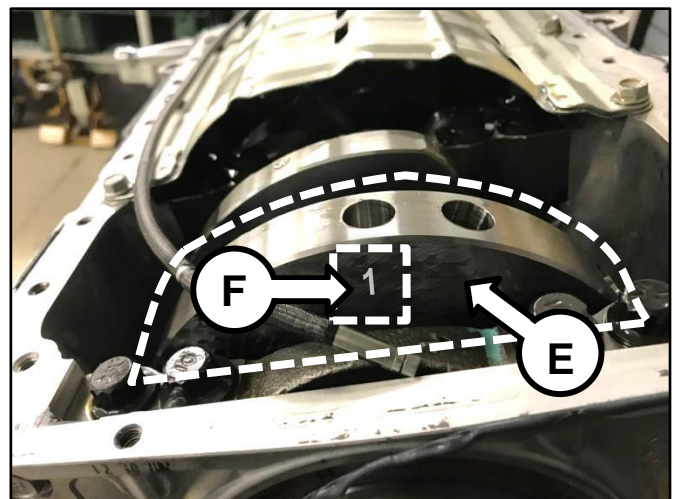
4. Locate the last crankshaft counter weight (E) (furthest away from the crank pulley). Using the endoscope, locate the lot number stamped on the back side (F) of the counter weight.

If the lot number cannot be located, rotate the crankshaft 90° to the left or right from the timing mark (red mark) on the crankshaft pulley.

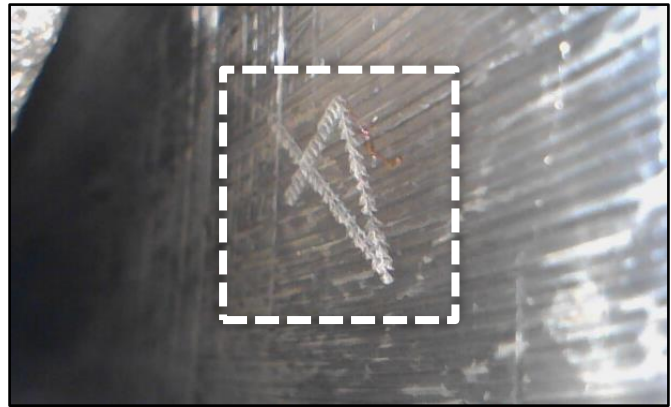
Example of lot number (4) shown on an endoscope.

If the lot number is 2, 3 or 4, replace the lower oil pan by referring to the “Engine Mechanical System → Lubrication System → Repair procedures” chapter in the applicable Shop Manual on KGIS and refill with new engine oil.

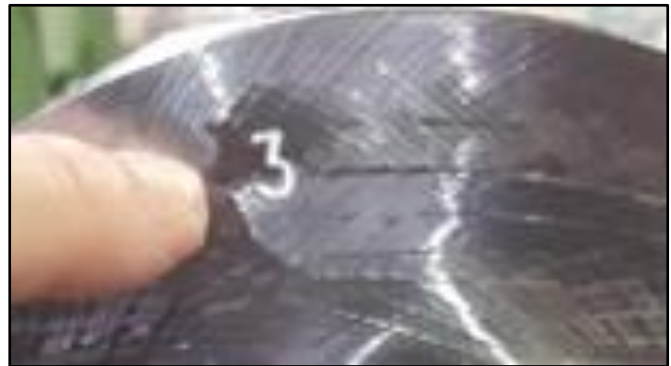
Example of lot number (3) shown on an endoscope.
