GROUP <b>Safety Recall</b>	MODEL <b>2017MY Sorento (UMa) 3.3L</b>
NUMBER <b>SC153</b>	DATE <b>November 2017</b>

**SUBJECT:** 3.3L LAMBDA ENGINE INSPECTION /  
REPLACEMENT (SC153)

This bulletin provides the procedure to inspect, and if necessary, replace the engine sub-assembly on certain 2017MY Sorento (UMa) vehicles, equipped with a Lambda engine produced from March 27, 2017 through March 30, 2017. The engine's crankshaft may not have been properly heat-treated during the manufacturing process. An improperly heat-treated crankshaft may produce a cyclic knocking noise from the engine, as well as result in the illumination of the vehicle's malfunction indicator lamp (MIL). If the warnings are ignored and the vehicle continues to be driven, the crankshaft may fail, and the vehicle may stall while in motion, increasing the risk of a crash. In addition, under certain conditions, a fire may occur. If the engine replacement is not necessary, replace the lower oil pan.

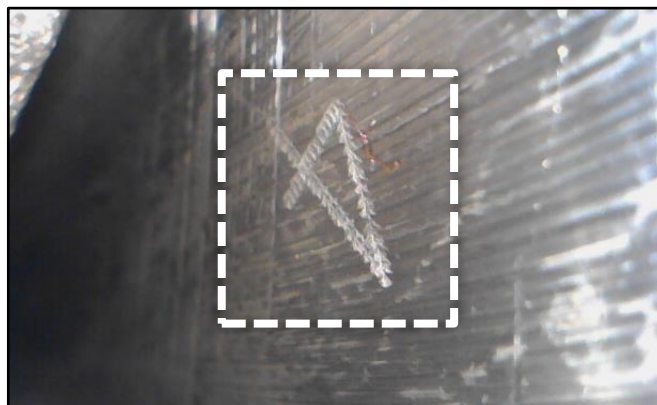
Example of lot number (4) shown on an endoscope.

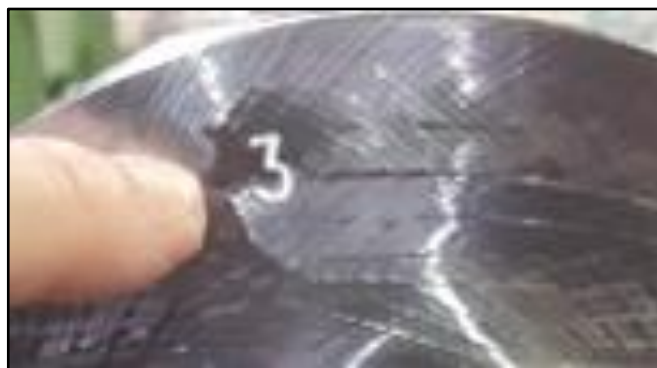
Example of lot number (3) shown on an endoscope.

If the lot number is 2, 3 or 4, replace the lower oil pan by referring to the “Engine Mechanical System → Lubrication System → Repair procedures” chapter in the applicable Shop Manual on KGIS and refill with new engine oil.
