Dana® Spicer® Steer Axle

Information Bulletin

ABIB-1701P

Topic: Steer Knuckle Recall Process – Peterbilt 817-C / Kenworth 17KWD

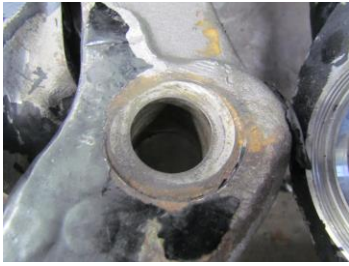
Tie Rod Arm Taper Bore

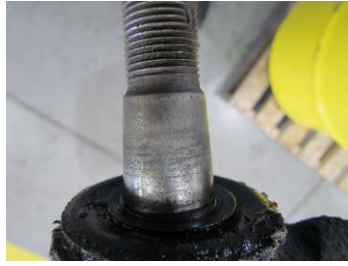
Tie Rod End Taper Stud

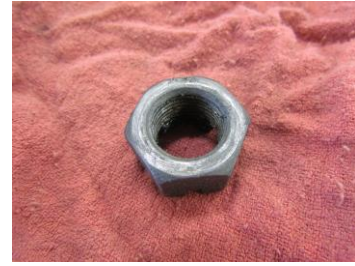
Back of Tie Rod Nut

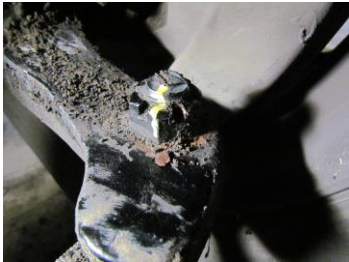
Nut Rotation

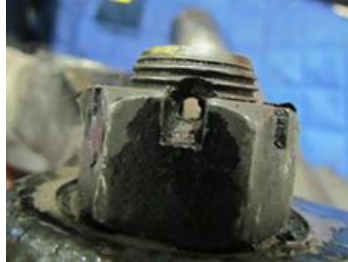
Cotter Pin Hole Position

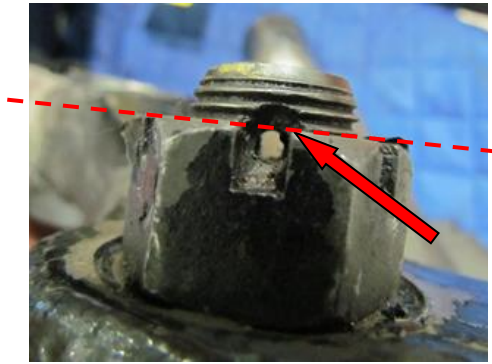
- Important:** Any tie rod stud with movement after proper nut torque and alignment will require the replacement of that knuckle and tie rod.
- Important:** One last check. After the nut has been aligned with a slot in the nut, the cotter pin hole **CAN NOT** be above the top of the nut as shown below. Any cotter pin hole that is above the top of the nut surface will require the replacement of the knuckle and tie rod end.

Cotter Pin Hole at Maximum Height

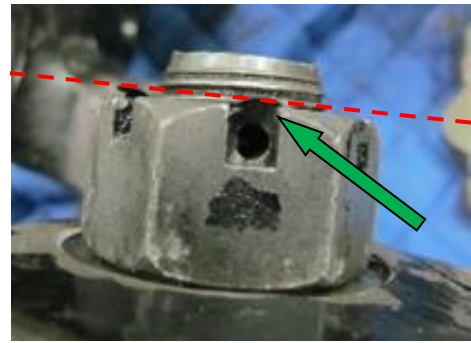
Good Cotter Pin Hole Position

10. Install new cotter pin and bend appropriately for retention.
