GROUP Safety Recall Campaign	MODEL 2014-2016MY Soul (PS) Soul (PS EV)
	NUMBER SC155	DATE November 2017
SAFETY RECALL CAMPAIGN		
SUBJECT: STEERING GEAR ASSEMBLY PINION PLUG INSPECTION/REPAIR/REPLACEMENT (SC155)

This bulletin provides information related to inspection, repair, and, if necessary, the replacement of the steering gear assembly of some 2014-2016MY Kia Soul (PS) and Soul EV (PS EV) vehicles, produced from July 21, 2013 through September 30, 2015. The vehicles included in this recall were previously recalled under Recall SC108 (14v332) and SC125 (15v736). This recall is being conducted to confirm that the subject vehicles received a proper repair. In some cases, the pinion plug may not have been secured properly. As a result, the pinion gear may separate from the steering gear assembly, causing loss of steering and could increase the risk of a crash.

Dealers are to inspect the pinion plug to ensure the recall repair, if previously conducted, was properly done. Based upon the inspection results, the previous recall repairs will either be redone with an improved method or, if necessary, the steering gear assembly will be replaced. Vehicles that were not previously repaired

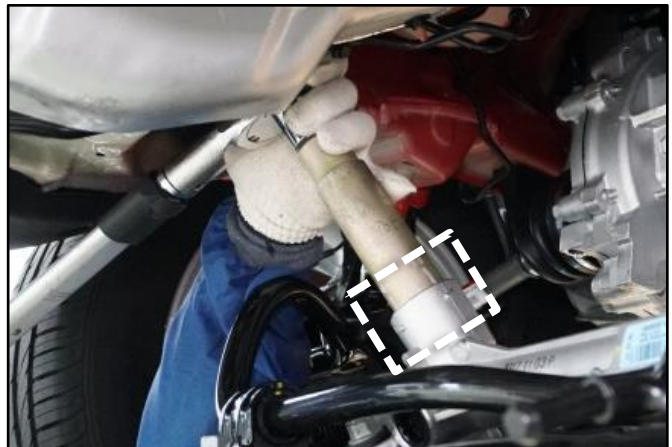
Use a reliable and calibrated torque wrench and confirm that proper torque is applied regardless of wrench type ("click" style, digital, or other.). Improperly torqued pinion plug will invalidate the entire repair.

12. With a torque wrench and the provided SST socket, tighten and torque the steering gear pinion plug to the specified torque.

Tightening torque:
57.56 lb.ft (78 N.m, 7.95 kgf.m)

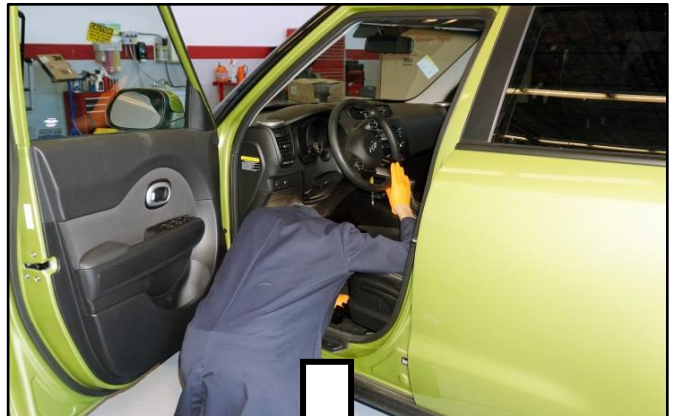
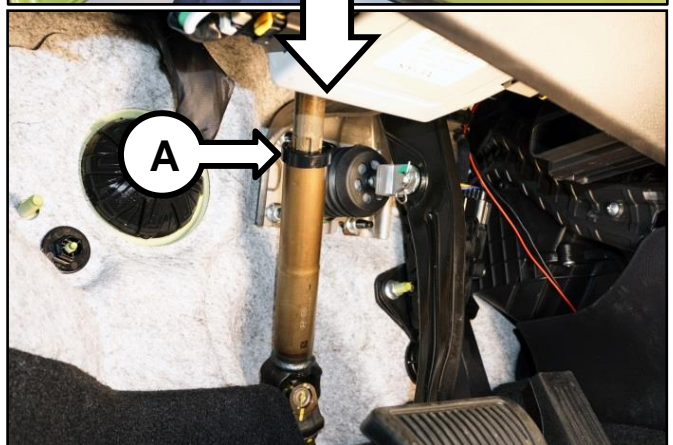
2. Turn the steering wheel from right to left, multiple times, while observing the intermediate shaft (A) for up and down movement.

- If the intermediate shaft does not move up and down when the steering wheel is turned, proceed to the Set Screw Inspection/Repair Procedure below.
- If the intermediate shaft moves up and down (indicating that the pinion plug has backed off) when the steering wheel is turned, perform the SC155A Pinion Plug Tightening and Set Screw Installation procedure on page 2.
- If one (1) or more of the three (3) conditions listed below exists, replace the steering gear assembly by referring to the “Steering System → Electric Power Steering → Steering Gear Box → Repair procedures” chapter in the applicable Shop Manual on KGIS.
 - Pinion shaft has separated from the steering gear assembly.
 - It is impossible to properly secure the pinion plug for any reason.
 - There is physical damage to the steering gear.

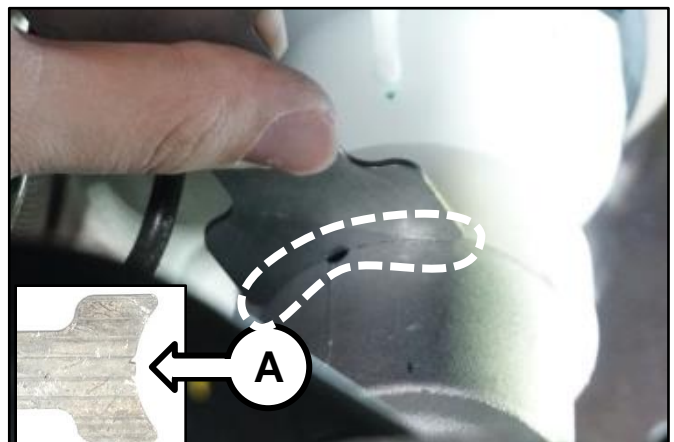
2. Verify that the previously installed set screw is installed properly and not protruding by using the provided 0.01in (0.3mm) depth gauge. Insert the notch (A) of the depth gauge into the screw hole, as shown, and ensure there is no gap between the gauge and the steering gear. See examples of gap/no gap below.

- If there is no gap and the set screw is installed correctly, take one (1) photo of the correctly installed set screw (using KVID, refer to page 19 of [KVID User Guide](#)) and attach them to the warranty claim (attachment type "XX: Other" in WebDCS). Then reapply silicone over the set screw and reinstall the engine under-cover. No further action is required.

If there is a gap and the set screw is protruding, proceed to the Set Screw Installation procedure below.

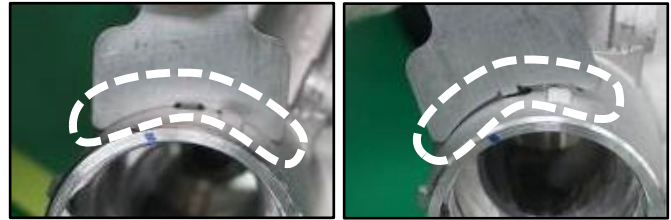
No Gap Shown

Gap Shown

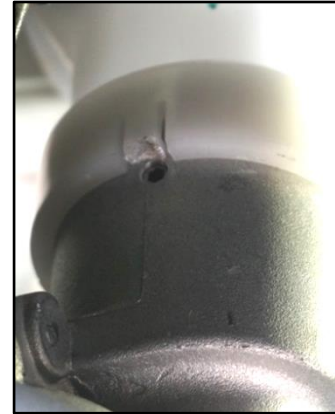
Photo 1

Ensure the photos are bright and clear enough to distinguish an exposed thread (photo 1) and no gap between the gear assembly and side of the set screw depth gauge without the notch (photo 2). Photo of the repair order is not required.

16. Take two (2) photos of the new installed set screw (using KVID, refer to page 19 of [KVID User Guide](#)) and attach them to the warranty claim (attachment type "XX: Other" in WebDCS).
