SI B64 07 17
Heating and Air Conditioning

RECALL 17V-676: BLOWER MOTOR WIRING

BMW AG is conducting a Voluntary Safety Recall (effective November 2, 2017) on Model Year 2006-2011 BMW 3 Series involving the wiring of the blower motor.

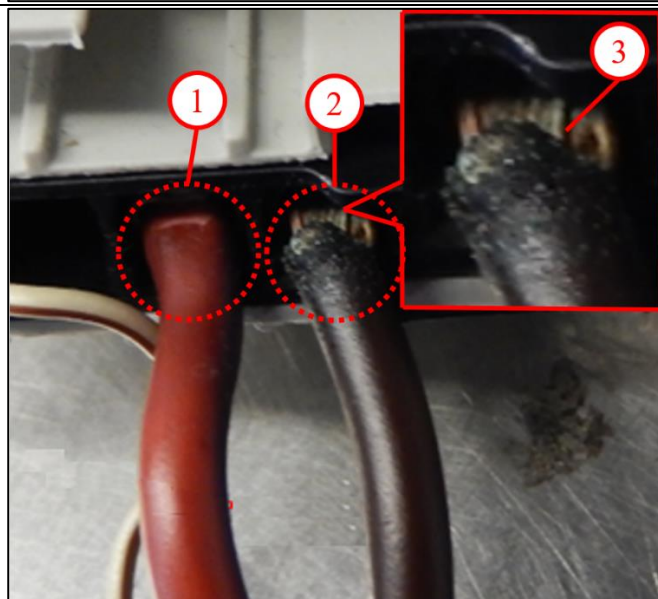
- Inspect the harness wires (1) and (2) at the connector for discoloration and copper wires (3) exposed.
- Are there both discoloration in the harness insulation and copper wire exposed as in the picture to the left?

Yes – This is a **Type 1** case.
Install the long repair harness and replace the blower regulator in order to finish the repair.

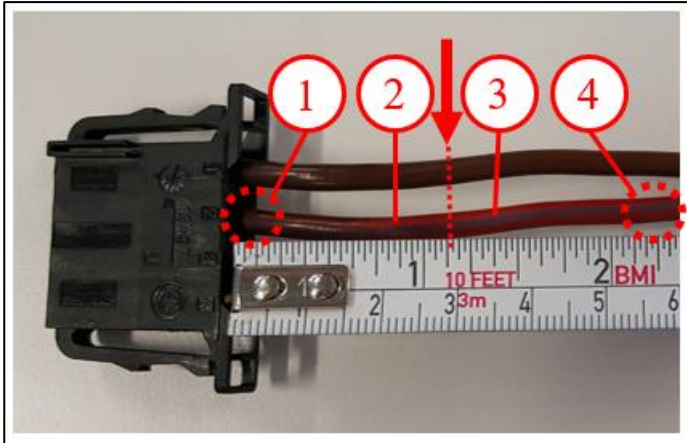
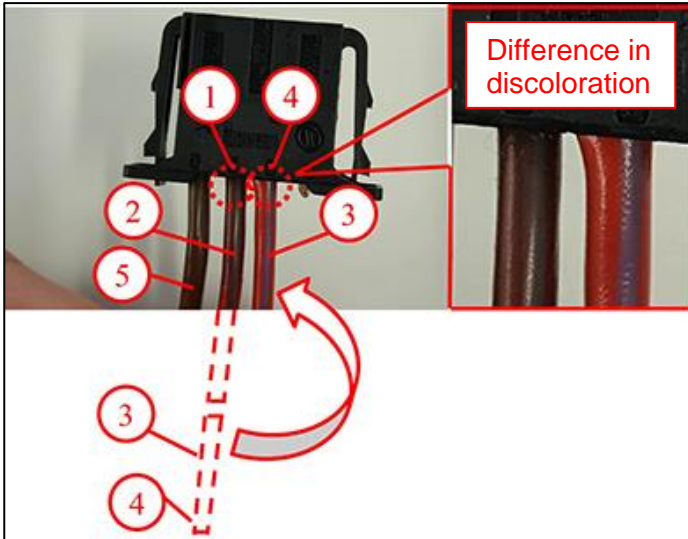
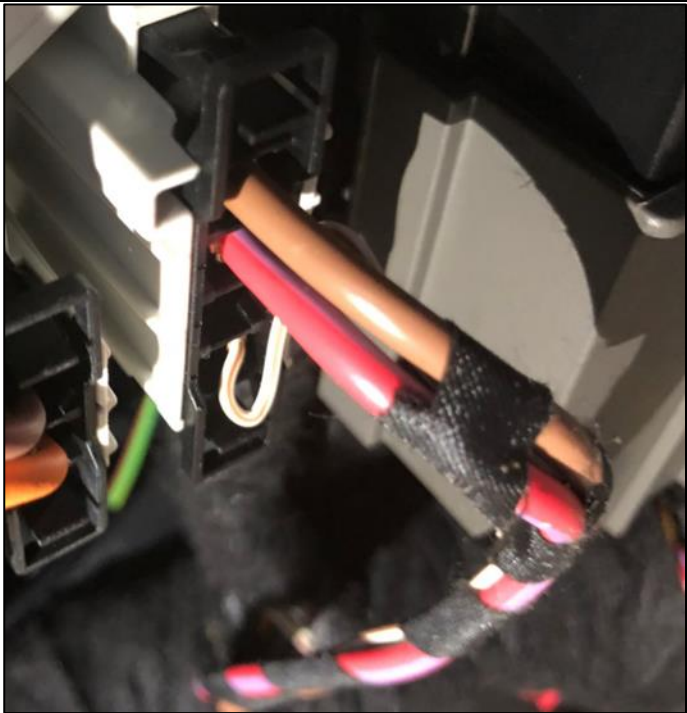
- Inspect the wires (3) end (4) next to connector end (1). Do this for both Red/Blue (Red/Violet) (2) and Brown (5) wires
- Is there a difference in the discoloration of the wire insulation at (1) and (4) as shown in the close-up picture?

Yes – This is a **Type 2** case. Install the short repair harness and replace the blower regulator and finish the repair.

- If there is no discoloration in the wire insulation at all then this is a **Type 3** case.
- Install the short repair harness and finish the repair.
