SAFETY RECALL BULLETIN

SUBJECT:			No: SR-17-006
MIRAGE SRS WARNING LAMP ILLUMINATION – SAFETY RECALL CAMPAIGN			DATE: November, 2017
			MODEL: 2014–2018 Mirage
CIRCULATE TO:	<input checked="" type="checkbox"/> GENERAL MANAGER	<input checked="" type="checkbox"/> PARTS MANAGER	<input checked="" type="checkbox"/> TECHNICIAN
<input checked="" type="checkbox"/> SERVICE ADVISOR	<input checked="" type="checkbox"/> SERVICE MANAGER	<input checked="" type="checkbox"/> WARRANTY PROCESSOR	<input checked="" type="checkbox"/> SALES MANAGER

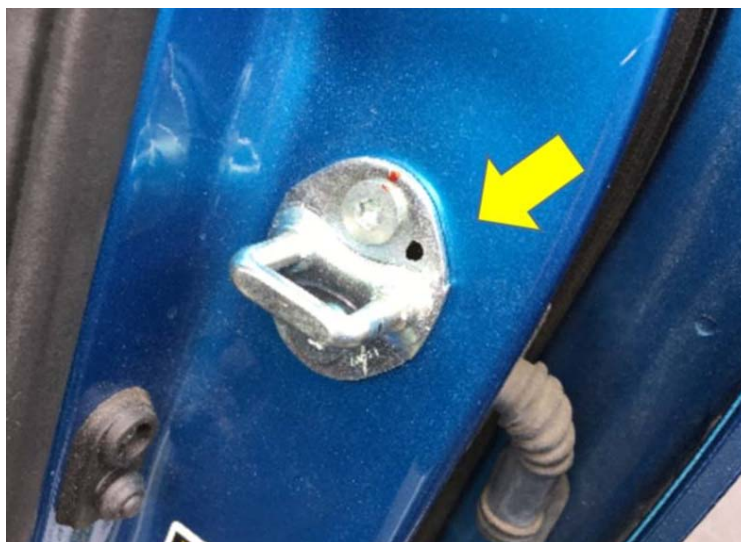
!! IMPORTANT !! Some vehicles may have already had the recall completed at the Port. These vehicles have been marked with a black dot on the Left Front door latch. Ensure that the vehicle does NOT have a black dot on the Left Front door latch before proceeding.

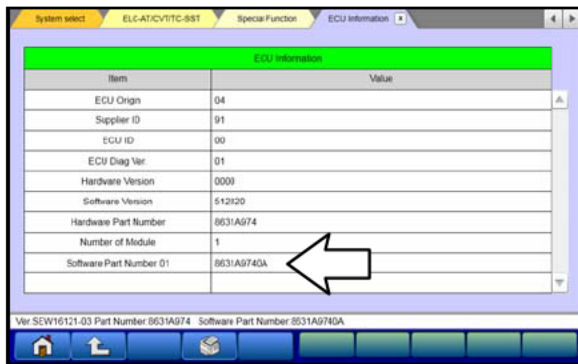
d. If the Software Part Number listed is **not** at the latest level (shown in the SRS–ECU Reprogramming chart), proceed with the next step.

If the Software Part Number **is** at the latest level, then reprogramming is not necessary.

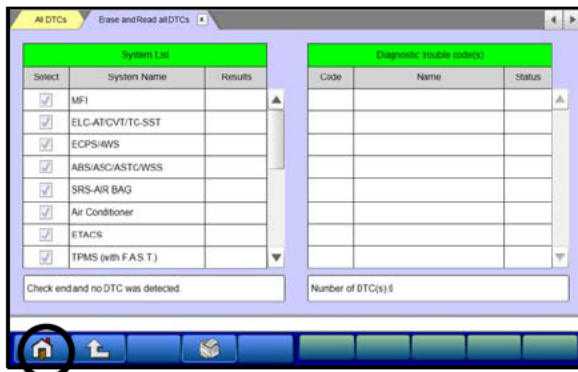
a. If DTCs other than **B1557** and **B1616** return after erasing is completed, click the check mark to clear the window. Diagnose and repair per the Service Manual.

b. If DTCs do not return, or only **B1557** and **B1616** remain, click the check mark to clear the window, then click the Home icon in the lower left to return to the System Select menu.
