**PRODUCT CAMPAIGN BULLETIN**

**APPLICABILITY:** 2018MY Crosstrek  
**SUBJECT:** Driver's Floor Mat Retention Bracket

**NUMBER:** WTR-77  
**DATE:** 11/09/17  
**NHTSA ID:** 17V-701

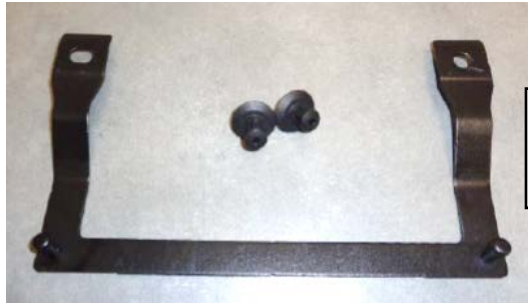
- If the retainer is a 1-piece metal bracket as shown in the photo below, **STOP**. Confirm both retaining clips are fully seated (see reference photos supplied in **Step 3**). Reconnect the floor mat to both posts. The procedure is complete.

1-Piece Metal  
Retention Bracket  
and retaining clips (2)

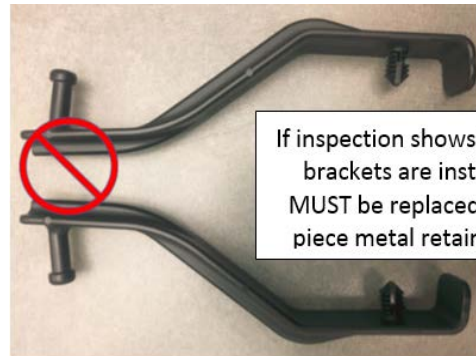
If inspection shows these plastic  
brackets are installed, they  
**MUST** be replaced with the 1-  
piece metal retainer bracket.

- If the retainer consists of 2 individual plastic brackets, remove and discard them. Proceed to **Step 3** and replace with the 1-piece metal bracket as shown above.

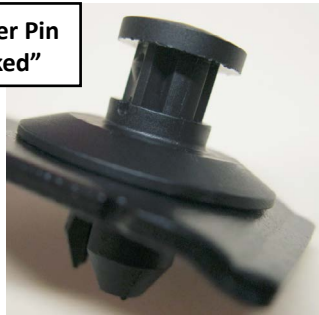
Clip Center Pin  
"Unlocked"

- Adjust the driver's seat all the way back to expose the 2 access points in the carpet.
- Peel back the 2 carpet access points and align the holes in the new metal bracket with the holes in the vehicle floor brace.
- Insert the 2 retaining clips into the holes and confirm an audible "click" is heard / felt when pressing in the center (locking) pin. **NOTE:** The locking pins will not be totally flush with the surrounding portion of the clip when fully seated. This is normal.

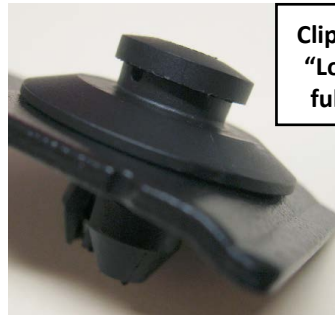
Clip Center Pin  
"Locked" and  
fully seated.
