PRODUCT CAMPAIGN BULLETIN

APPLICABILITY: 2018MY Crosstrek
SUBJECT: Driver's Floor Mat Retention Bracket

NUMBER: WTR-77
DATE: 11/01/17
NHTSA ID: TBD

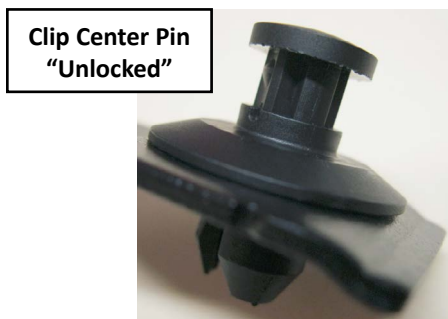
Clip Center Pin "Unlocked"

- Adjust the driver's seat all the way back to expose the 2 access points in the carpet.
- Peel back the 2 carpet access points and align the holes in the new metal bracket with the holes in the vehicle floor brace.
- Insert the 2 retaining clips into the holes and confirm an audible "click" is heard / felt when pressing in the center (locking) pin. **NOTE:** The locking pins will not be totally flush with the surrounding portion of the clip when fully seated. This is normal.

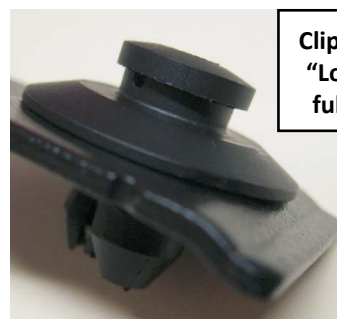
Clip Center Pin "Locked" and fully seated.
