MODEL: 2017 & 2018 Z900 & 900 ABS (ZR900AHFL/BHFL/BJF/BJFL)

## FRAME INSPECTION & REPAIR

### RECALL

### NHTSA RECALL NO. 17V-703

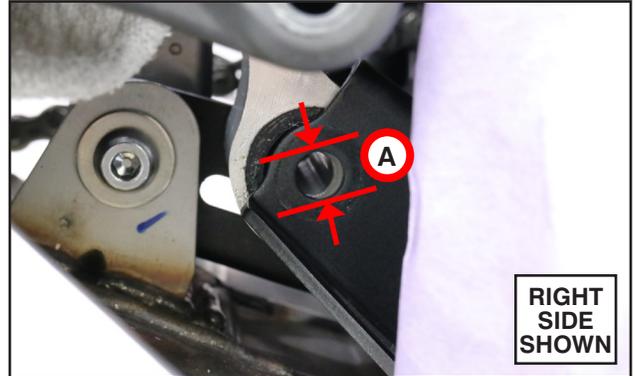
- Remove and discard the tie rod nut, bolt and washer
  - Measure the elongation length [A] of the left or right tie rod installation hole in the frame along the same line as the centerline of the tie rod.
- ★ If the hole measures **16mm or less** in diameter, proceed to the “**Install Brackets**” section of this bulletin.
- ★ If the hole measures **over 16mm** in diameter or has visible cracks, proceed to the “**Replace Frame**” section of this bulletin.

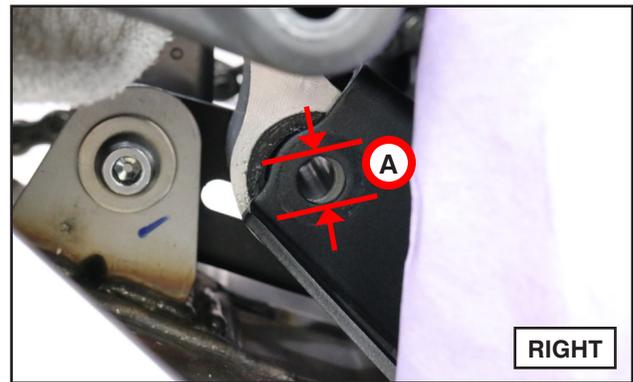
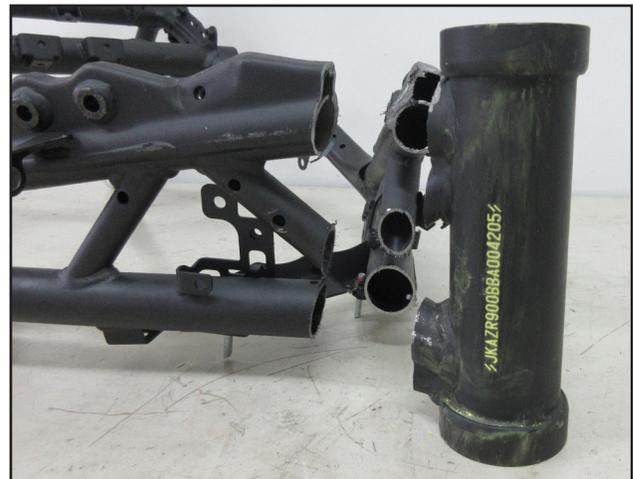
- o Only replace the frame if the hole [A] in the frame bracket measures over 16mm in diameter or has visible cracks.

- Replace the frame with a new one.
- After installing all components on the replacement frame, use an appropriate cutting tool to remove the steering head with the VIN from the old frame. Ensure the VIN is not damaged during removal.
- Dispose of the remainder of the frame in accordance with all local laws and regulations. Return the "VIN" portion of the frame with a copy of your work order and the warranty claim to the following address:
