January 2018

Dealer Service Instructions for:

# **Safety Recall T64 / NHTSA 17V-712 Front Door Impact Pressure Sensor**

**2018 (VF) RAM ProMaster**

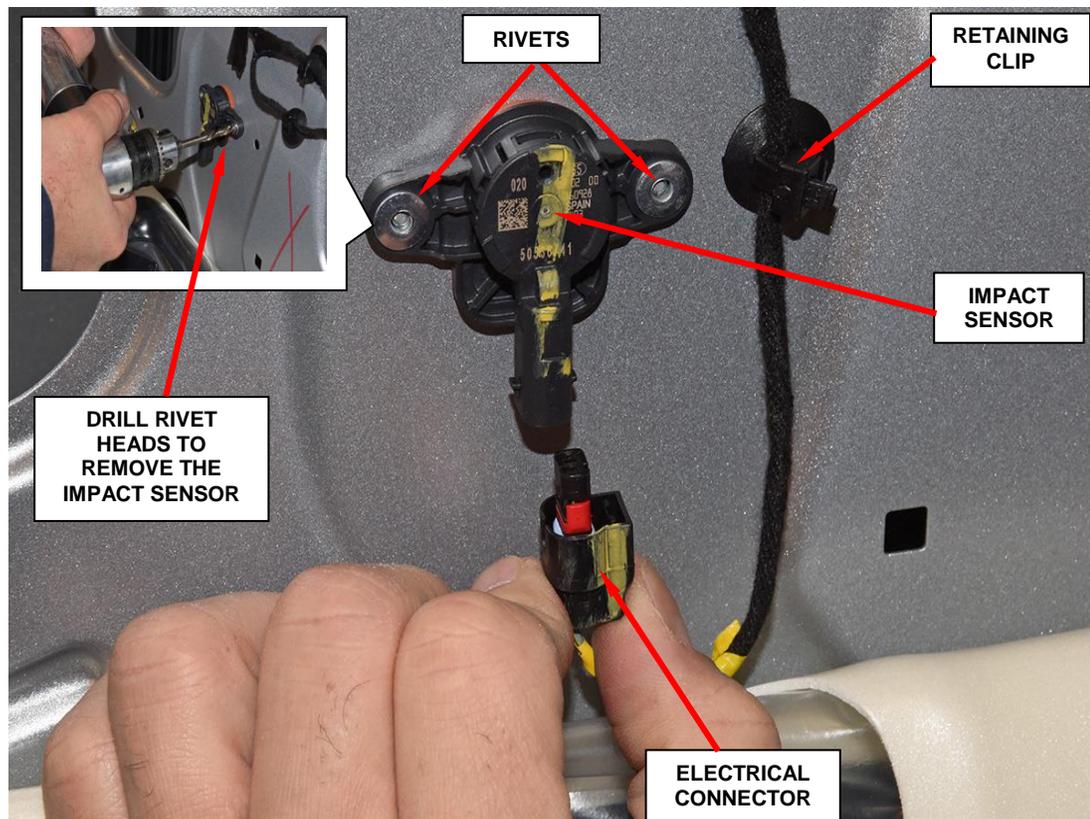
**Figure 10 - Impact Sensor**

The front door impact pressure sensors on about 3,500 of the above vehicles may have been fractured during installation. A fracture of the sensor housing could, in some instances, compromise the integrity of the sensor retention or gasket seal to door inner. This issue may increase the risk of injury to front seat occupants during certain side impact crashes if sensor retention or gasket seal to door inner is not maintained.

6. Disconnect the impact sensor electrical connector from the impact sensor connector receptacle and release the retaining clip from the door (Figure 10).
7. Using a drill and the recommended (4.76mm or 3/16in) drill bit, carefully remove the two blind rivets that secure the impact sensor to the door inner panel (Figure 10).

**NOTE: If necessary, after removing the impact sensor, grind the rivet off while holding the rivet on the inside of the door opening with vise grip pliers or equivalent.**

8. Remove and **discard** the sensor from the front door.

**NOTE: Remove any rivet material from the inside of the door opening to avoid rattles.**
