TECHNICAL INSTRUCTIONS

SAFETY (NONCOMPLIANCE) RECALL H0W

ELECTRONIC PARKING BRAKE (EPB) - SKID CONTROL ECU REPROGRAM

CERTAIN 2018 C-HR

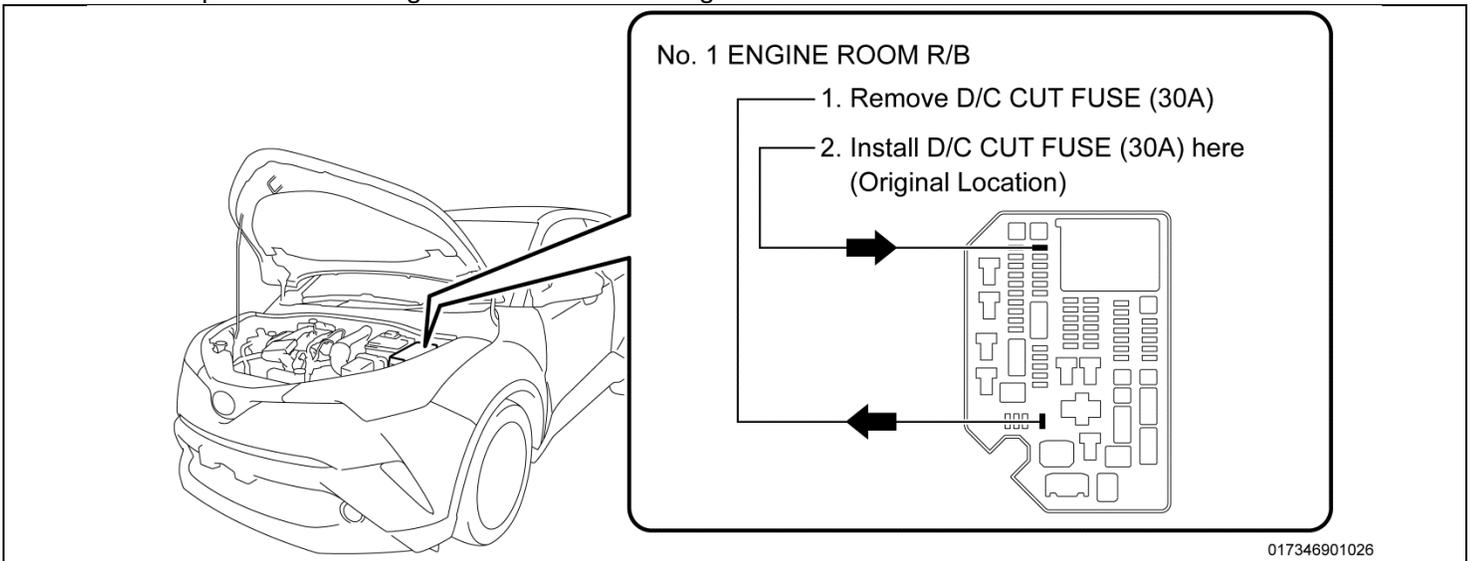
- a) In order to Skid Control ECU reflashing, it is necessary to reinstall the D/C CUT FUSE (30A) stored in the blank space of No. 1 engine room R/B in the original location as shown in the illustration.

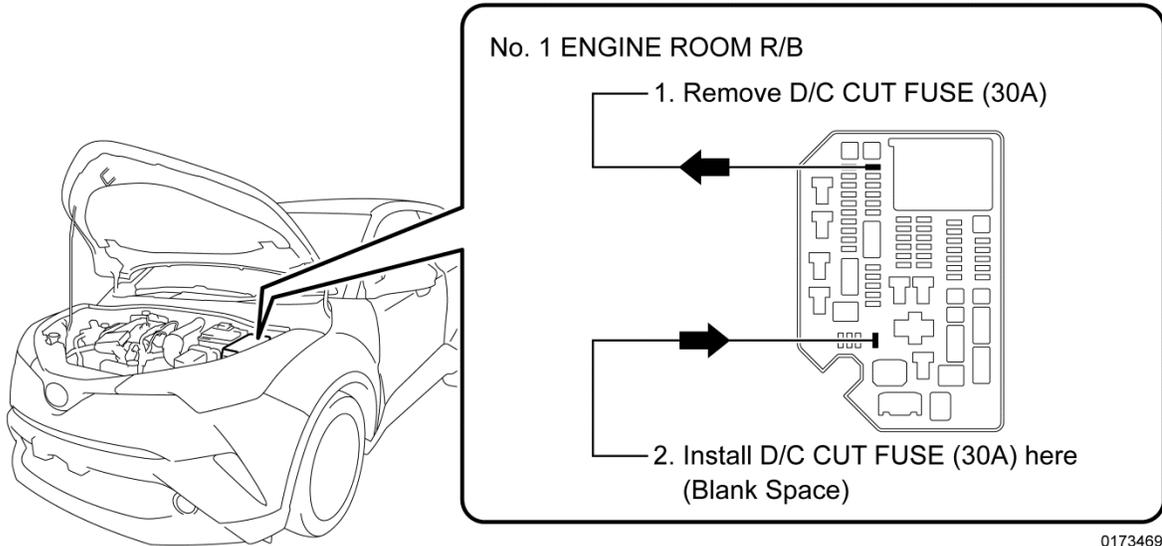
To reduce the parasitic current draw in storage, remove the D/C cut fuse (30 A) of the No. 1 engine room R/B and store it in the blank space as shown in the illustration. The D/C CUT FUSE (30A) reinstall to the original location during PDS (Pre- Delivery Service) at the dealership.
