DELIVERY STOP & RECALL 17V-XXX: INSTRUMENT PANEL DISPLAY

This Service Information bulletin replaces SI B62 16 17 **dated November 2017**

**Instrument Panel Display
Non-Compliance Recall 17V-xxx
Model Year 2018
2 Series / 5 Series / X2 SAV / X3 SAV
*Last Updated 11/10/2017***

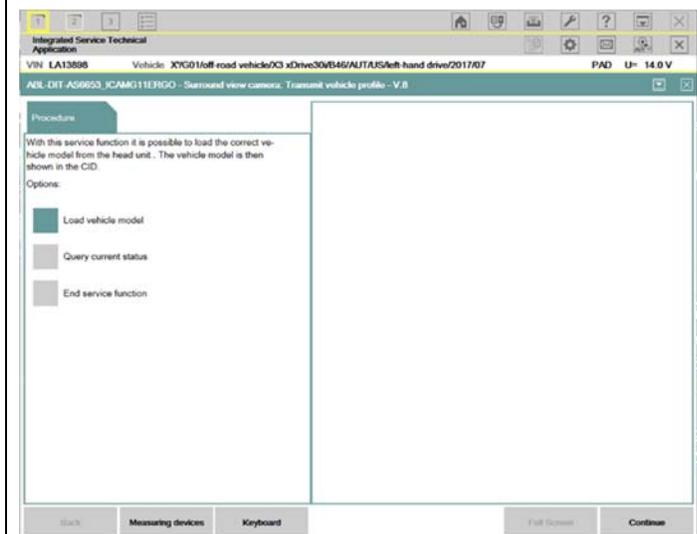
8. Check the fault memory after for FC 800B8A “TRSV: vehicle type not updated.
9. Calculate the test plan.

10. Select “Load vehicle model” and finish the test plan.
11. Turn the ignition off and let the vehicle sleep (for at least 2 minutes).
12. Make sure that all faults are corrected and that the correct model is displayed I the iDrive.
