SI B31 05 17
Front Axle

January 2018
Technical Service

SAFETY RECALL 17V-727: VEHICLE SUSPENSION BOLTS

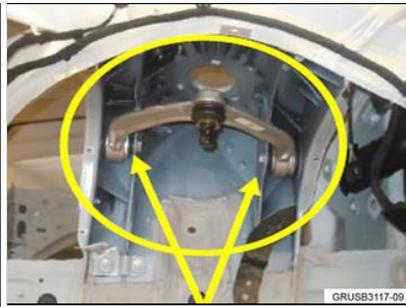
1. Wishbones
 - A. Remove wheel housing cover (front part) left and right as per RA 51 71 038.
 - B. Remove wheel housing cover (rear part) left and right as per RA 51 71 039.

Vehicles may have been produced with an incorrect tightening torque on the suspension bolts.

C. Visually check on both sides that the nuts and bolts are contacting flat to the contact surface.
 D. If not, replace nut with new one and torque bolt (not nut) as per RA to 38 Nm + 90° +/- 15°
 E. If yes, mark screw head to see if screw head moves when torquing to 38 Nm. When torquing hold nut turn screw.

- if the screw head did not move the connection is OK
- if the screw head moved the nut needs to be replaced with a new one and he connection needs to be torqued as per RA to 38 Nm + 90° +/- 15°

Note: When replacing the nut on the wishbones, the front left and right ride-height has to be set to normal loaded position before the connection can be tightened/torqued.
