GROUP Safety Recall Campaign	MODEL 2018MY Sorento (UMa)
	NUMBER SC159 (Rev 2, 1/24/2018)	DATE December 2017

SUBJECT: SIDE CURTAIN AIRBAG REPLACEMENT (SC159)

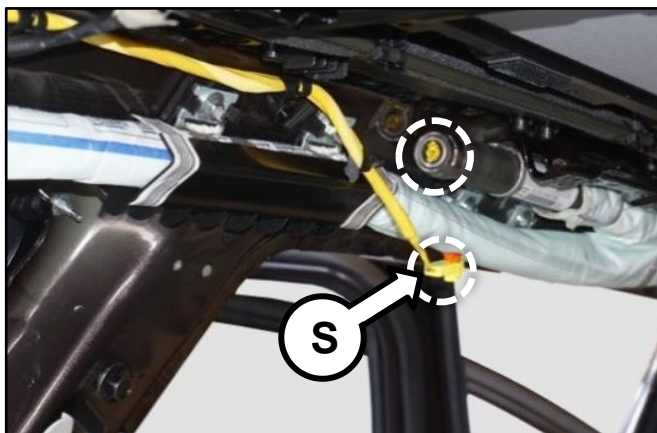
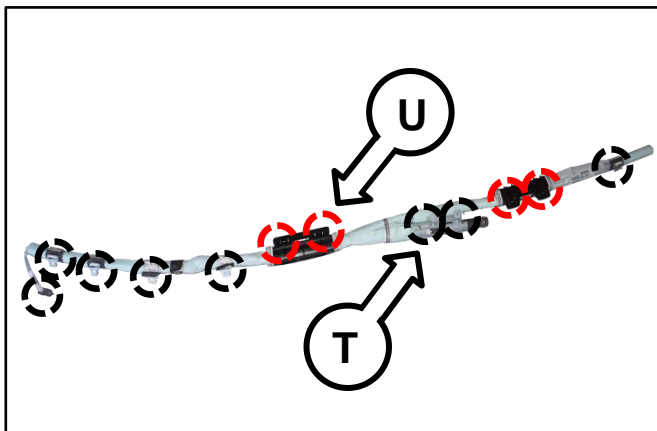
This bulletin provides the procedure to replace both Side Curtain Airbags on certain 2018MY Sorento (UMa) vehicles, produced from September 5, 2017 through November 29, 2017. The inflator in the side curtain airbag is equipped with a top hat diffuser. Some diffusers formed improperly during the manufacturing process. In the event of a crash necessitating deployment of the side curtain airbag, the diffuser may detach and could possibly enter the vehicle occupant compartment, thus increasing the risk of occupant injury.

22. Disconnect the yellow side curtain airbag harness connector (S) from side airbag module. Repeat for the opposite side.
23. Remove the eight (8) retaining bolts (T) and four (4) retaining nuts (U) and remove the side curtain airbag module. Repeat for the opposite side.

Bolt: 5.8 – 8.7 lb-ft (7.8 – 11.8 N.m,
0.8 – 1.2 kgf.m)

Nut: 2.9 – 4.3 lb-ft (3.9 – 5.9 N.m,
0.4 – 0.6 kgf.m)

24. Install the improved side curtain airbag module then reinstall all removed components in the reverse order of removal.
