GROUP Safety Recall Campaign	MODEL 2018MY Sorento (UMa)
	NUMBER SC159 (Rev 1) 01/11/2018	DATE January 2018
SAFETY RECALL CAMPAIGN		
SUBJECT: SIDE CURTAIN AIRBAG REPLACEMENT (SC159)

This bulletin provides the procedure to replace both Side Curtain Airbags on certain 2018MY Sorento (UMa) vehicles, produced from September 5, 2017 through November 29, 2017. The inflator in the side curtain airbag is equipped with a top hat diffuser. Some diffusers formed improperly during the manufacturing process. In the event of a crash necessitating deployment of the side curtain airbag, the diffuser may detach and could possibly enter the vehicle occupant compartment, thus increasing the risk of occupant injury.

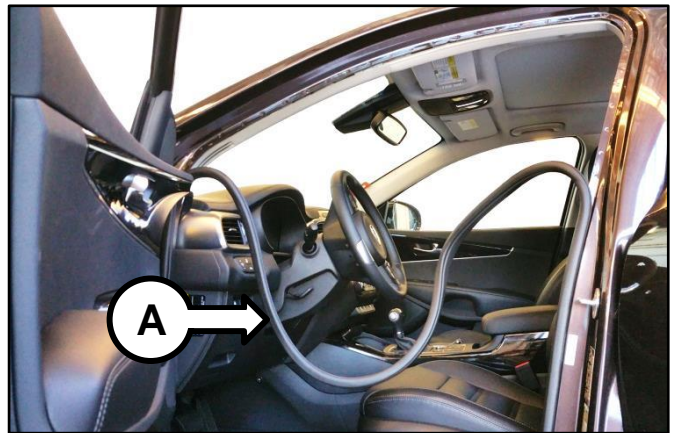
1. Lower the upper half of the front door weather-strip (A). Repeat for the opposite side.

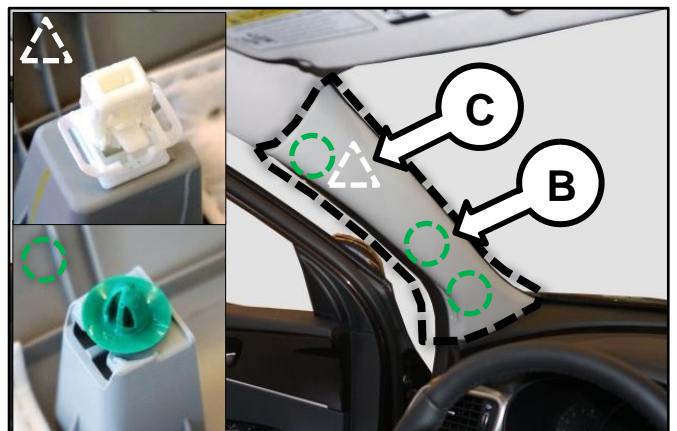
2. Use a non-marring trim removal tool and carefully unclip the three (3) inner green retaining clips (B) and one (1) inner white tether clip (C) and remove the A-pillar trim. Repeat for the opposite side.

Any broken interior pillar clips must be replaced prior to reinstalling trims. A-pillar tether clips (C) must be replaced.

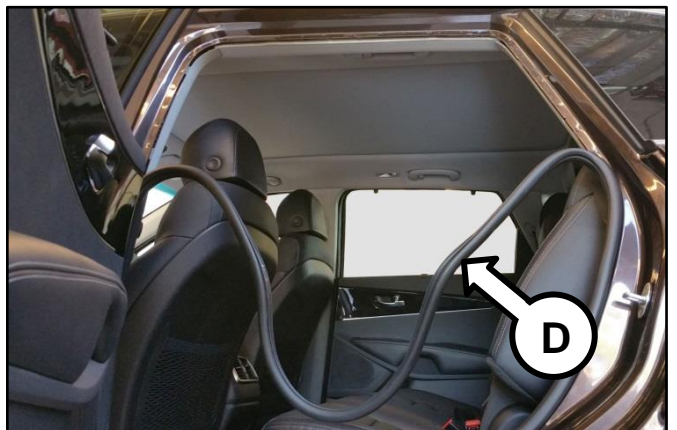
3. Lower the upper half of the rear door weather-strip (D). Repeat for the opposite side.

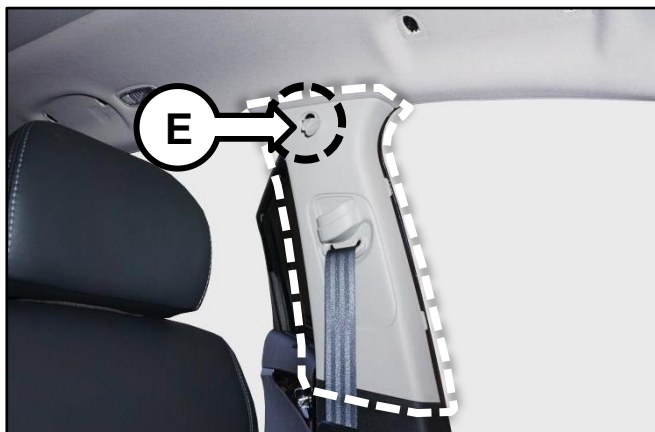
4. Using a pick tool, carefully pull open the B-pillar bolt cover and remove the B-pillar trim retaining bolt (E). Use a non-marring trim removal tool and carefully remove the B-pillar trim and let hang from seat belt. Repeat for the opposite side.

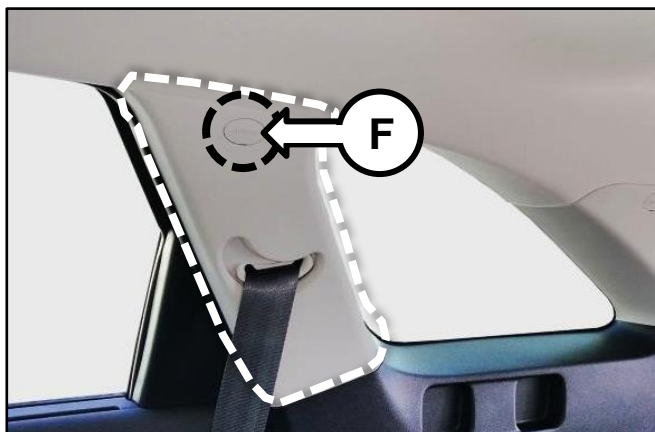
5. Using a pick tool, carefully pull open the C-pillar bolt cover and remove the rear C-pillar trim retaining bolt (F). Use a non-marring trim removal tool and remove the C-pillar trim and let hang from seat belt. Repeat for the opposite side.

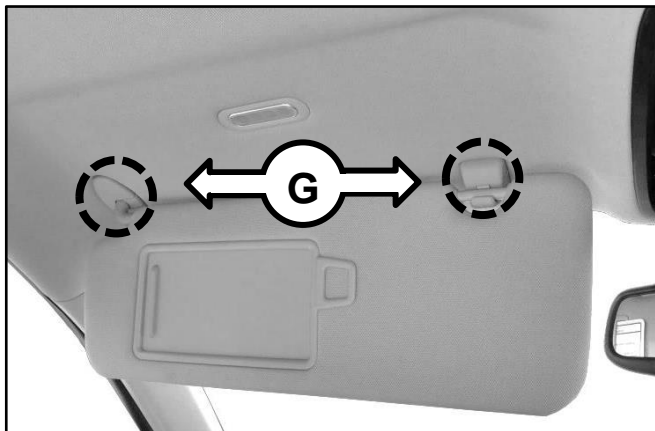
6. Remove the sunvisor from the retainer. Using a pick tool, carefully remove the two (2) sunvisor caps and remove the two (2) retaining bolts (G). Once the sunvisor is loose, disconnect the sunvisor lighting connector and remove the sunvisor. Repeat for the opposite side.

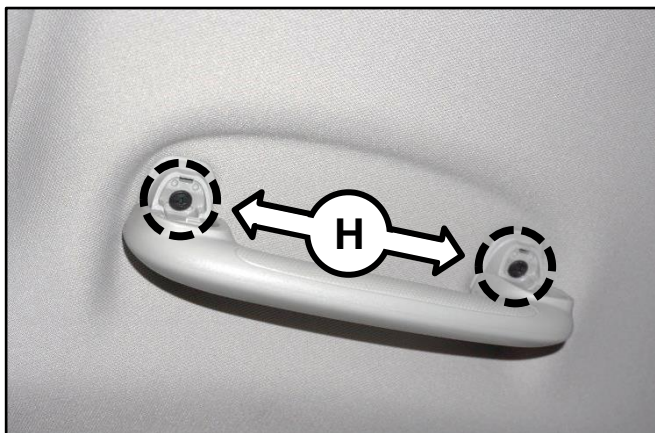
7. Using a pick tool, carefully pull open the two (2) assist handle caps. Remove the two (2) assist handle retaining screws (H) and remove the assist handle. Repeat for the remaining three (3) assist handles located on the roof trim (headliner).

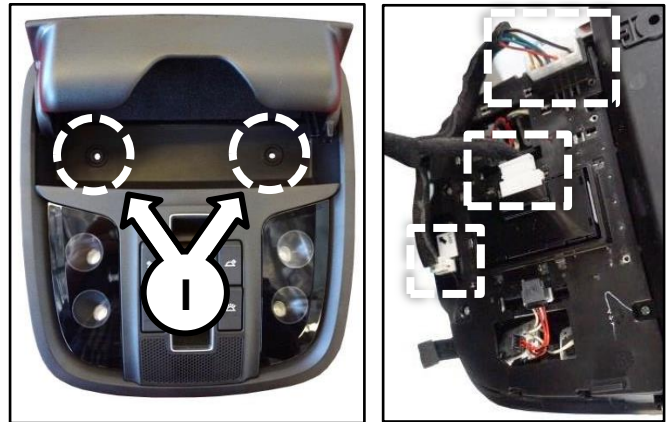
8. Open the overhead storage cover and remove the two (2) overhead console retaining screws (I). Lower the overhead console and disconnect the three (3) connectors on back side and remove the overhead console.

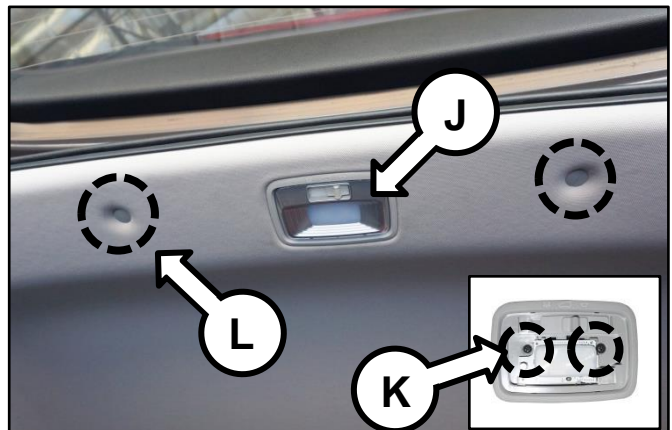
9. Carefully remove the luggage room lamp (J) lens with a small flat-tip screwdriver. Remove the two (2) lamp retaining screws (K) and lower the luggage lamp. Disconnect the luggage room lamp connector and remove the lamp.

Carefully remove the two (2) roof trim rear retaining clips (L) using a non-marring tool.

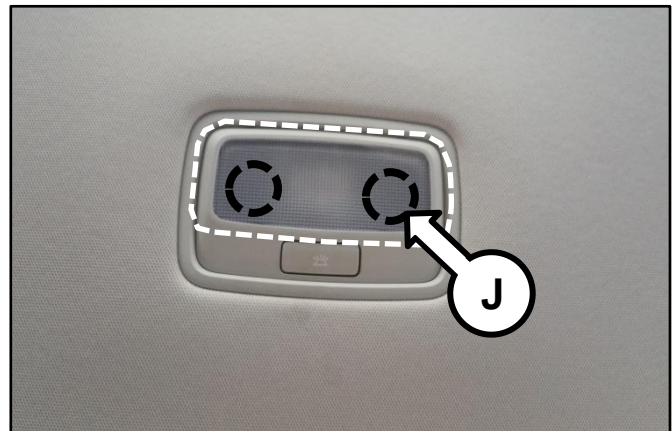
10. If equipped with center room lamp (non-panoramic roof models), carefully remove the room lamp lens using a small flat-tip screwdriver. Remove the two (2) lamp retaining screws (J) and lower the room lamp then disconnect the room lamp connector and remove the lamp.

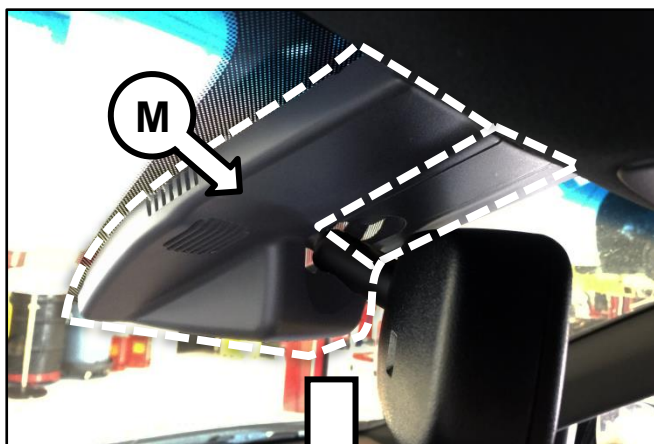
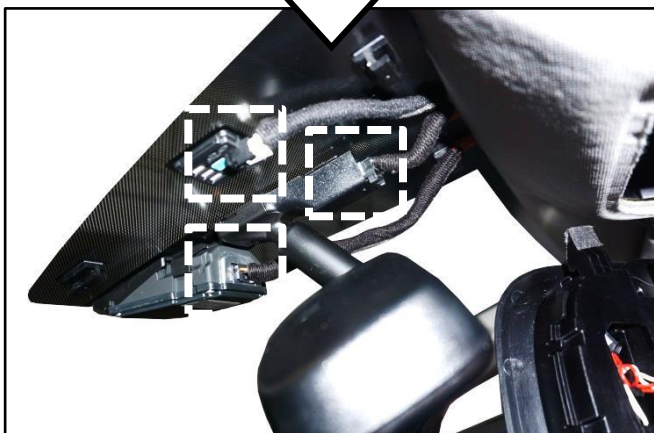
13. If applicable, tilt the inside rear view mirror downwards then carefully remove the mirror cover and the Lane Departure Warning System (LDWS) cover (M) and disconnect all related connectors, as shown.

NOTE: Do not remove the rear view mirror assembly from the windshield as it not required.

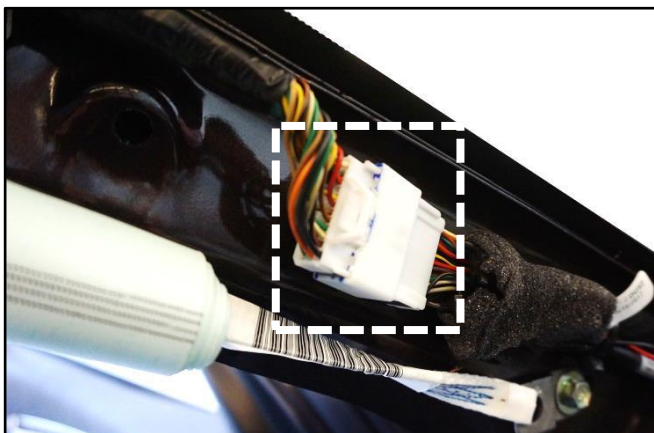
15. Disconnect the front roof trim connectors located at both driver and passenger A-pillars.

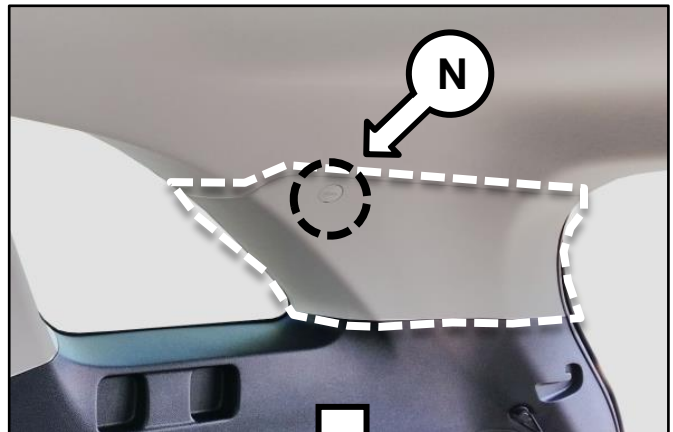
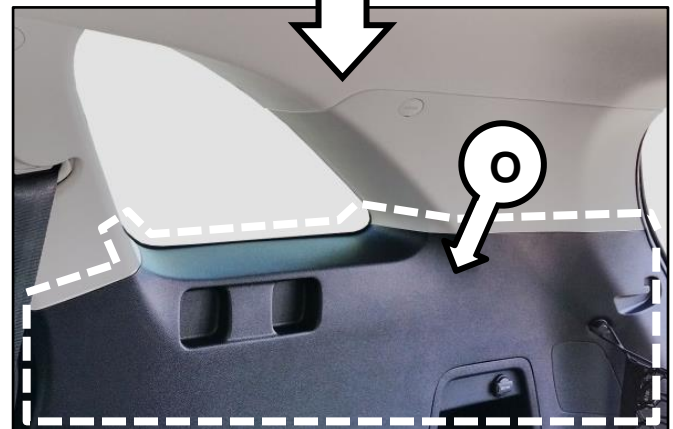
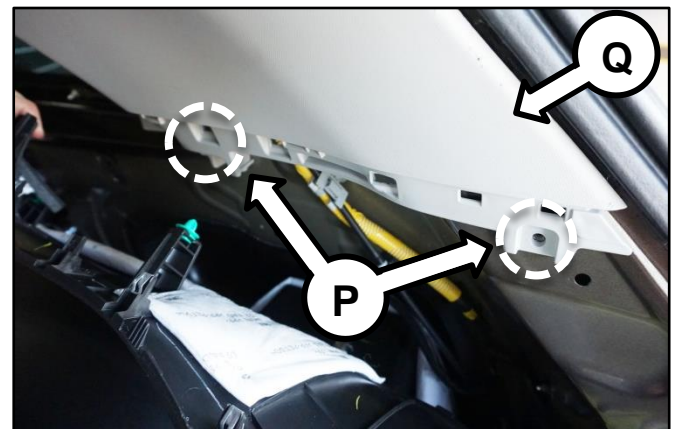
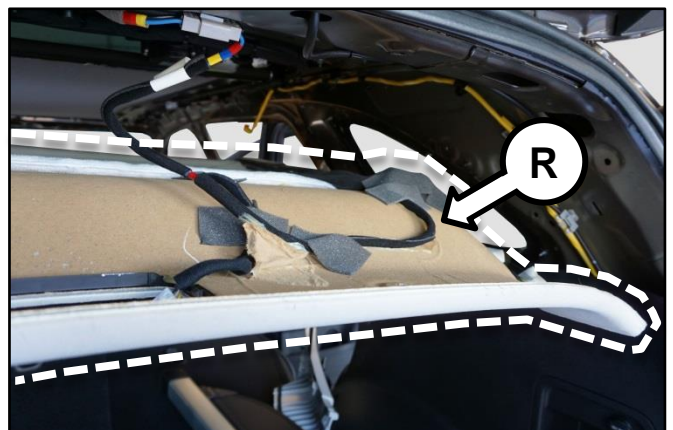
16. Using a pick tool, carefully pull open the bolt cover and remove the tail gate pillar trim retaining bolt (N). Repeat for the opposite side.

17. Use a non-marring removal tool and unclip the upper section of the lower luggage side trim (O) and carefully pull the trim away approximately 6 inches to allow room for the next step (19). Complete removal of the lower luggage side trim is not required.

18. Remove the two (2) retaining bolts (P) then use a non-marring removal tool and unclip and remove the tail gate pillar trim (Q).

20. Tilt the front seats forward to a normal seating position then beginning at the front, carefully lower the headliner (R) and allow the roof trim to rest on front headrests. Allow the rear of the roof trim to hang.
